Heritage Audit and Landscape Assessment for the Nene Park Trust 2018

For and on behalf of the Nene Valley Archaeological Trust

At the instruction of the Nene Park Trust (NPT) and funded by the Heritage Lottery fund the Nene Valley Archaeological Trust were commissioned to carry out a full heritage audit and landscape assessment of land within the Nene Park Trust's land holding and management areas. This work was carried out between February and August 2018 by Dr Stephen Upex. The objective of this work was to itemise, record and comment upon all heritage assets with regard to their importance, present state of conservation and the current understanding, in terms of date and function, of these heritage assets. These assets comprised a variety of sites and finds, both historical and archaeological, some as upstanding structures, some as hidden or buried archaeological features and some as individual find spots of coins or pottery of only minor importance. The area of the NPT's holding comprises 137 separate entries within this heritage audit of which some entries consist of large complexes containing multi period and archaeologically detailed landscapes of international importance.

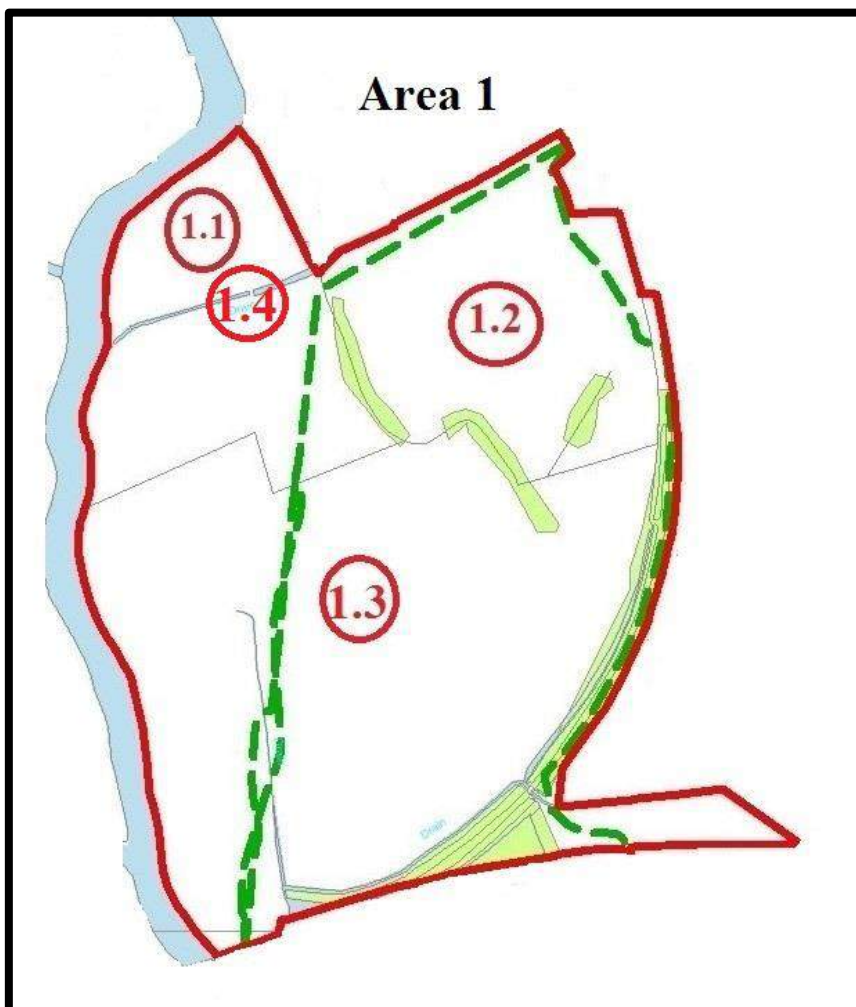
*Figure 1.1 Area 1 and its historical and archaeological assets.
(Site numbers refer to the listed sites below)*

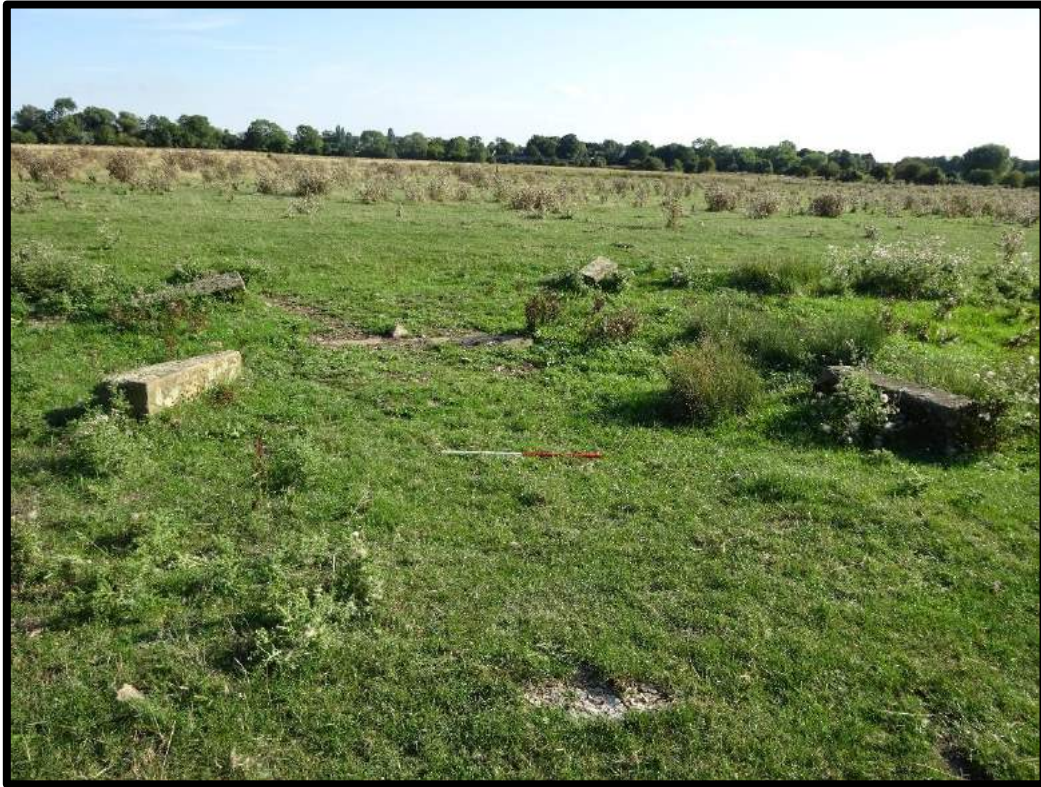
Figure 1.7. *The four stone blocks for site 1.4 looking south (SGU 2018)*

Four stone blocks, each approximately 1.30m long, which appear to mark the crossing of a culverted dyke (Figure 1.7 and Figure 1.8). The stones do not appear to have been gate posts as there are no drill holes to take gate hinges. Geologically the stones seem to be of local

limestone and may be originally derived from the railway line, some 400m to the east. Their function is unclear.

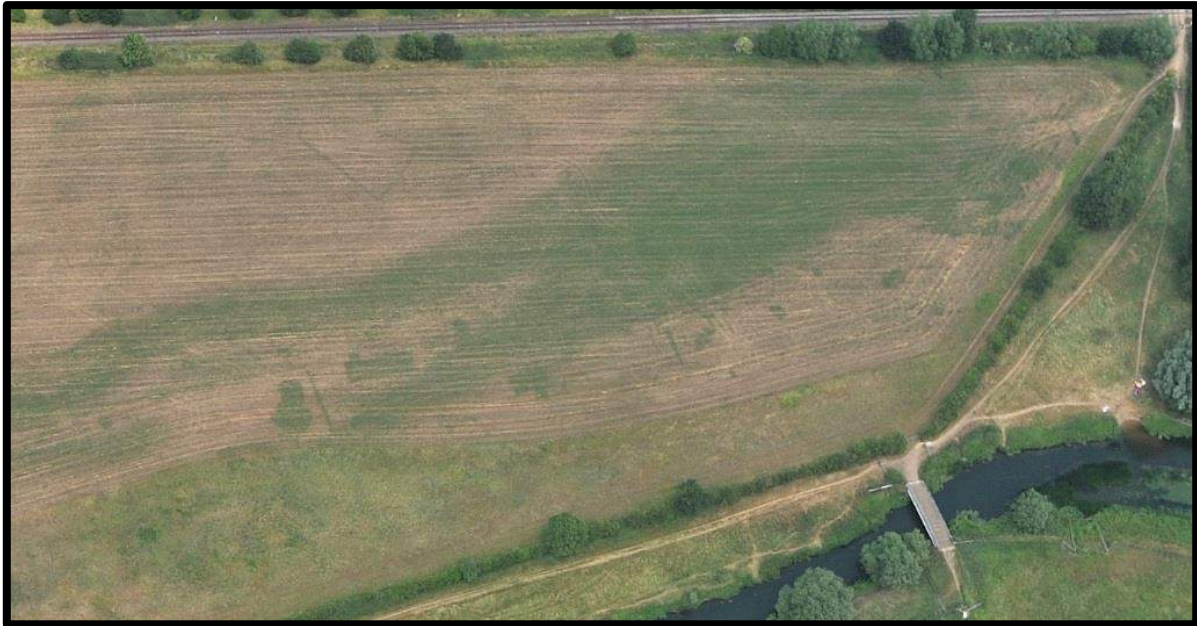
Figure 2.7 Site 2.1 looking north with the railway line at the top of the frame. The dark irregular and regular outlines may be a combination of Artis' irregular excavation areas, shown for example in Figure 2.5 above, or possibly minor quarrying at some unknown period for aggregate. Equally these regular shaped areas may represent water being retained within the outlines of Roman walls which have caused the crop to remain greener for longer. The enclosure (site 2.5) is shown to the south of the railway line. (NVAT/A&CPC & St. K's Collection)

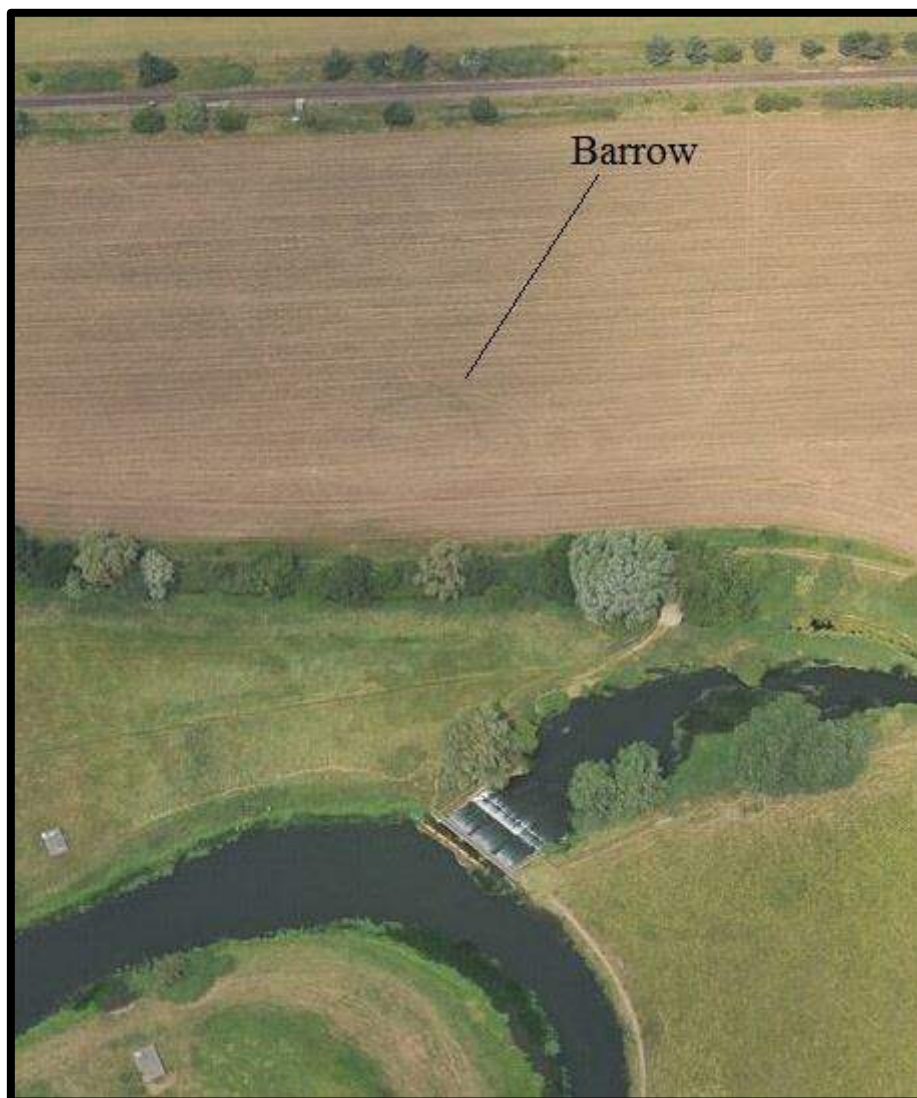
A probable ring ditch or ploughed out Bronze Age barrow shown in plan in Figure 2.10 where it appears to lie under (?) the Roman villa (Site 2.2). The ring of the ditch is rather irregular and approximately 45-50 feet (13.75 x 15.25m) in diameter. The feature shows on recent air photographs (Figure 2.11) and others (CUAPC; RAF Verts F22/58; 5164:0149) as a green ring and one might thus assume that it is a ditched feature. The centre of the ring shows as a slight mound and is shown on the Lidar view shown in Figures 2.15 & 2.16 below.

Figure 2.11. The ring of a Bronze Age barrow (Site 2.6) showing in the area of the Roman villa (Site 2.2) (NVAT/A&CPC & St. K's Collection)

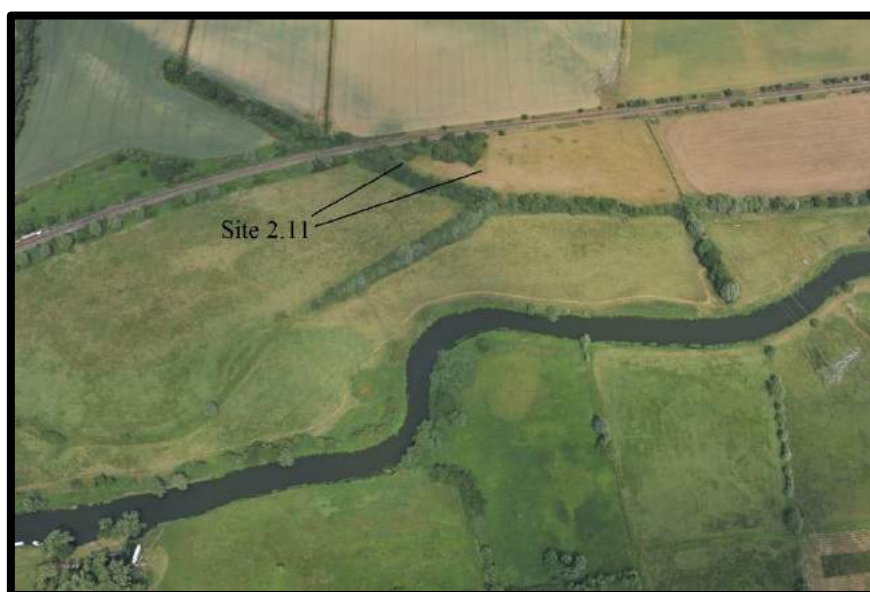
Figure 2.14. The position of Site 2.11 to the south of the railway line. This site is also shown on the Lidar image shown in Figure 2.13a (above)

An area of probably quarrying for gravel (?) set against the railway line (see Figure 2.14) to the north and marked by a hedged boundary which is shown on the 1845 Tithe map of the parish of Sutton (NRO Map T18). This site may be associated with the railway and could have been used to extract ballast for the line's construction. The railway line cuts across the southern area of field 145 shown on the Tithe map and this small piece of land was thus isolated from the rest of the field area and would have been difficult to plough due to its shape and thus may have been taken as a 'borrow-pit' for the railway line.

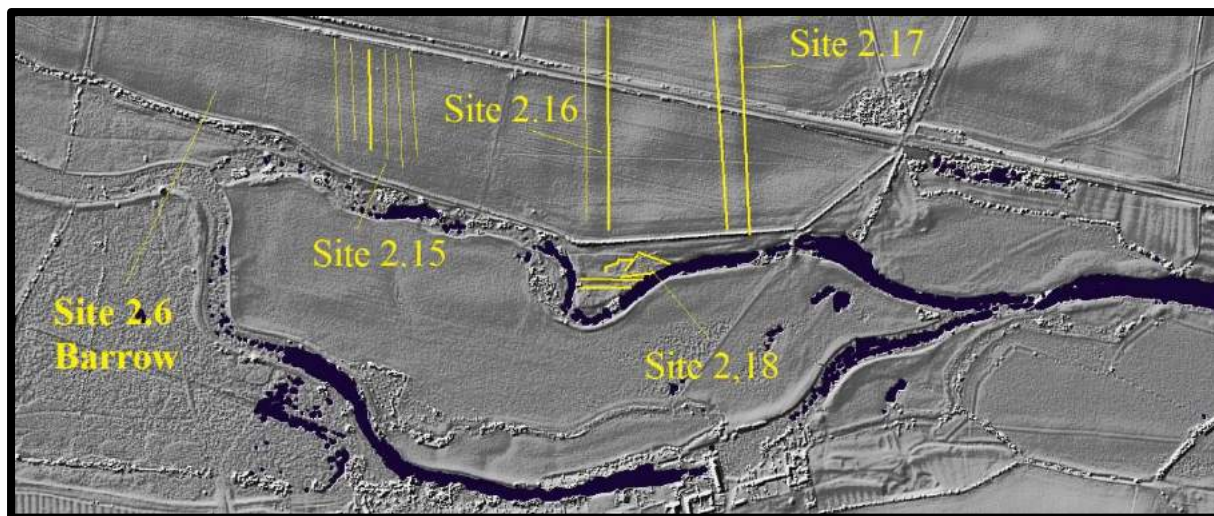
Figure 2.15a Lidar image of the eastern part of Area 2 showing Sites 2.15- 2.18

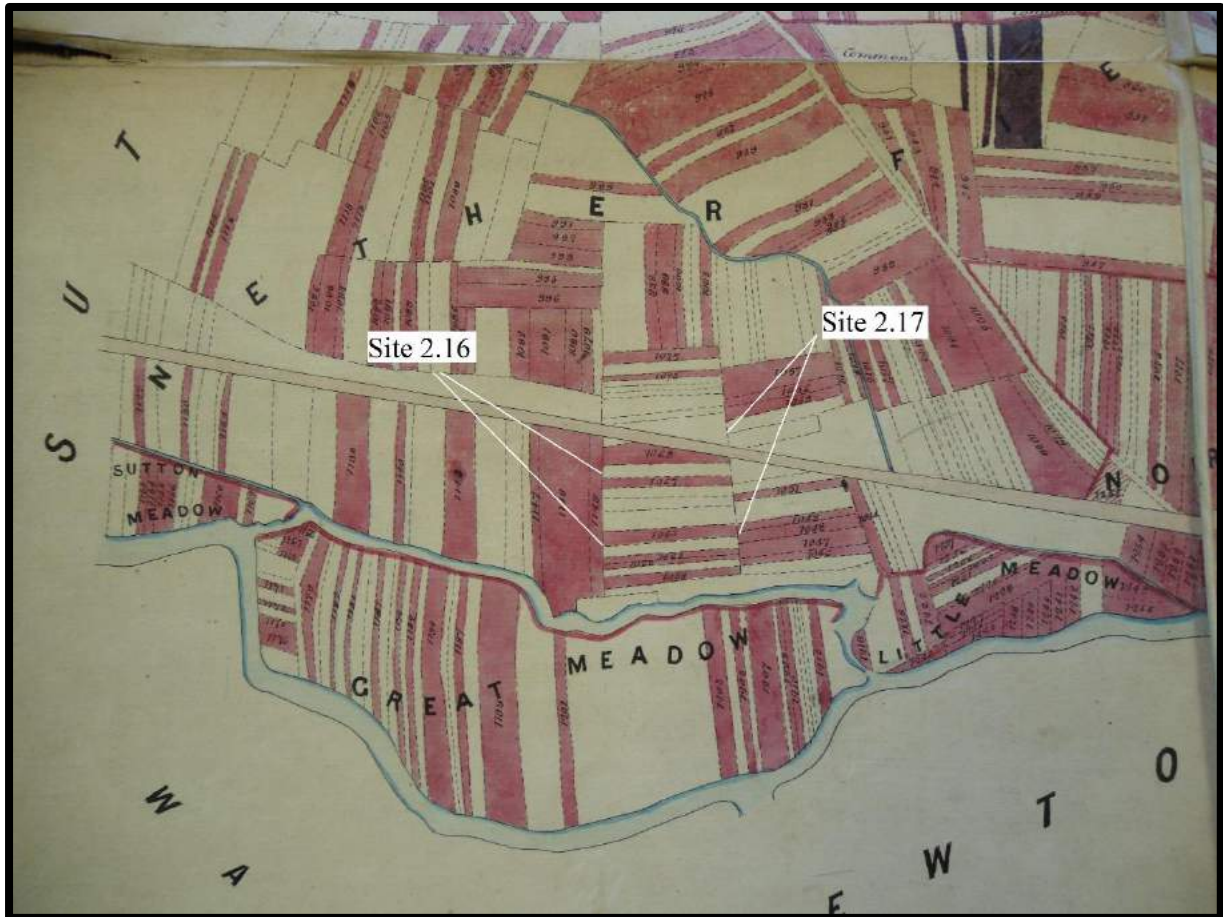
Figure 2.16. Map of Ailsworth and Castor dated 1892 showing the furlong layout within the eastern part of Area 2. (Private Collection)

A medieval ploughing headland/baulk related to the open field system of the parish (see Hall 1972; 198; 1995; Upex 1984 for ploughing headland formation). This headland is shown on

an open field map of 1892 (see Figure 2.16) and also on an earlier open field map of 1846 (NRO map T236).

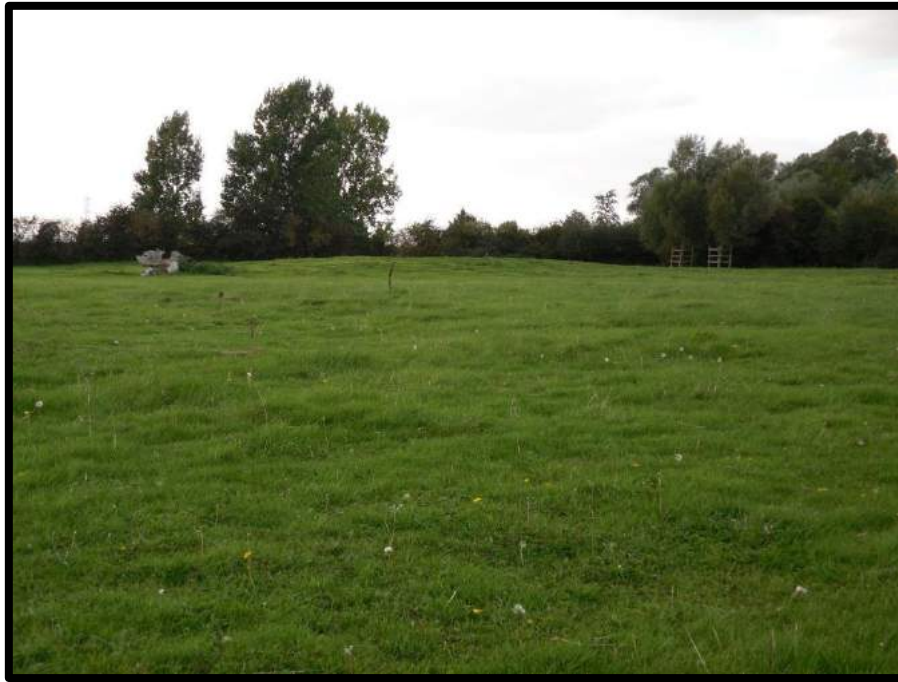
Figure 4.2. Site 4.1, A barrow of probable Bronze Age date looking to the north-west. The rise of the mound is shown to the right of the tree stump and to the left of the two fenced trees. (SGU2018)

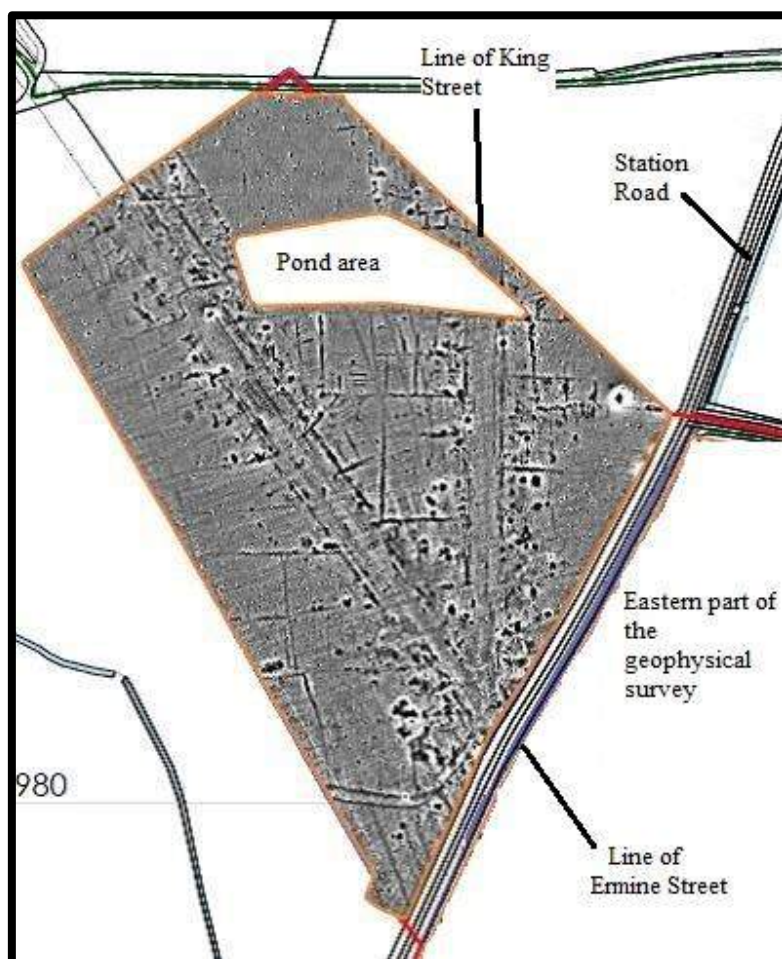
Figure 5.4 *The geophysical Survey of the scheduled area within Area 5.
(Taken from ASD. 2018. Fig 3) (ASD 2018)*

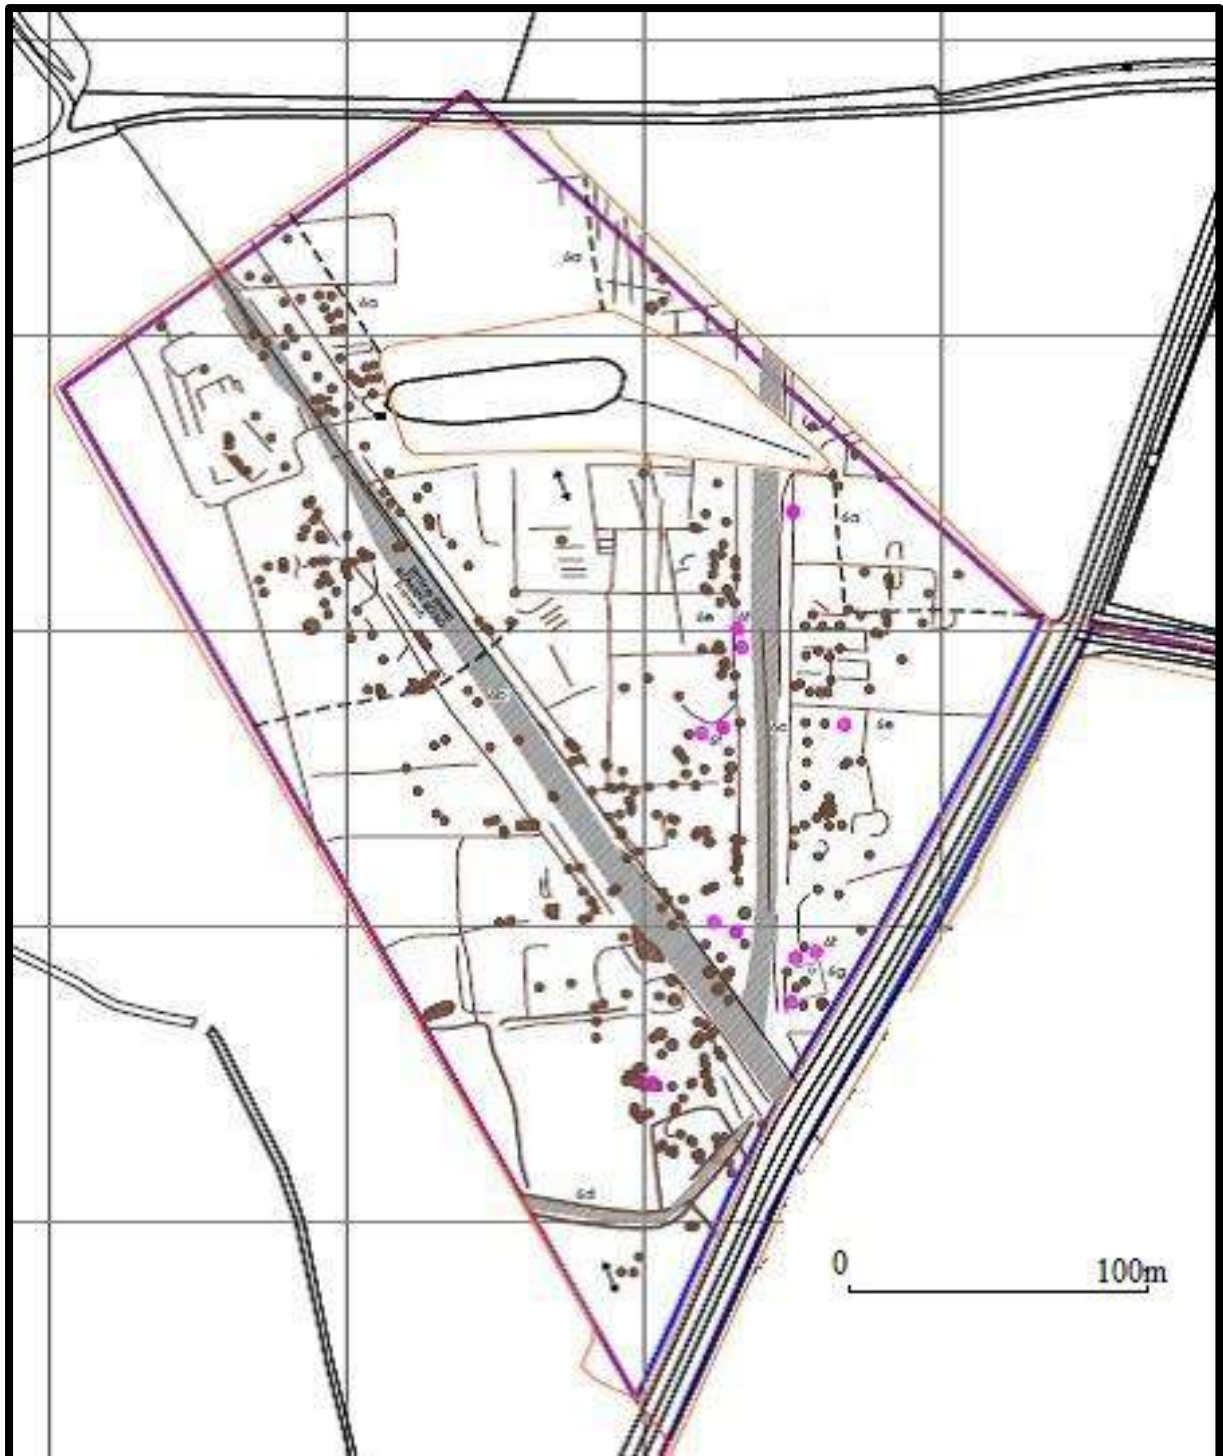
The details extracted from the ASD survey are shown in Figure 5.5 and the numbering system is referred to below. The north-west/south-east aligned Ermine Street has been detected across the centre of this area (**6b**). As in Areas 4 and 5 (of the geophysical survey) to the east, this corresponds to a slight ridge noted in the field. A former field boundary, shown on historic OS maps, also follows the course of Ermine Street. A north/south road has also been detected in the eastern part of the area (**6c**) and corresponds to a road identified as King Street (Road 26) in aerial photographic surveys. A narrower double-ditched road or track (**6d**) has been detected in the south of the area, aligned broadly east/west and turning to the north-east to join Ermine Street.

Figure 5.5. Archaeological interpretation of the geophysical survey. Numbering refers to numbers outlined within the text.

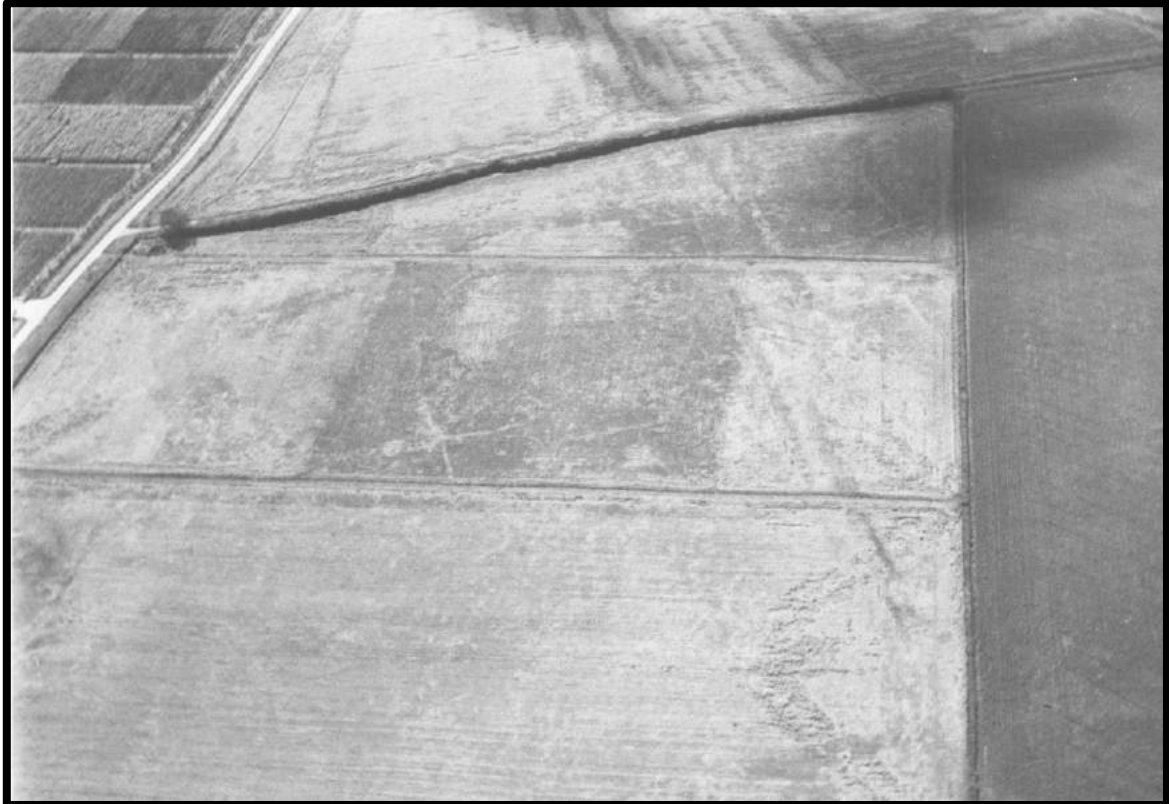
Figure 5.8 Air photograph looking south down the line of King Street, showing evidence of paddock enclosures set out to respect the line of the Roman road. Station road is on the left. (SGU/NVAT/1976)

A series of crop marks that extends to the north and outside of the scheduled area and that covered by the geophysical survey and shown in Figures 5.1 and 5.7. The links between both these crop marks and the features shown on the geophysical survey and shown in Figures 5.4, 5.5, & 5.6 suggest a series of paddocks extending along the line of King Street and set out to align with this road. In addition to the paddocks there are also what appear on the air photographs to be a series of enclosures of unknown date but probably prehistoric. These air photographs are shown in Figure 5.8 and 5.9

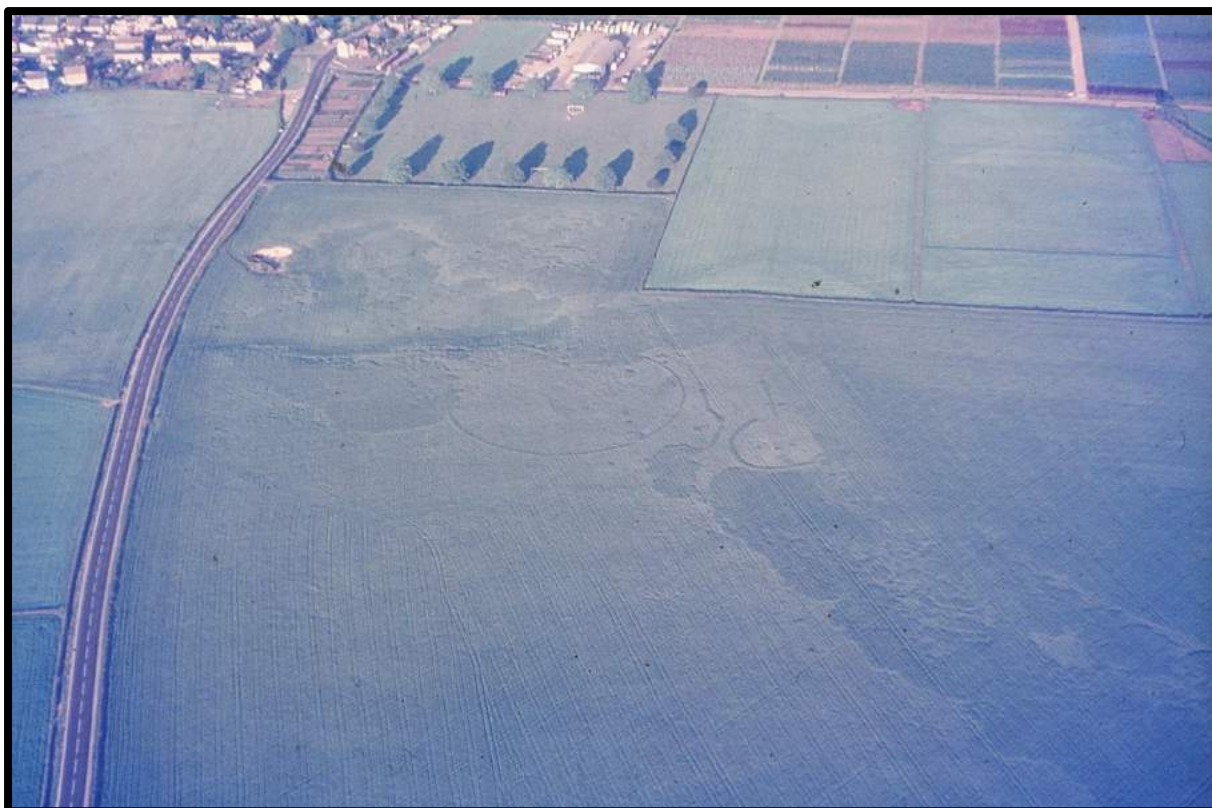
A large circular feature (250 feet /76m dia) showing as a crop mark (see Figure 5.10) on various air photographs (CUAPC & SGU/NVAT). The circle has no visible features within the centre but is probably a henge type monument of late Neolithic and early Bronze Age date. The ring is perhaps too large to be classed as a barrow. Close by are other crop marks of what the RCHM described as a ‘settlement’ (RCHM 1969, p 17 no 14) with a number of discontinued lengths of ditch including a semi-circular feature and covering 5 acres. This description may include in its extent the field boundaries and enclosures described here as Site 5.2. although they are in fact probably separate monuments and have been listed here as such. Henges are considered to be ceremonial monuments with a date range between the 3rd and 2nd millennium BC (Burl, 1976 chap. 2; Pollard, 2008 chap. 6; Bradley 2007).

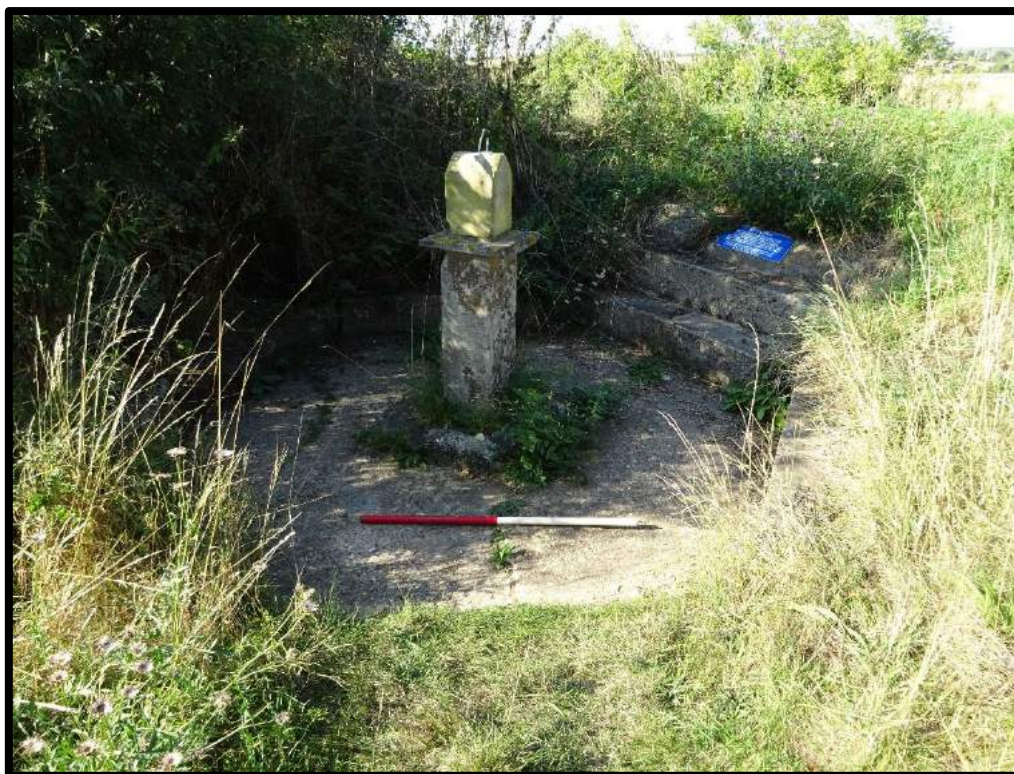
Sutton Cross at the junction of Ailsworth, Sutton and Upton parish boundaries. The site was in the medieval period the position of a medieval cross marking the junction of Sutton Crossways and Ermine Street. The cross is listed as a grade 2 Scheduled Monument (number 1127436) and was listed in 1974. The original medieval cross base is all that survives of the structure but the upper part of the cross has recently been replaced by a modern reproduction – which was recently (2018) vandalised (see Figure 5.12).

Figure 5.12. The base of Sutton Cross with the broken replacement upper part of the structure after vandalism in 2018. (SGU2018)

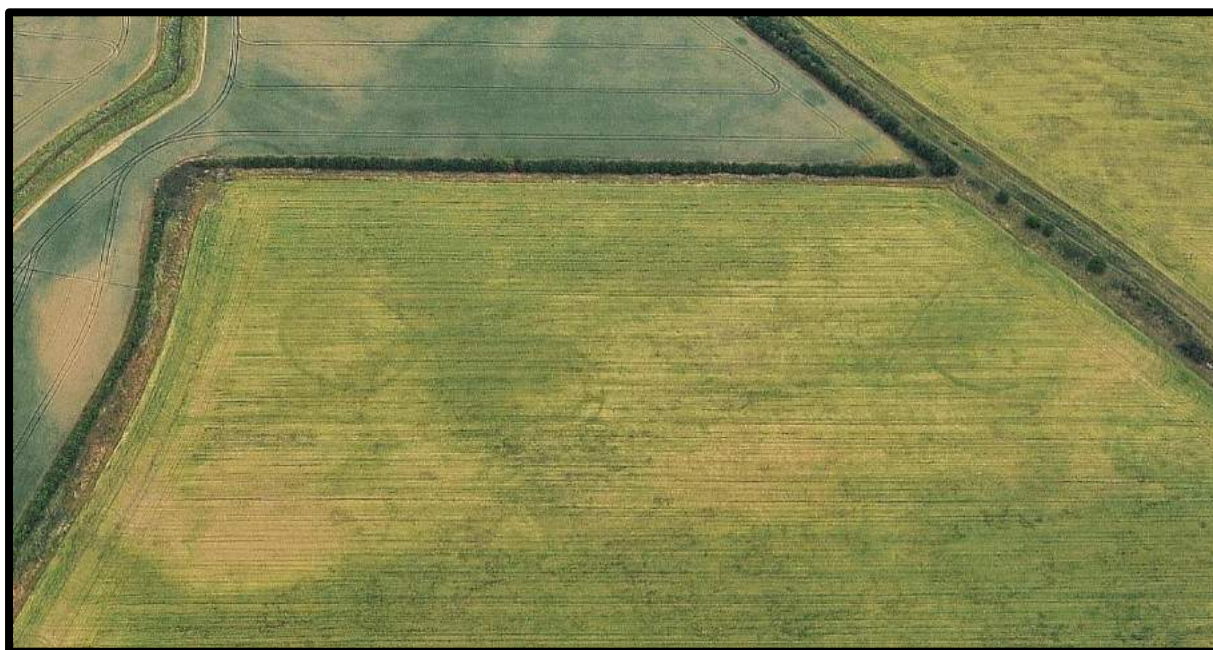
Part of a barrow cemetery consisting of 4 barrows represented by ring ditches on air photographs that also extends into Sutton parish to the west where other ring ditches are known. The barrows are shown in Figure 5.13. One barrow is cut by the modern hedge line (top left- Fig 5.13), two barrows are centre left, one with an inner circle, while the fourth is centre right. Above this barrow is the line of a ditch which extends through the area for 200m. Cutting under

the hedge line and to the right of the barrow is a trackway that runs into Area 5 for some 30m but extends to the north of the modern hedge for another 120m. This is not seen on the air photograph shown in Figure 5.13 but is marked on Figure 5.7.

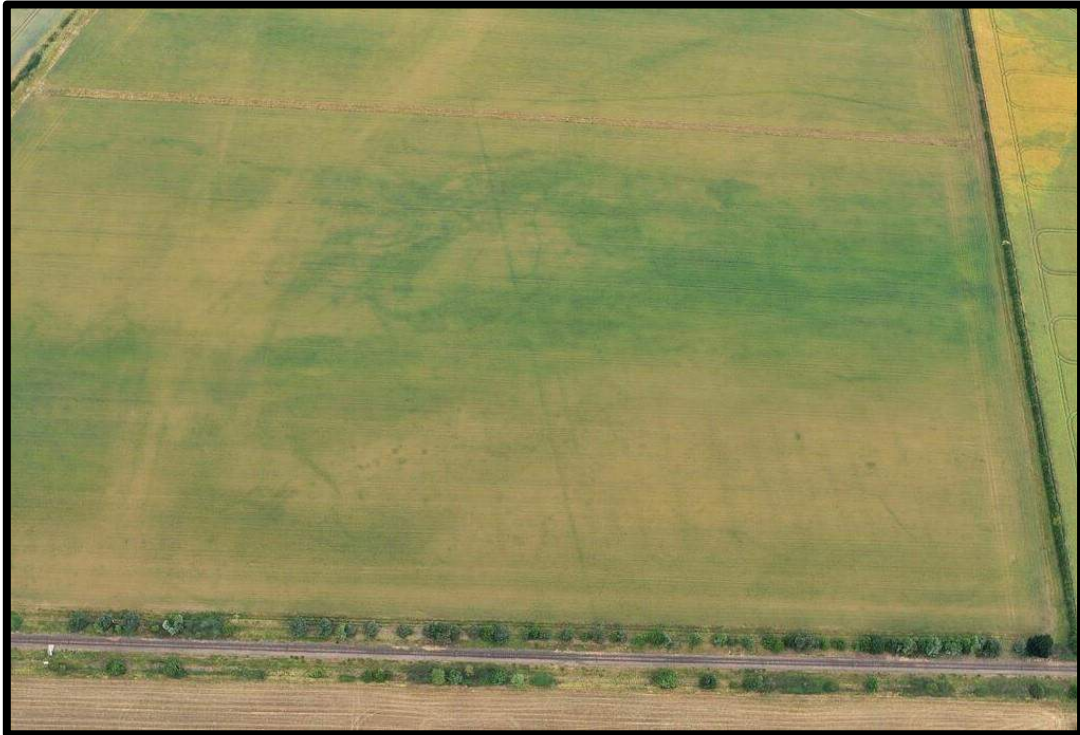
Figure 5.14a. The southern area of Area 5 looking north showing Sites 5.8, 5.9 and 5.10 The green area running left to right (centre) is an area of alluvial soil that probably represents former shallow stream courses of a geological period. (NVAT/A&CPC & St. K's Collection)

A ditch seen on air photographs traceable for 500m and running W.N.W- S.S.E. The southern part of this system appears to be a trackway which appears to end and a single ditch turns to

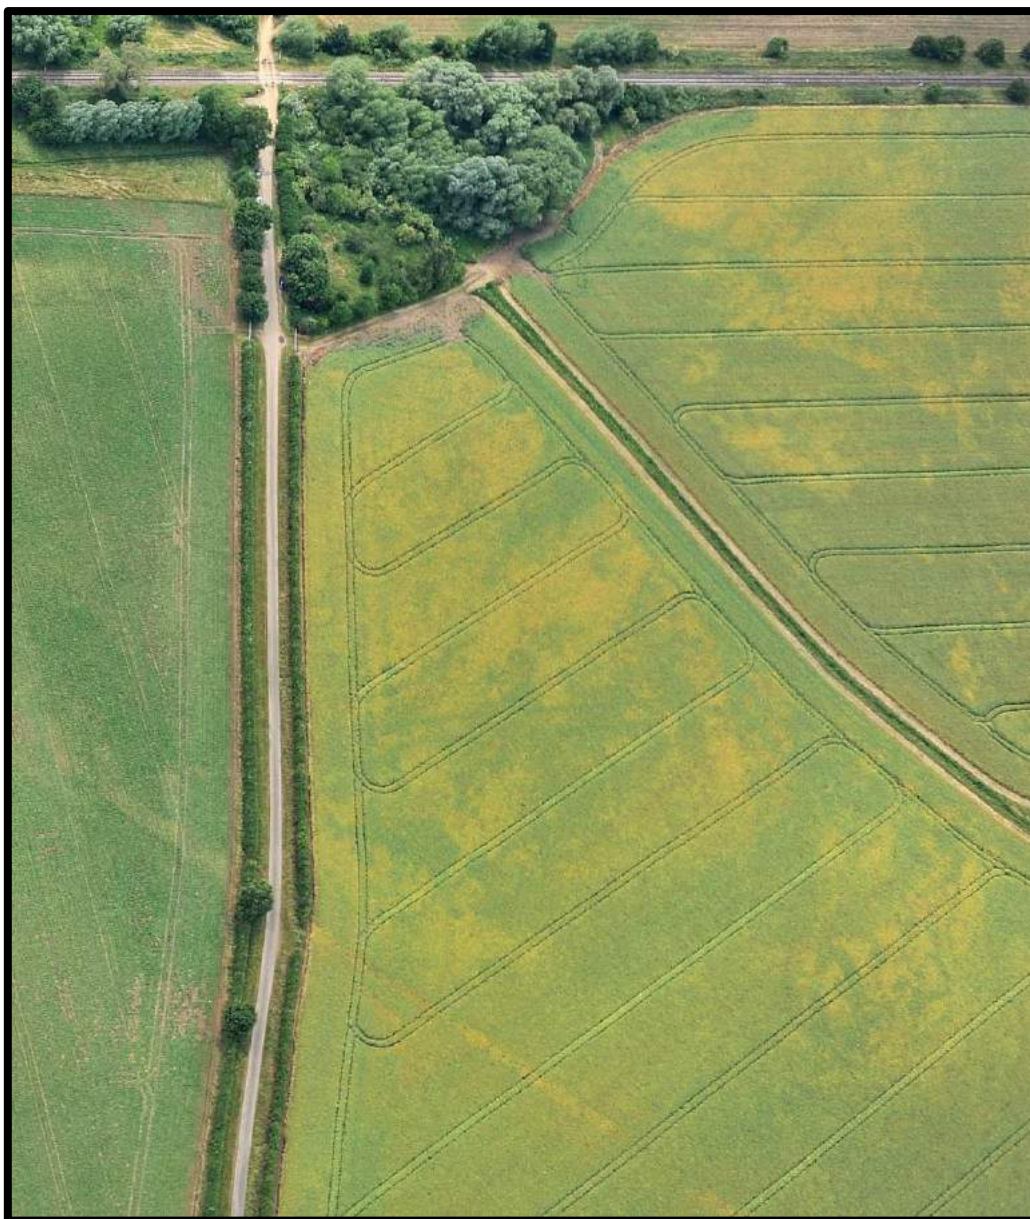
Figure 5.15. Trackway showing as a crop mark within part of the area of Site 5.11 looking south. Ermine Street is running obliquely across the frame (bottom left) and Station Road is running top to bottom (left). (NVAT/A&CPC & St. K's Collection)

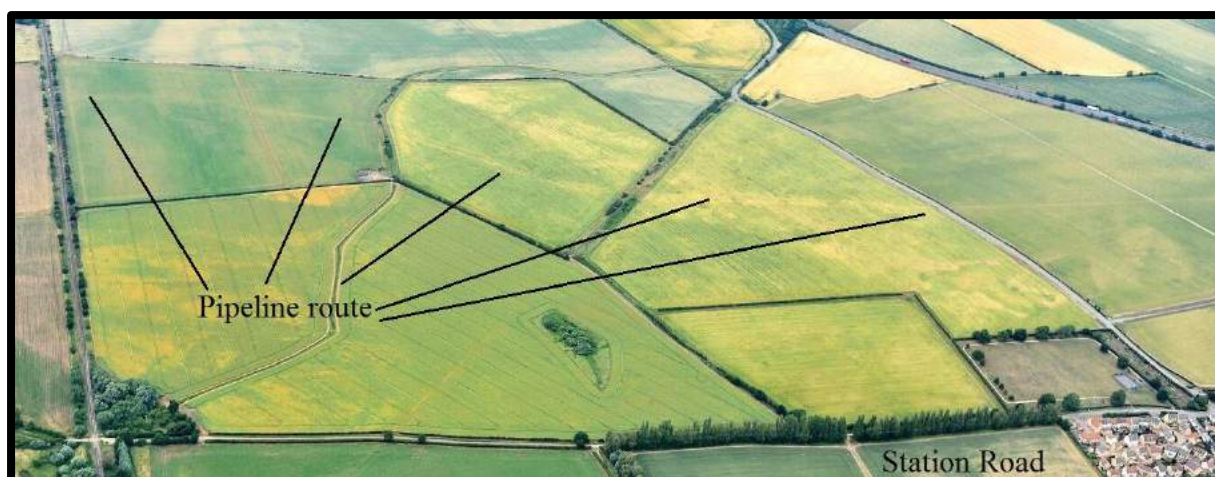
Figure 5.16 Air photograph looking west showing the route of the Transco Gas Pipeline showing as a crop mark. (NVAT/A&CPC & St. K's Collection)

The Sites 5.17 to 5.20 were cut as part of the Transco Gas Pipeline which ran across the area of Area 5 (see Network Archaeology 1997; 1998; 1999; 1999a & No date). The line of this pipeline is shown in Figure 5.16 and 5.17 (below).

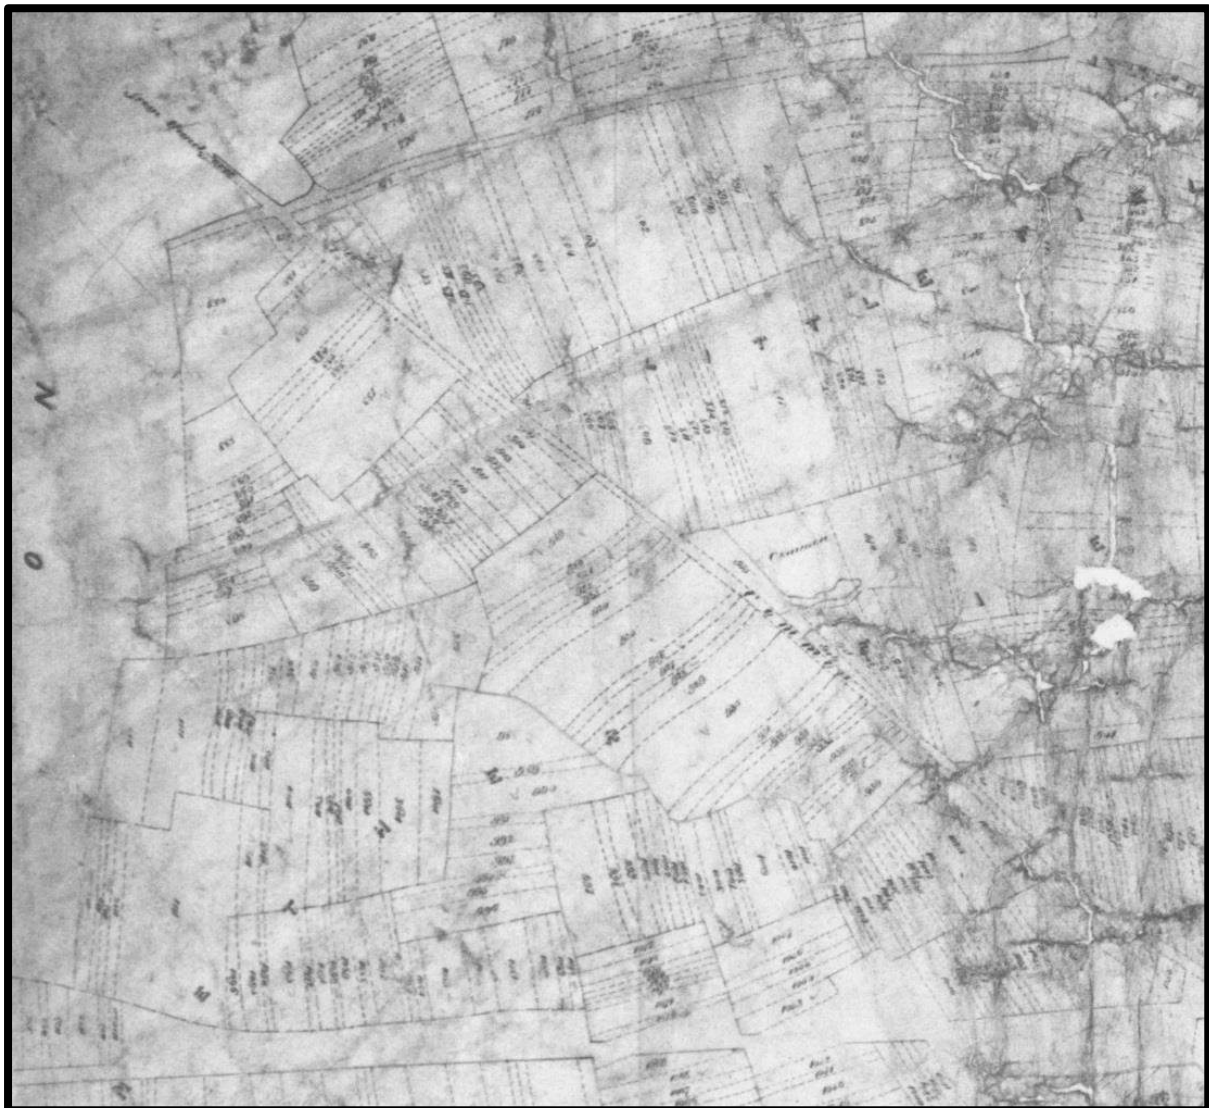
Figure 5.19 Detail of the open field map of Area 5 showing the layout of the furlongs and strips of land in 1846. (NRO map 236)

There are extensive remains of medieval headlands (Site 23) and ploughed out ridge and furrow (Site 24) within Area 5 which relate to the open fields of Ailsworth. These are shown on two open field maps of the area which are shown in Figures 5.19 and 5.20 and map out the furlongs within the open fields of Nether Field and Little Field. The headlands remain in their ploughed out form as low linear banks of earth which have accumulated over the centuries as ploughmen turned their ploughs at the same point and then cleaned the earth from the ploughs. Both King Street and Ermine Street formed major headlands as early ploughmen didn't want to risk damaging their ploughs over the underlying aggregate and metalling that forms the surfaces to both these roads.

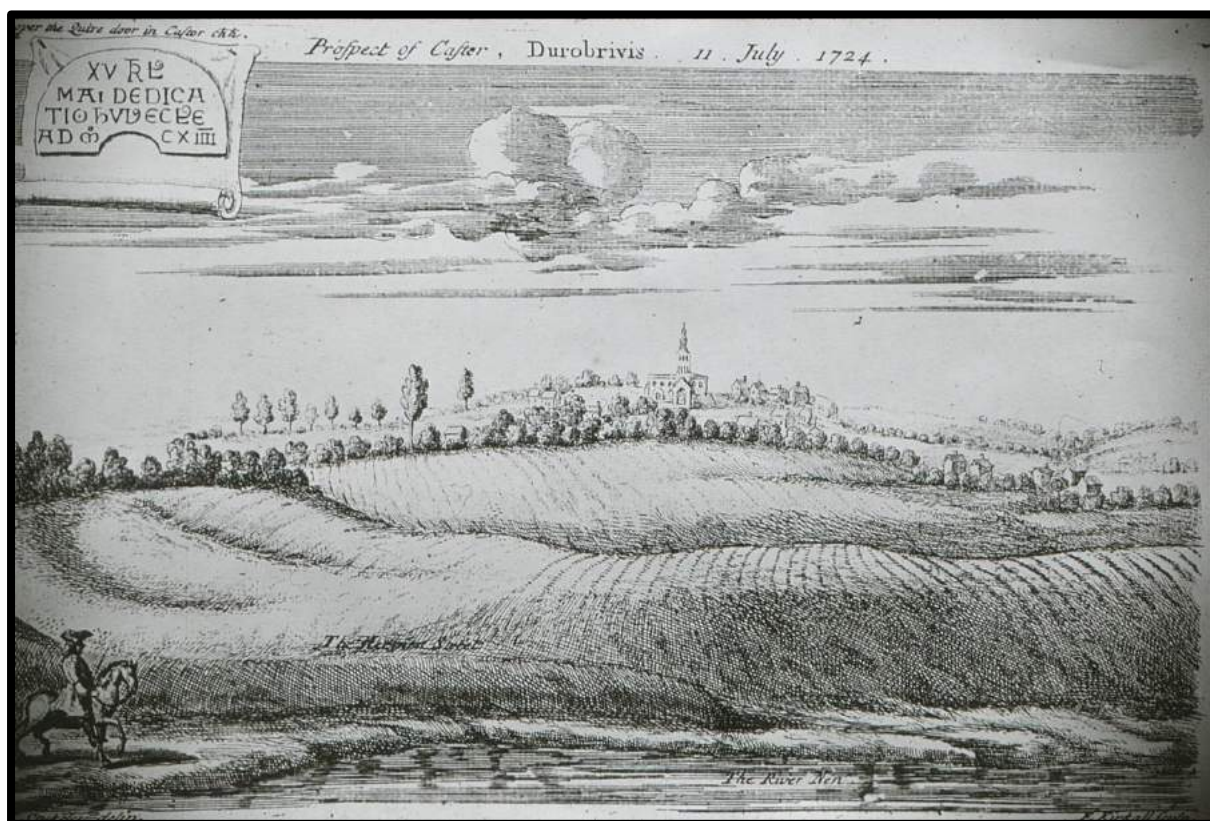
The area of Normangate Field has long been recognised as of great significance during the Roman period. William Camden came here in the 17th century and made comment that the remains were extensive and that ... *'in the field called Normanton....are found such quantities of Roman coins that one would think they had been sown there'*. (Camden 1607). William Stukeley also visits the area in the early part of the 18th century and makes comment on the numbers of remains he saw during his visits (Stukeley 1885) and illustrates Normangate Field and the line of the Roman Ermine Street (Figure 6.4).

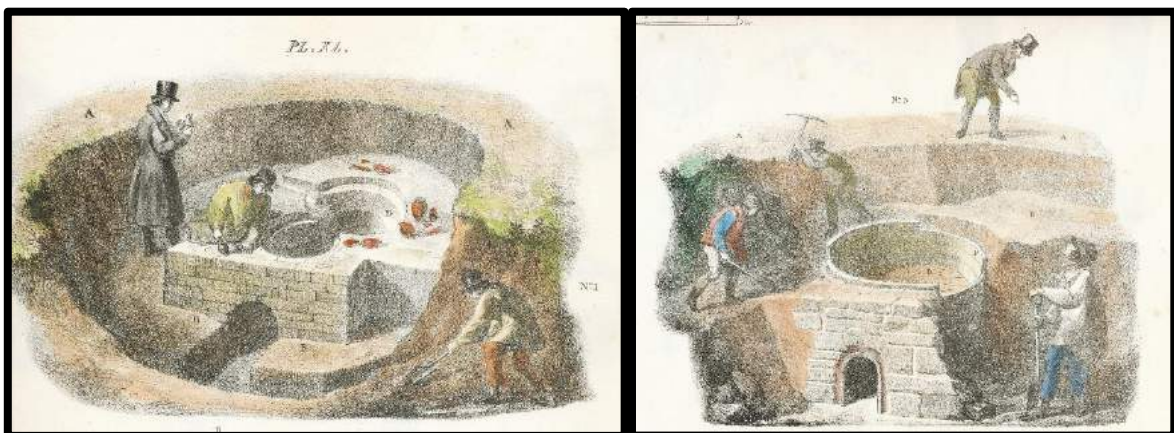
Figure 6.6a & 6.6b Plate XL from Artis 1828 showing pottery kilns being excavated in 1822 within Normangate Field

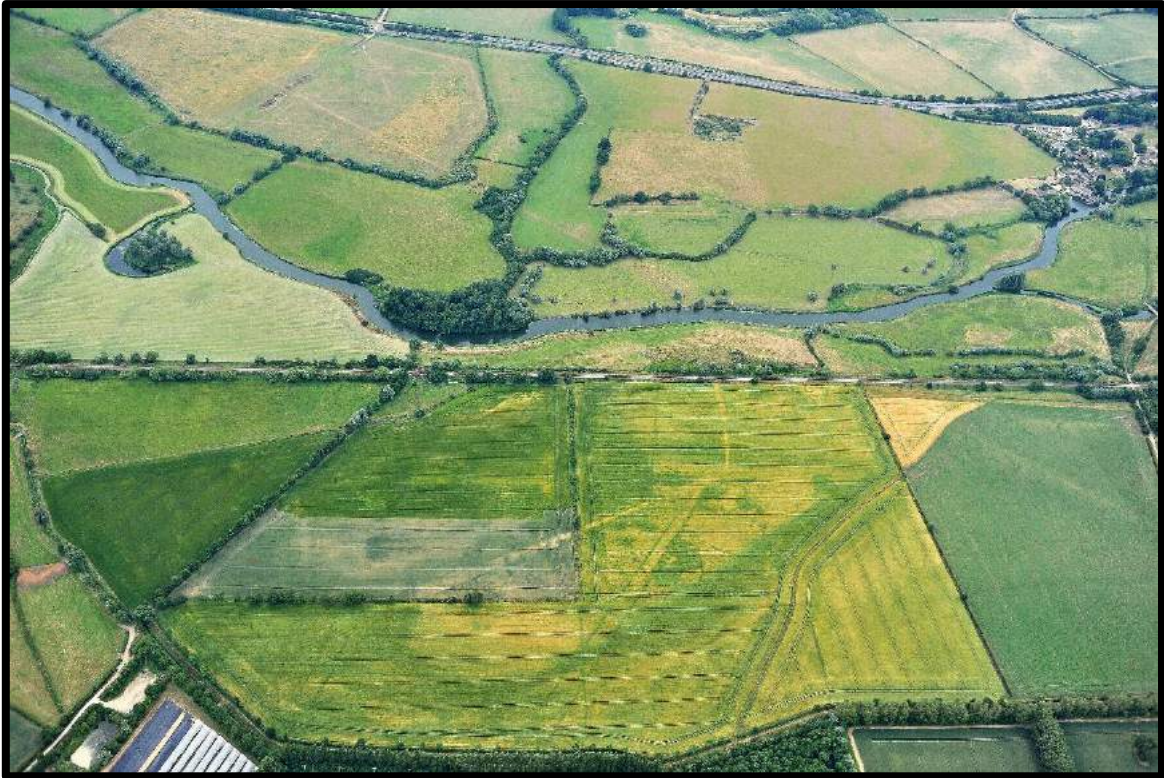
Figure 6.9 Air photograph looking south across the SM area with Normangate Field centre –bottom of the frame. The railway which forms the southern limit of Area 6 runs left-right.
(NVAT/A&CPC & St. K's)

Most of what appears in the RCHM detail has been taken from air photographs and more recent aerial images have added some detail to this plan. Figures 6.9 - 6.13 show images taken during the 1970s (Figure 6.10) and during 2015.

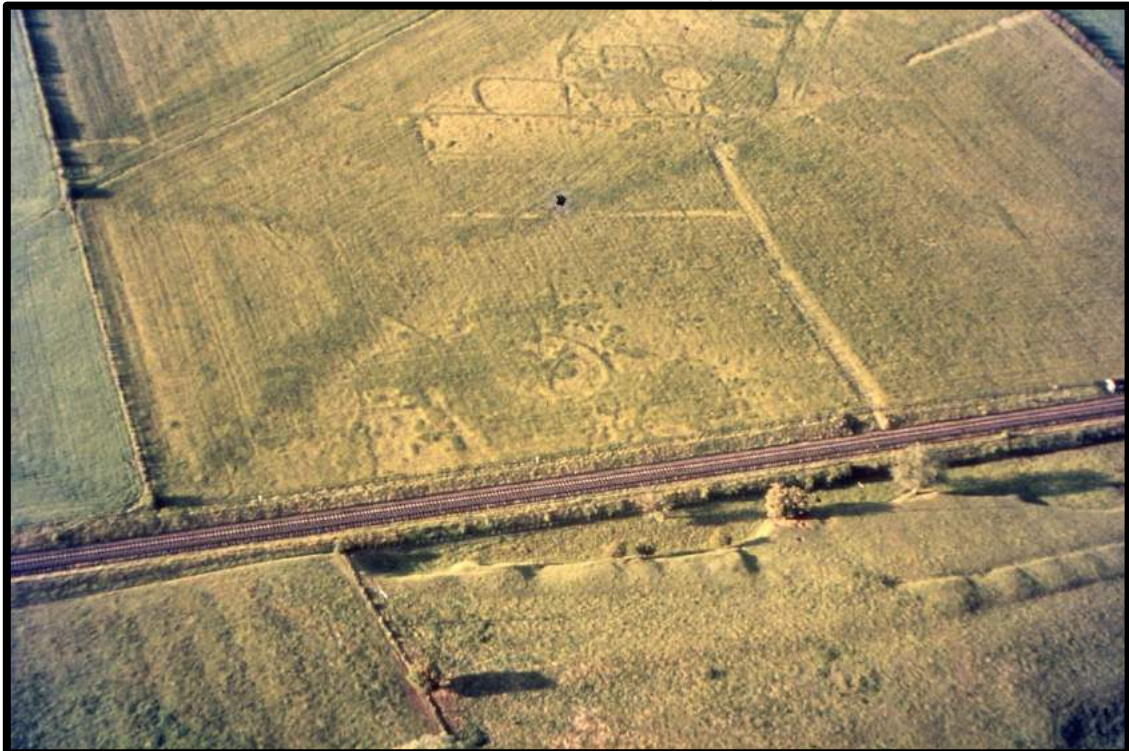
Figure 6.10 Normangate Field looking north across the railway. The line of the Roman roads show as lighter 'parch marks'. (SGU/NVAT)
