Heritage Audit and Landscape Assessment for the Nene Park Trust 2018

For and on behalf of the Nene Valley Archaeological Trust

At the instruction of the Nene Park Trust (NPT) and funded by the Heritage Lottery fund the Nene Valley Archaeological Trust were commissioned to carry out a full heritage audit and landscape assessment of land within the Nene Park Trust's land holding and management areas. This work was carried out between February and August 2018 by Dr Stephen Upex. The objective of this work was to itemise, record and comment upon all heritage assets with regard to their importance, present state of conservation and the current understanding, in terms of date and function, of these heritage assets. These assets comprised a variety of sites and finds, both historical and archaeological, some as upstanding structures, some as hidden or buried archaeological features and some as individual find spots of coins or pottery of only minor importance. The area of the NPT's holding comprises 137 separate entries within this heritage audit of which some entries consist of large complexes containing multi period and archaeologically detailed landscapes of international importance.

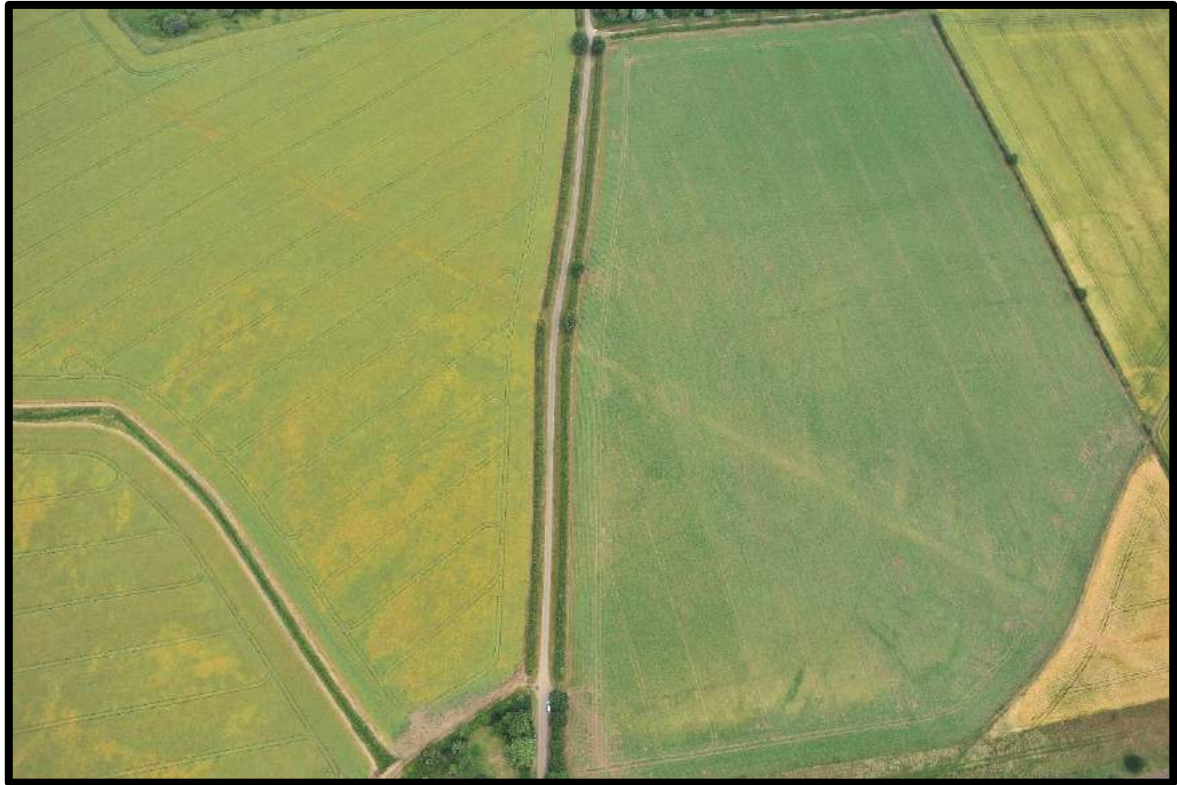
Figure 6.13 Normangate Field looking north with Station Road centre (top-bottom) showing the line of Ermine Street running obliquely across the frame. (NVAT/A&CPC & St. K's)

Most of what appears in the RCHM detail has been taken from air photographs and more recent aerial images have added some detail to this plan. Figures 6.9 - 6.13 show images taken during the 1970s (Figure 6.10) and during 2015.

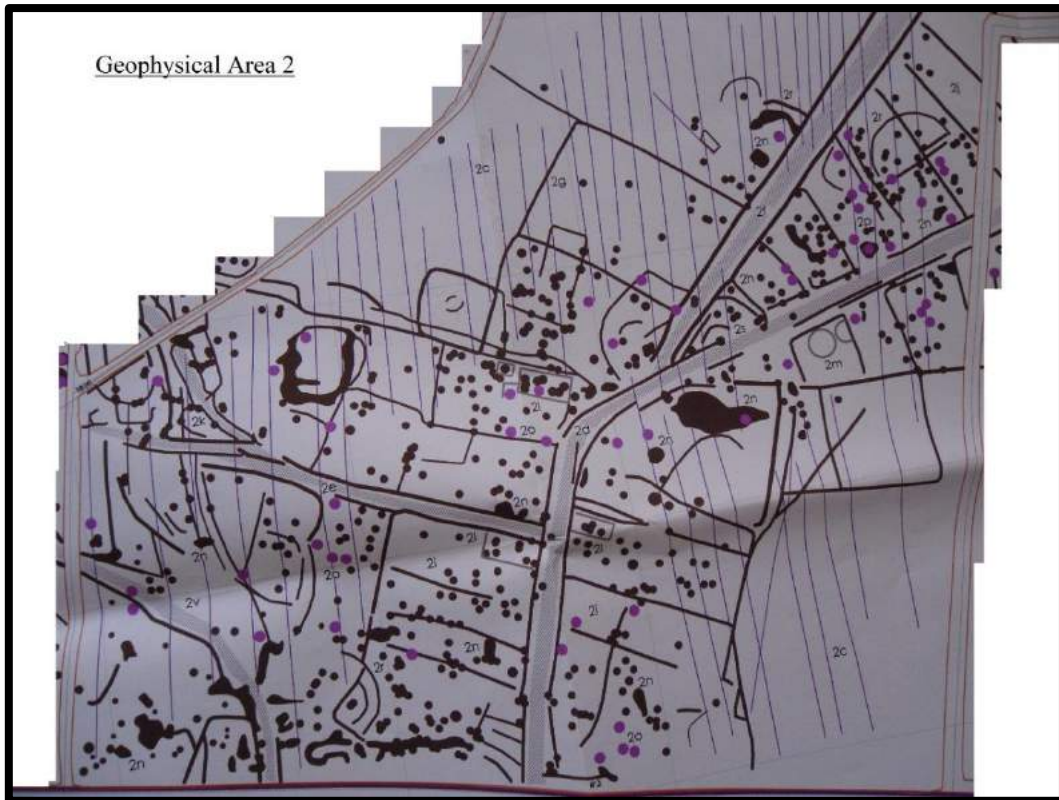
Figure 6.17a Area 2 of the geophysical survey showing numbers referred to within the text.
(ASD 2018)

- 5.30 The south-western and central parts of this area are dominated by a high concentration of strong geomagnetic anomalies. As in Area 1, to the east, many of these form enclosure complexes alongside roads.
- 5.31 Several pairs of strong, parallel, positive magnetic anomalies have been identified across this area. These almost certainly reflect ditches to either side of former roads. Negative magnetic anomalies have been detected in places between these ditches, which could represent the remains of metalled or paved surfaces.

- in the 1960s and found to have at least four layers of metalled surface, with traces of stone and timber buildings on its south side. The north-east/south-west road (**2f**) splits from Road 250 (**2d**) in a V-shape, with several enclosures to its south side, continuing into Area 1.

- 5.37 Several stone and timber buildings have been identified by excavation in the south of this area. Rectilinear negative magnetic anomalies have been detected within the enclosures here, which almost certainly reflect stone remains of former structures (**2l**) close to road **2d**. As in Area 1, it is very probable that more structures survive than those noted on the archaeological interpretation plan, including timber structures and robbed-out stone foundations.

- 5.38 At least two c.10m diameter ring-shaped negative magnetic anomalies (**2m**) have been detected in an enclosure in the east of the area. These almost certainly reflect circular stone-founded structures and are similar in size to features excavated to the west in Area 4, in the 1960s and 1970s, which were interpreted as putative shrines. Circular stone structures of this size can have many varied functions, however, including mill houses and horse gins, weaving and metalworking, for example.

A site found underneath and during work on the Castor Leisure Centre. The finds consisted of a building with a coin hoard, a cremation and ditches and pit. This site may be related to the extensive remains associated with the Praetorium under and around Castor church (Upex 2011) or linear development along the line of the Roman road which is shown in Figure 6.12 and Figure 6.17a (2f).

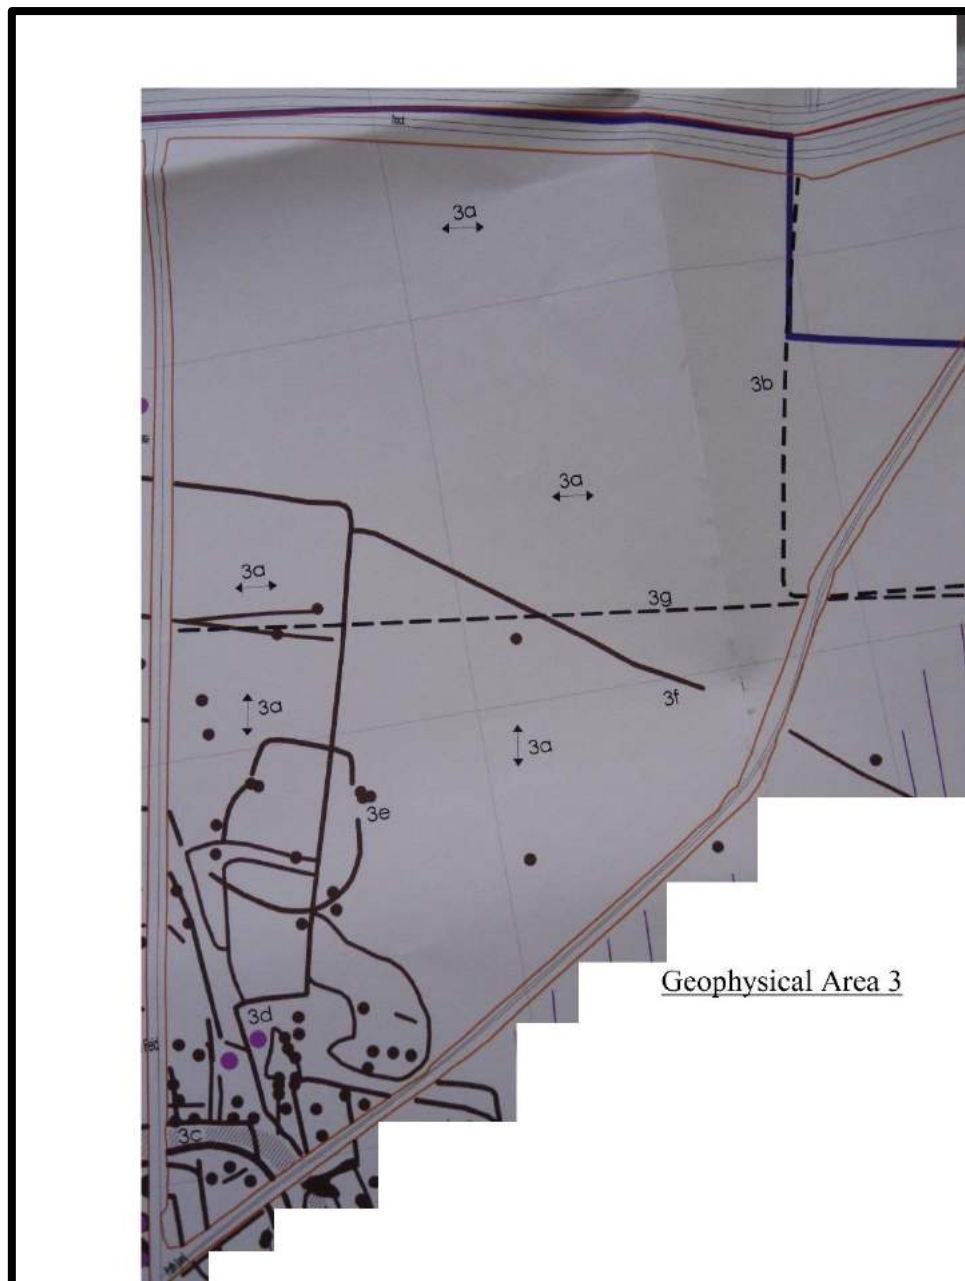
Figure 6.18 Area 3 of the geophysical survey showing numbers referred to within the text.
(ASD 2018)

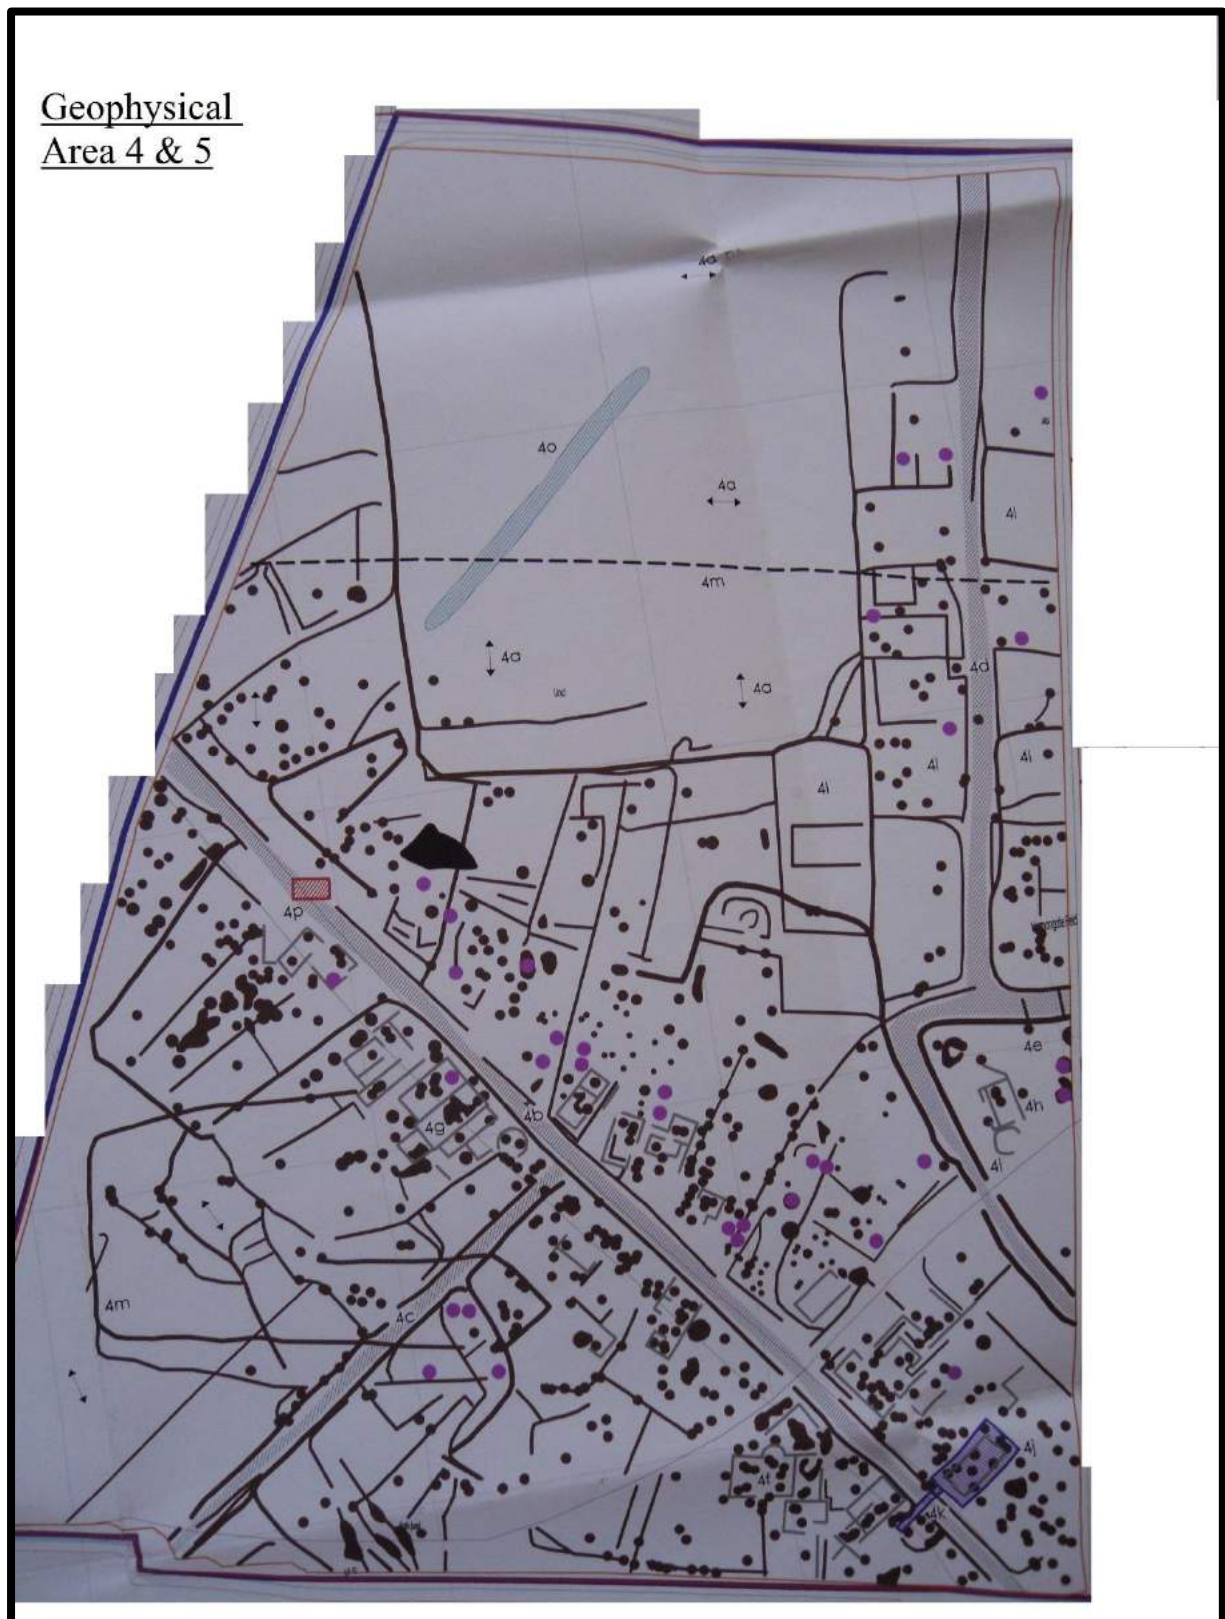
Figure 6.19 Area 4 & 5 of the geophysical survey showing numbers referred to within the text (ASD 2018)

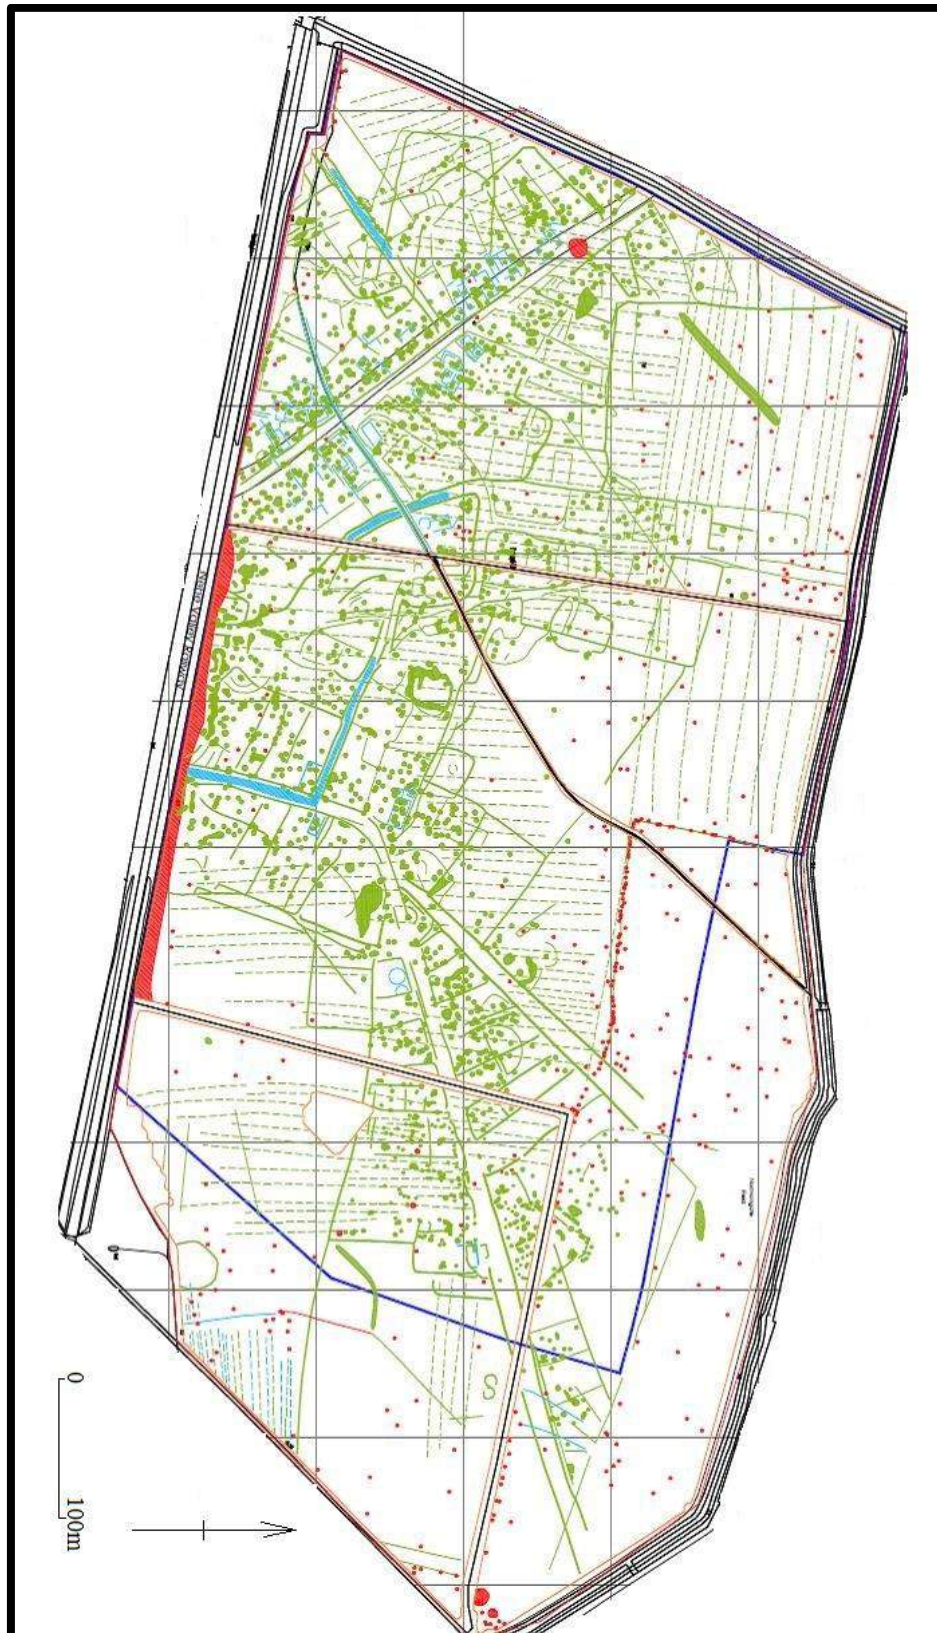
Figure 6.21 Archaeological interpretation of the Geophysical survey.
Green lines = positive magnetic anomaly (Ditches?)/ Blue lines = negative magnetic anomalies (Walls?) (ASD 2018)

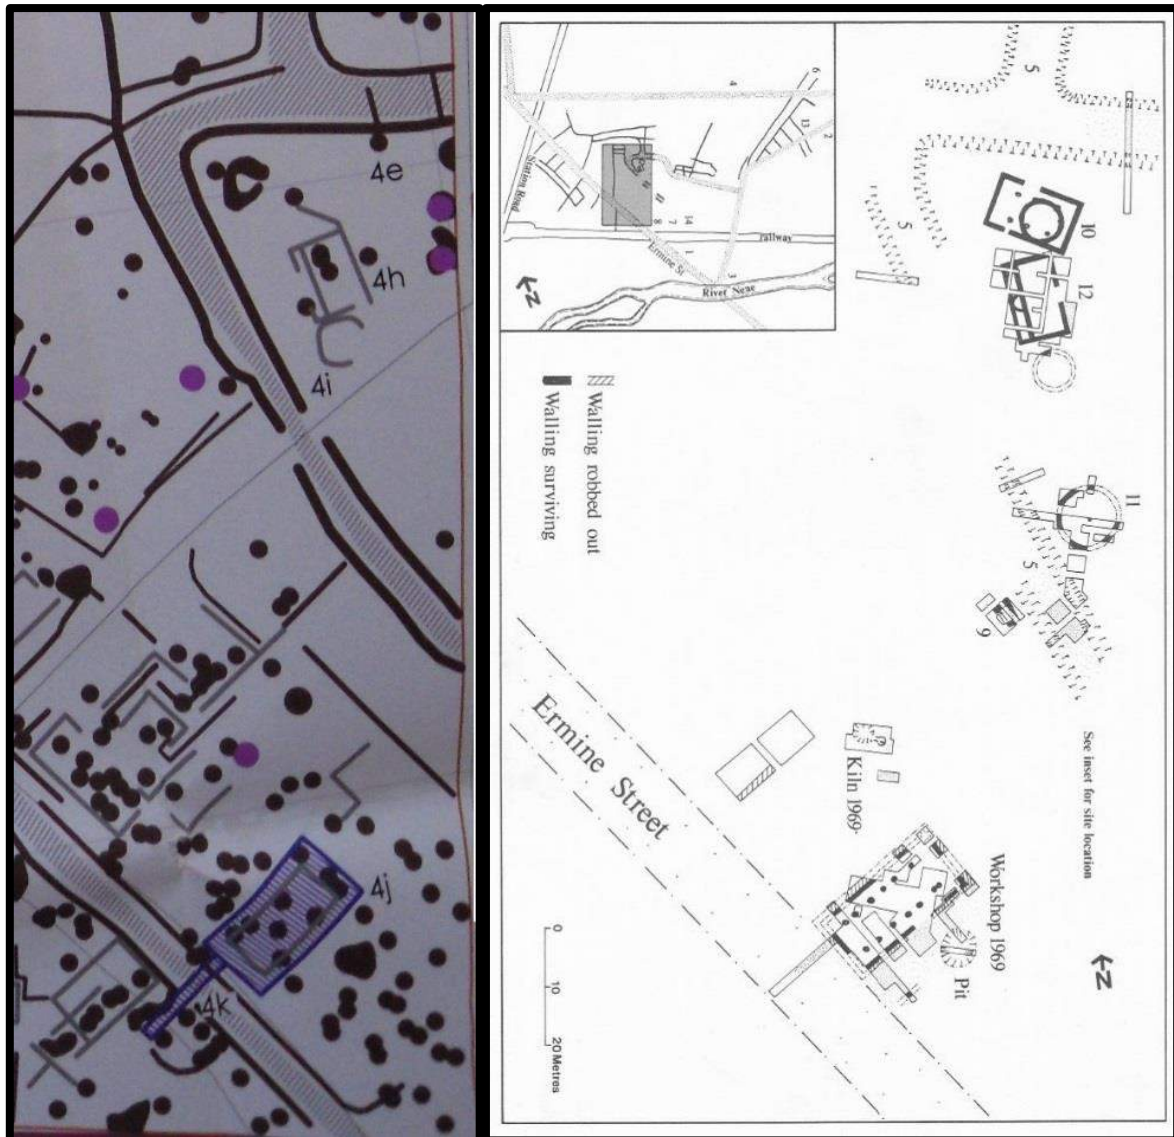
Figure 6.24a and 6.24b. A comparison between the excavated areas shown by Dannell (1974) and the ASD geophysical plot (ASD 2018). The outline of the main building (Workshop 1969) and its associated pit and kiln, and building 12 all show clearly on the ASD survey.

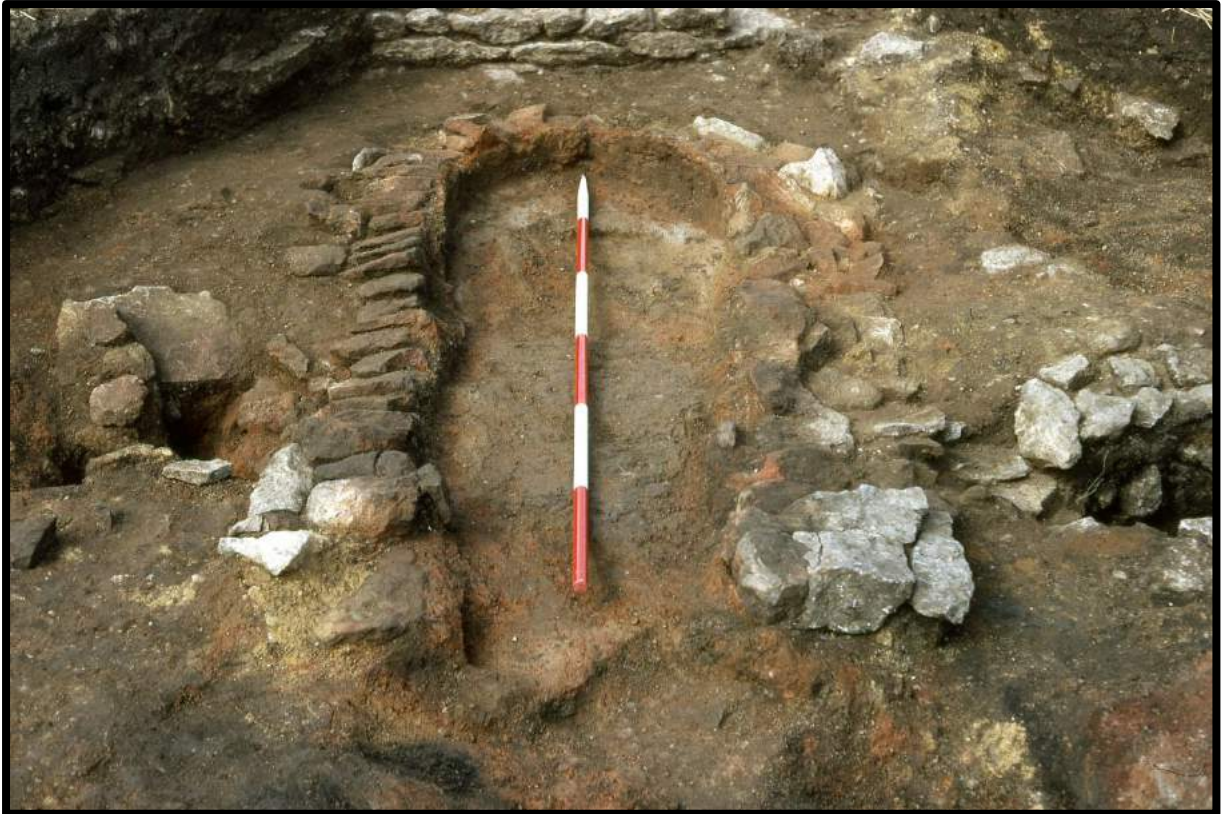
Figure 6.25. Castor 1969- main furnace in workshop 'A' (Archive of the NVAT)

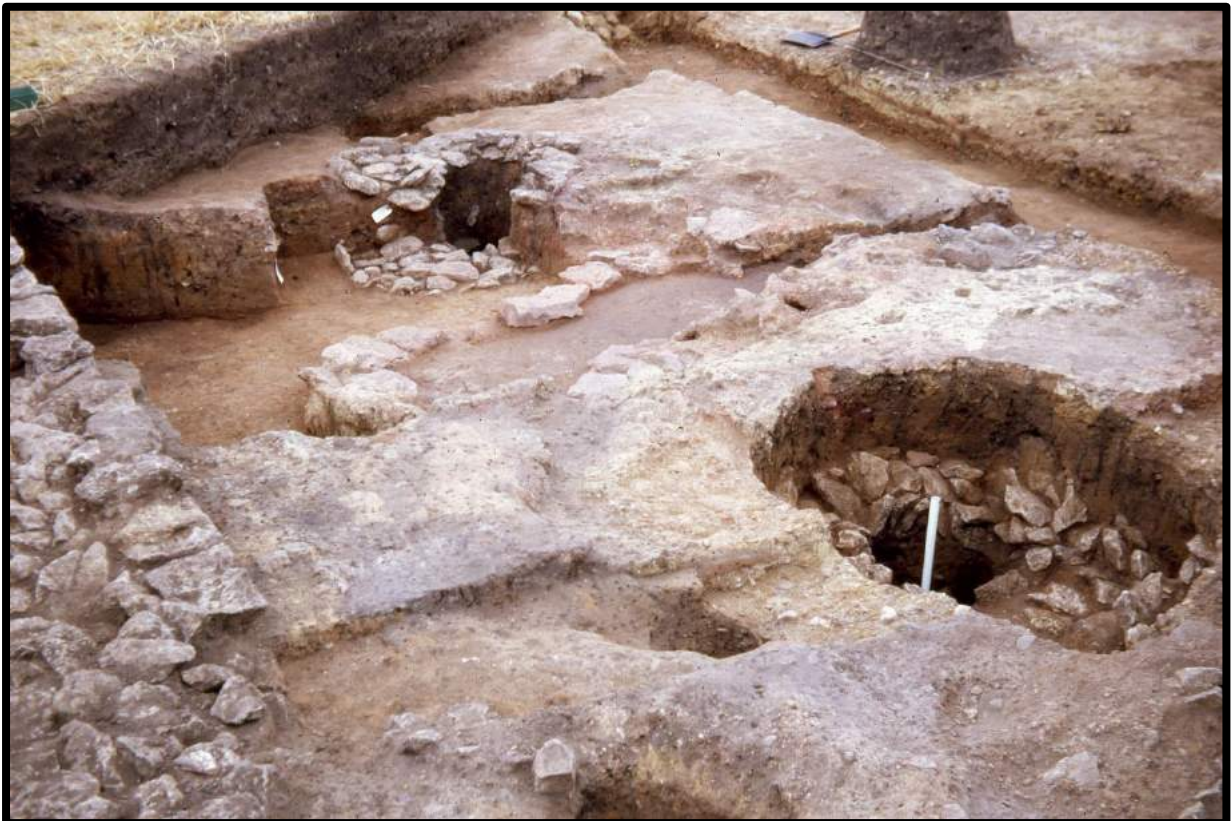
Figure 6.26 Castor 1969 -workshop 'A' -west side showing the positions of two aisle posts with the central nave between. (Archive of the NVAT)

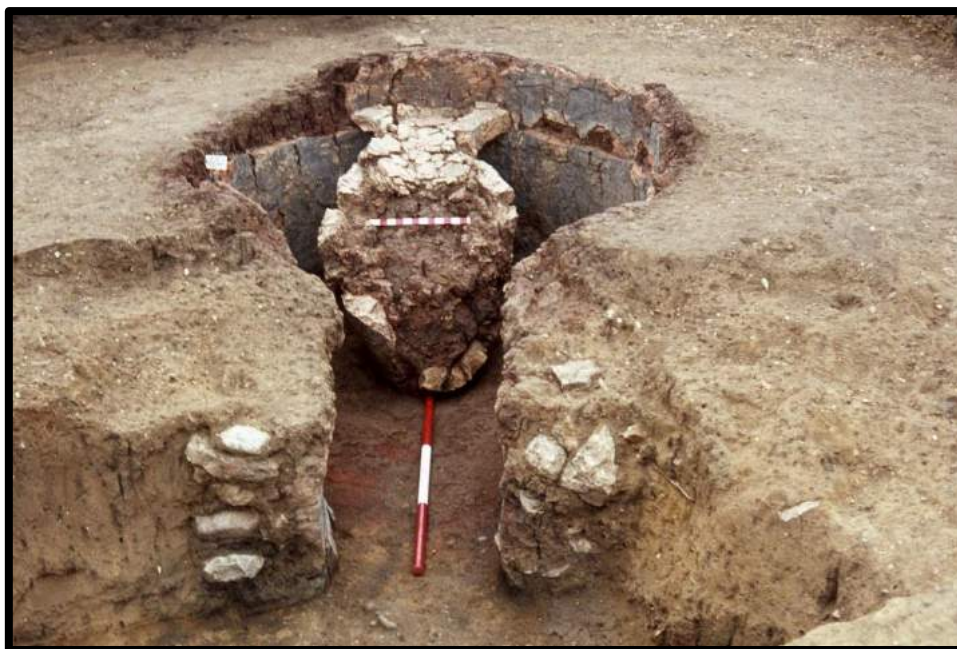
Figure 6.27 Castor 1969 Pottery kiln behind workshop 'B'. (Archive of the NVAT)

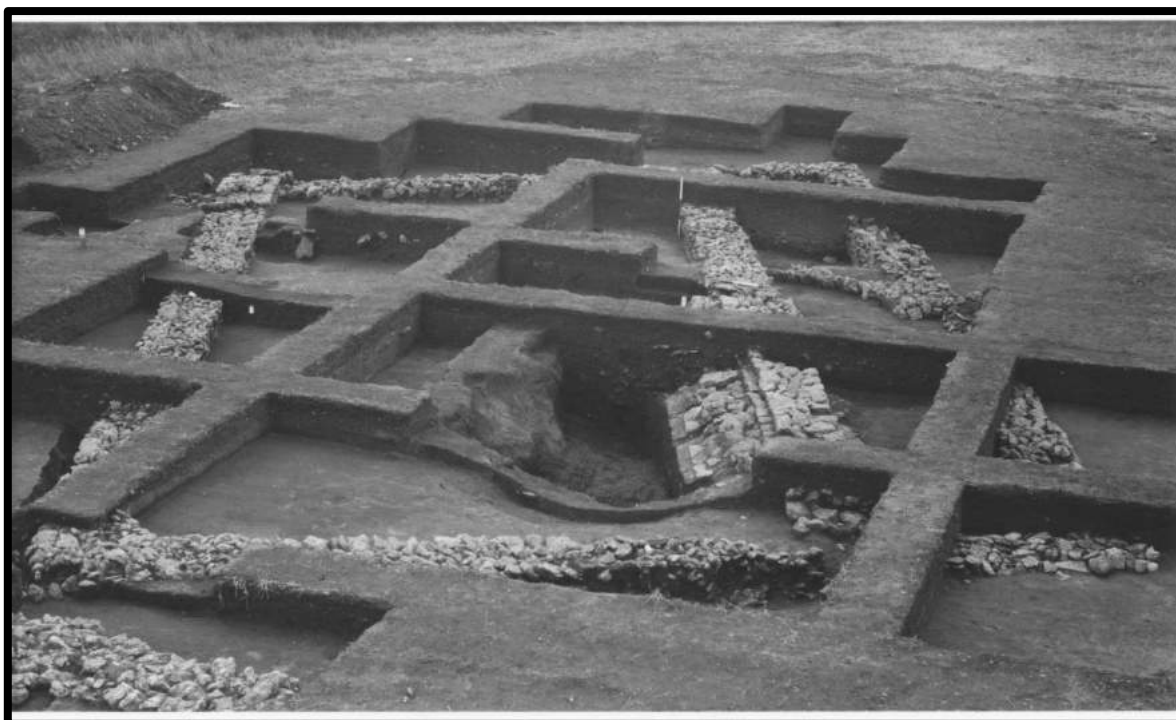
Figure 6.28 Building 12 looking south-east (see Fig 6.23) showing the portico on the western side.
(Archive of the NVAT)

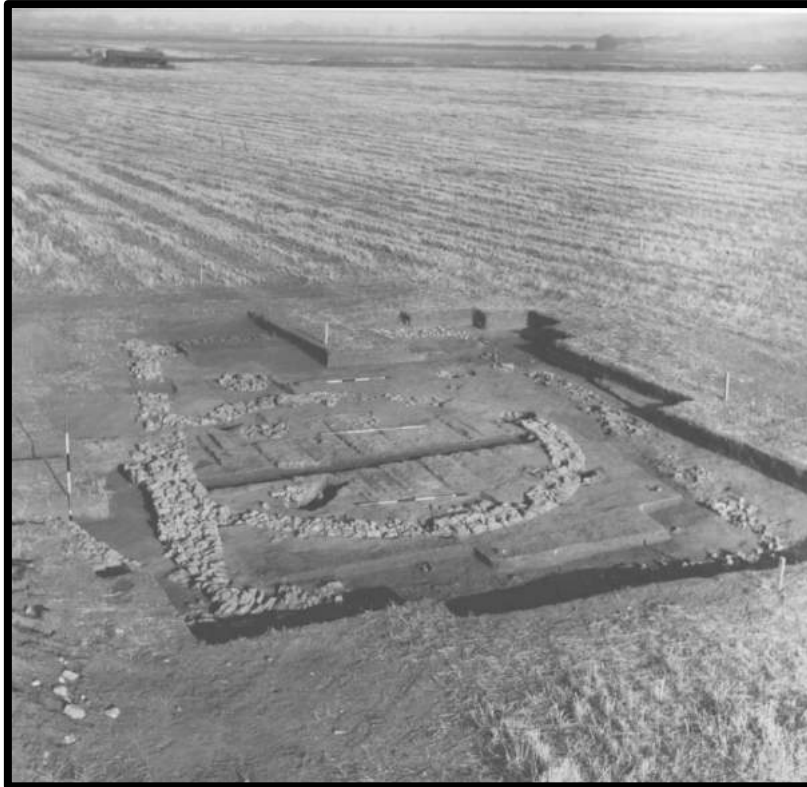
Figure 6.29 Building 10 looking north (see Fig 6.23) showing the rectangular aisled building with the earlier circular structure underneath. (Archive of the NVAT)

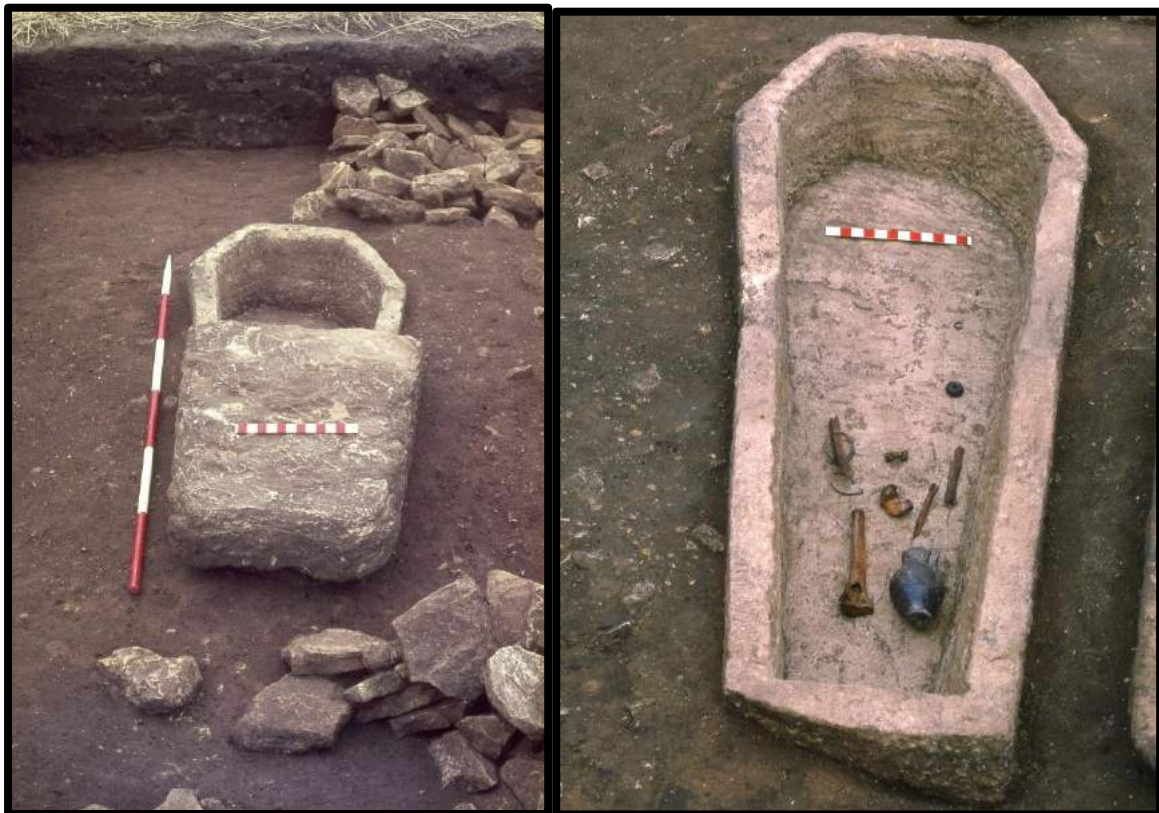
Figure 6.30a & 6.30b Coffin in mausoleum area with lid and without lid showing contents. (Archive of the NVAT)

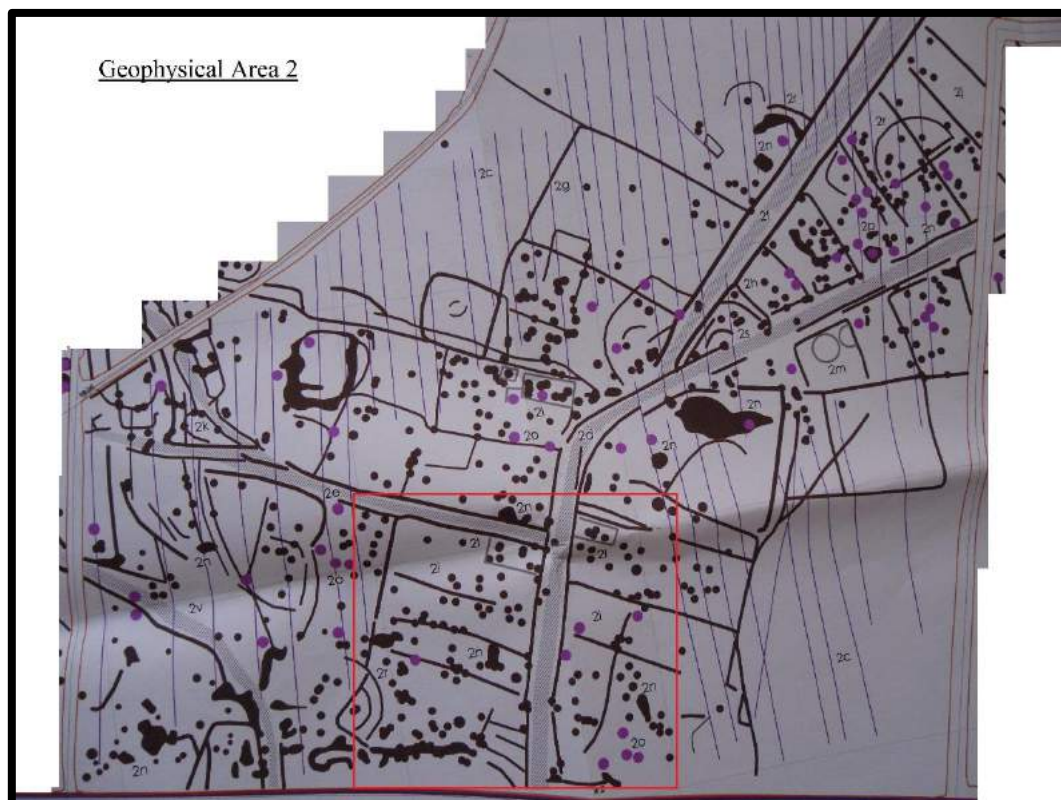
Figure 6.34. Extract from the ASD geophysical Survey showing the approximate area (red box) of the 1962-3 excavations (ASD 2018) - to be compared with Figure 6.33 above.

The excavations by Webster in 1962-3 were carried out in the southern part of Area 6 in what has been identified as area 2 on the ASD survey (see Figure 6.15) and this work has been partly published (Perrin and Webster 1990) as a pottery report with an outline of the pits and structures encountered. The area of the excavation is shown in Figure 6.32 and the details of features found is shown in Figure 6.33

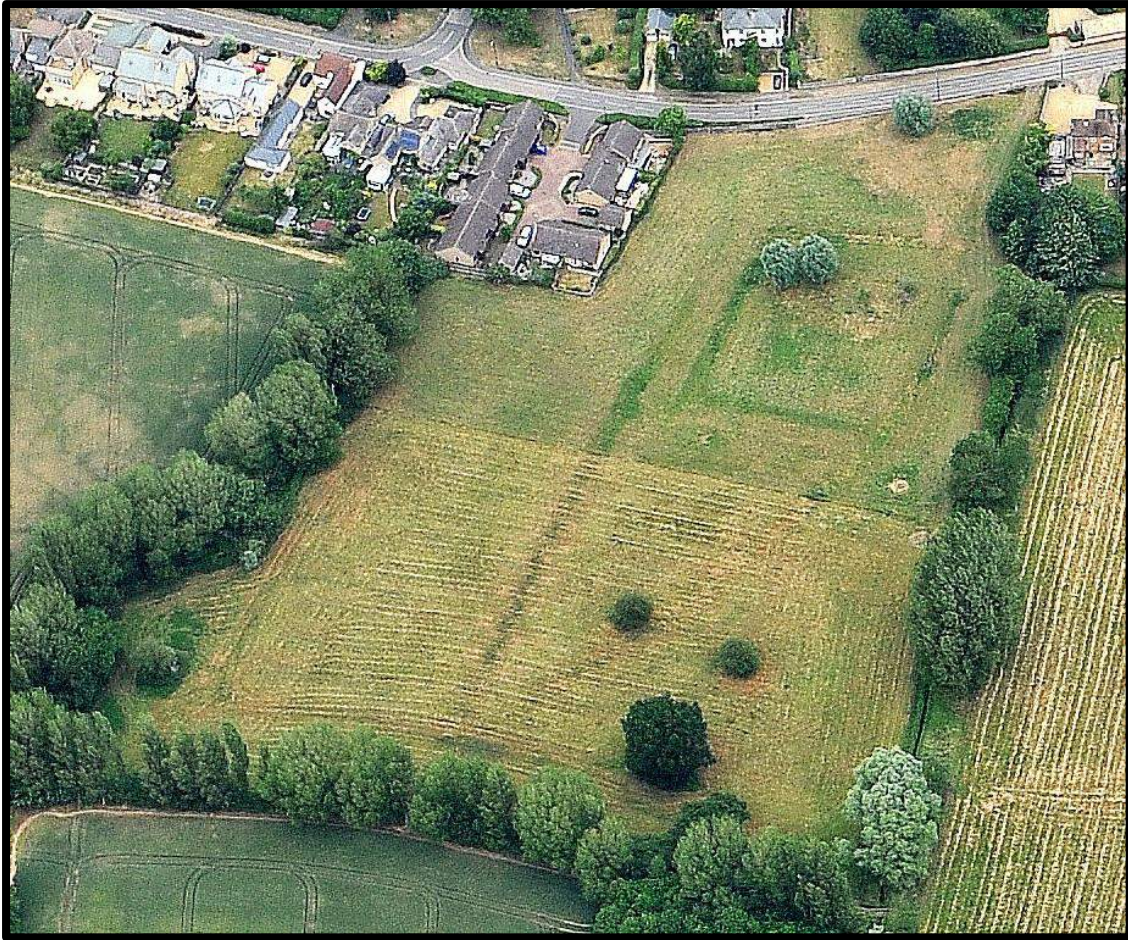
*Figure 6.36 The moated site (Site 6.2) looking north with Castor village at the top of the frame.
(NVAT/A&CPC & St. K's)*

A small rectangular moat (Figure 6.35) enclosing a small island with a wide ditch, 1.3m deep and with an external bank lies on the north side of a larger enclosure bounded by a similar ditch. Outside the western corner of the larger enclosure is another small square moated site bounded by a wide shallow ditch with a maximum depth of 0.80m. The site is a scheduled monument (SM number PE 159).

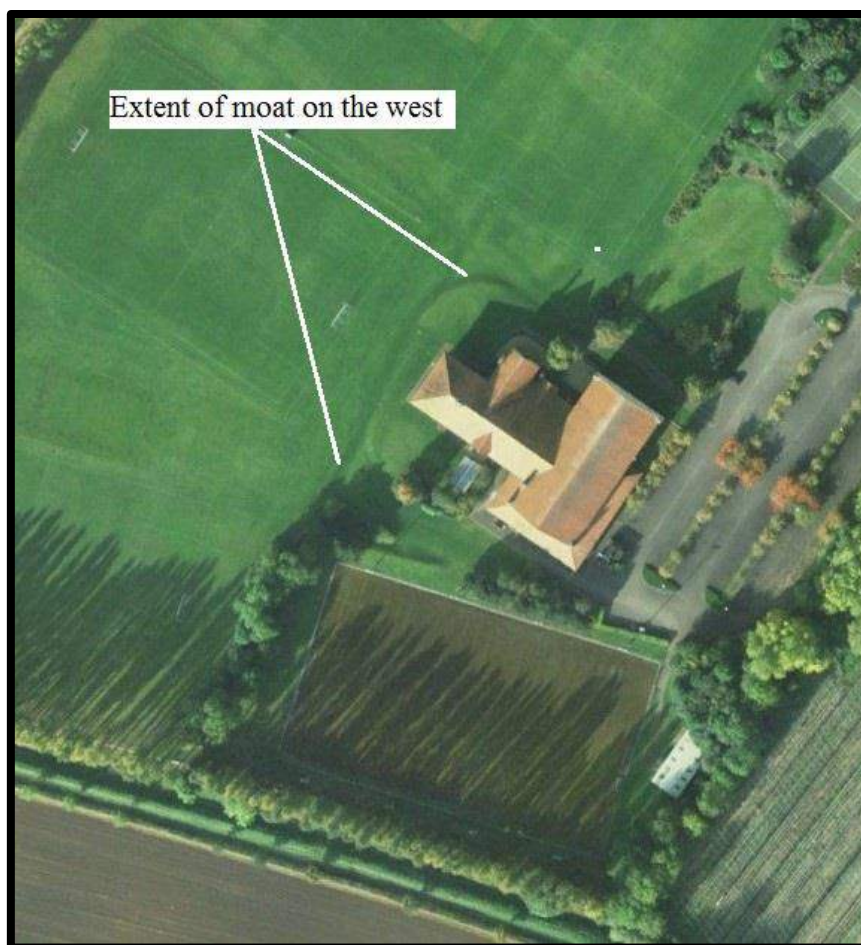
*Figure 6.39 Air view of Site 6.3 showing possible extent of ditch on the western side of the site.
(Google Earth 1990)*

The HER reports a second moated site located during work on the Leisure Centre to the south of the former A47 road. No other details but this may be the manorial complex associated with Thorold's Manor (CAMUS Project 2004 p 59). The RCHM describes the site as a sub rectangular enclosure of about an acre orientated N.E-S.W. bounded by a shallow ditch 10 ft wide and 3 ft deep (RCHM 1969 p 27. No. 46.). Slight traces of the moated area showing as a crop mark under grass can be seen on early google earth images – see Figure 6.39.

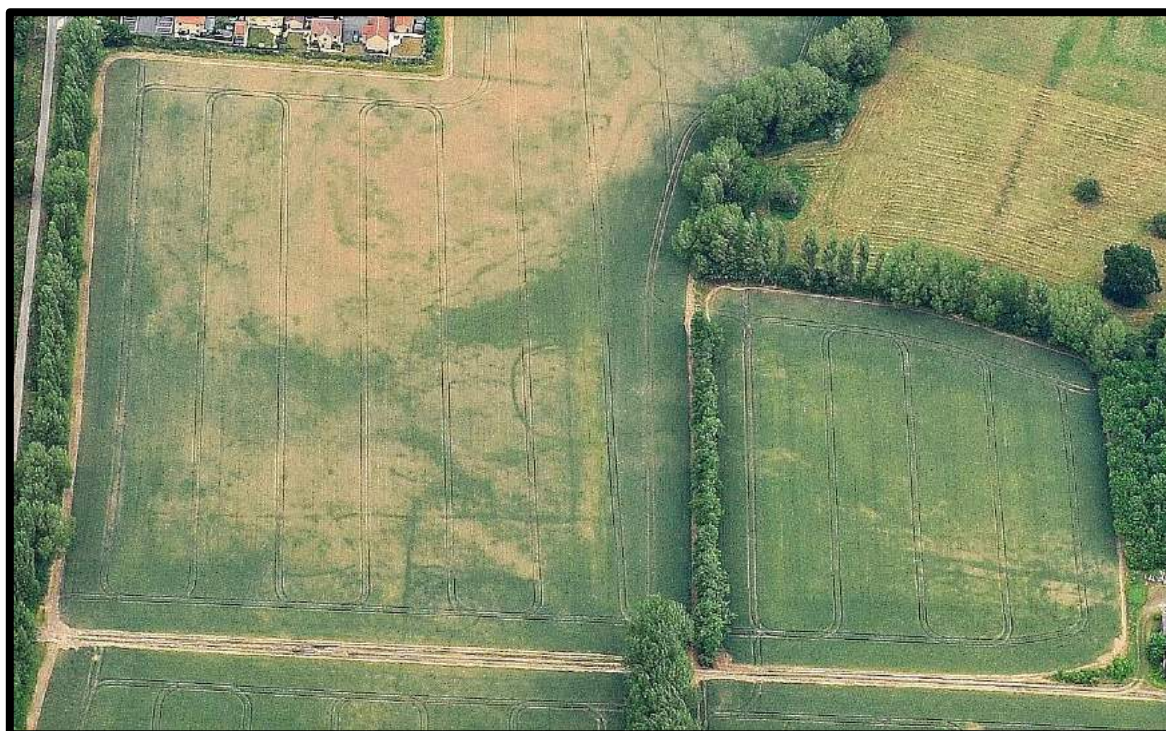
Figure 6.40a Air photograph looking north showing crop marks in fields next to Station Road (Left)

Crop marks in the area that the HER (HER 01821) reports buildings, kiln waste, tile and pits. The air photographs show (see Figures 6.40 and figure 6.41) crop marks within two fields (centred on TL 117984). The field next to Station Road shows a series of ditches including what appears to be a circular feature which may be a BA barrow (ring ditch). Some of the linear ditches may be dated to the medieval period (see Figure 6.40b) and represent part of the Lamas Enclosures to the south of Ailsworth village and which are shown on the 1898 enclosure map (*HRO. CCS 33*).

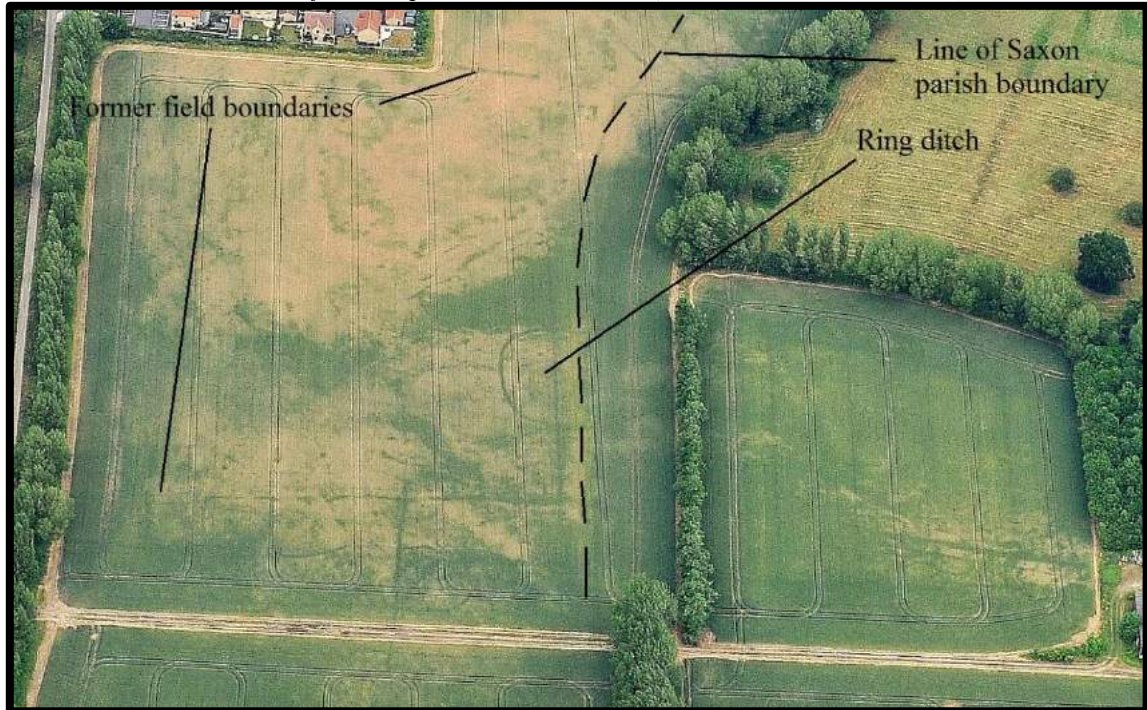
Figure 6.40b Air photograph looking north showing crop marks in fields next to Station Road with interpretive annotations. (NVAT/A&CPC & St. K's)

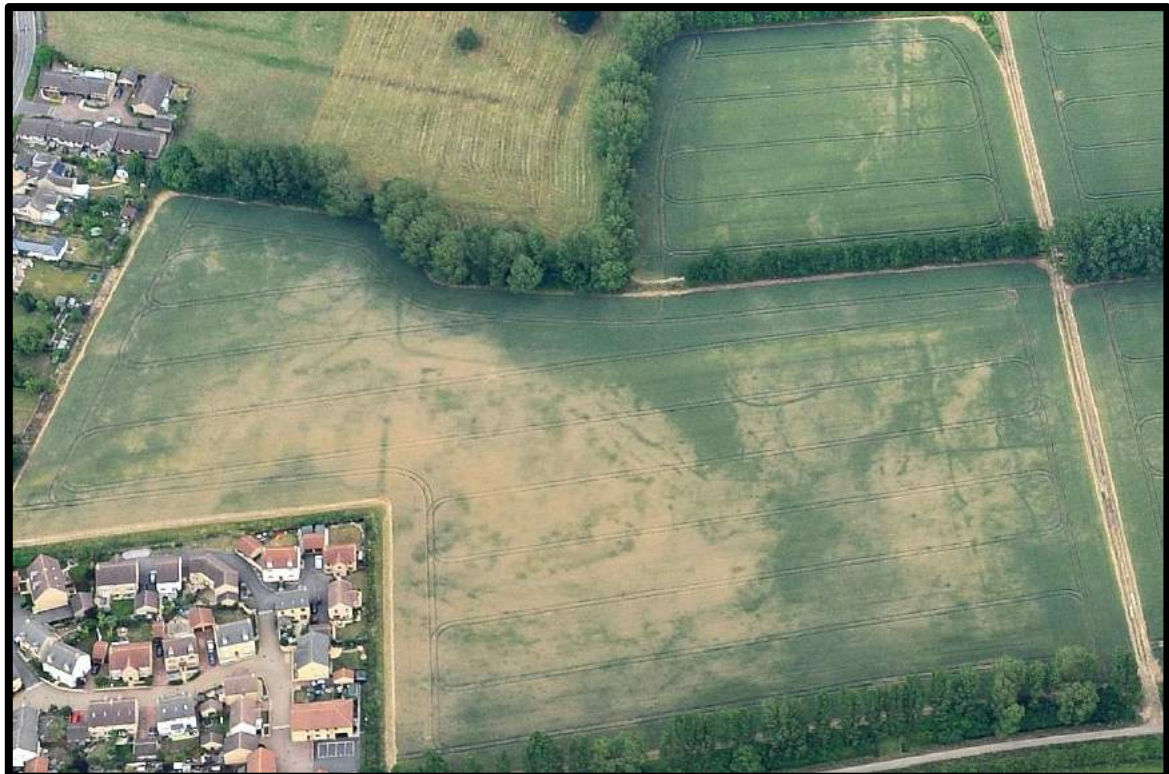
Figure 6.41 Air photograph looking east showing crop marks in fields next to Station Road (bottom right). The manor Site (Site 2) is shown top left. (NVAT/A&CPC & St. K's)

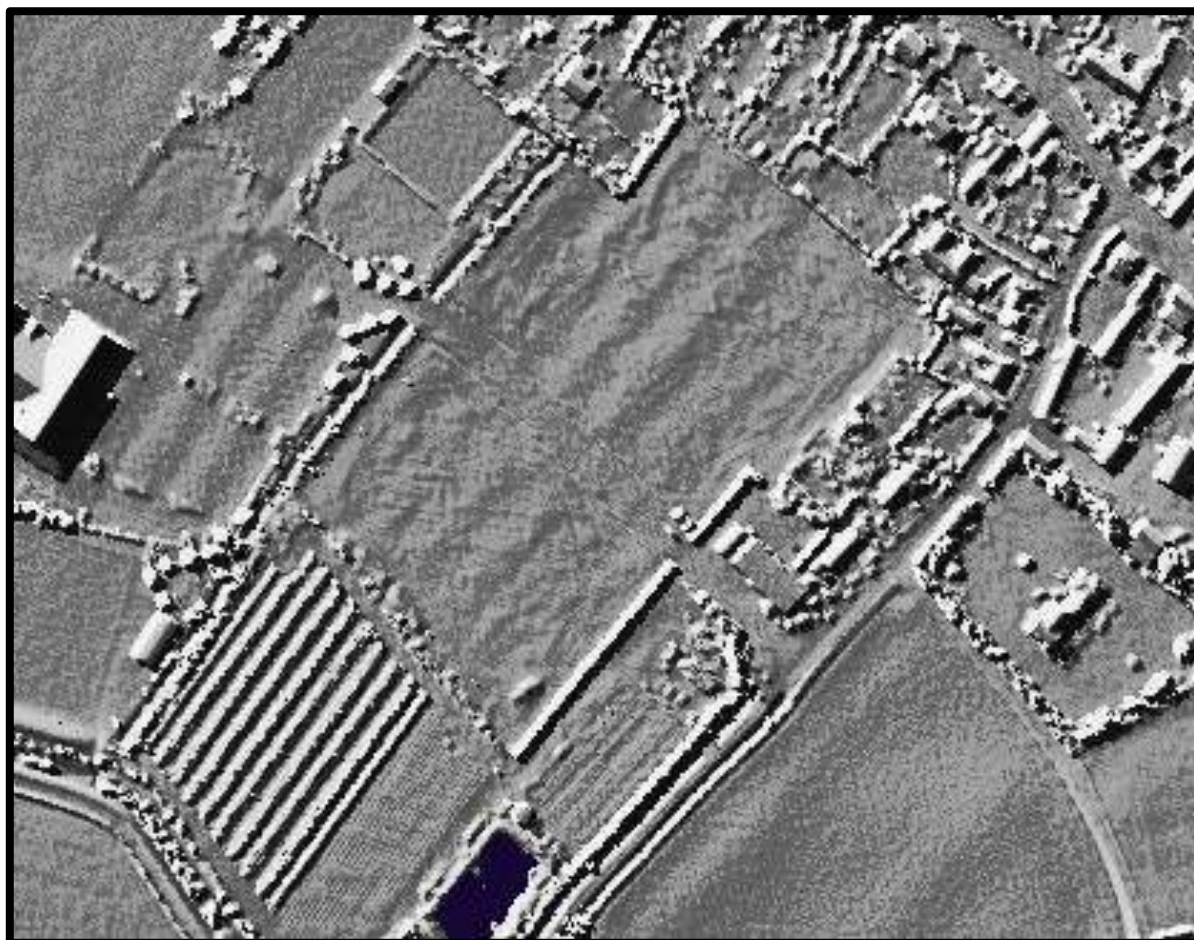
Figure 6.43. Lidar image of the ridge and furrow at Site 6.7.

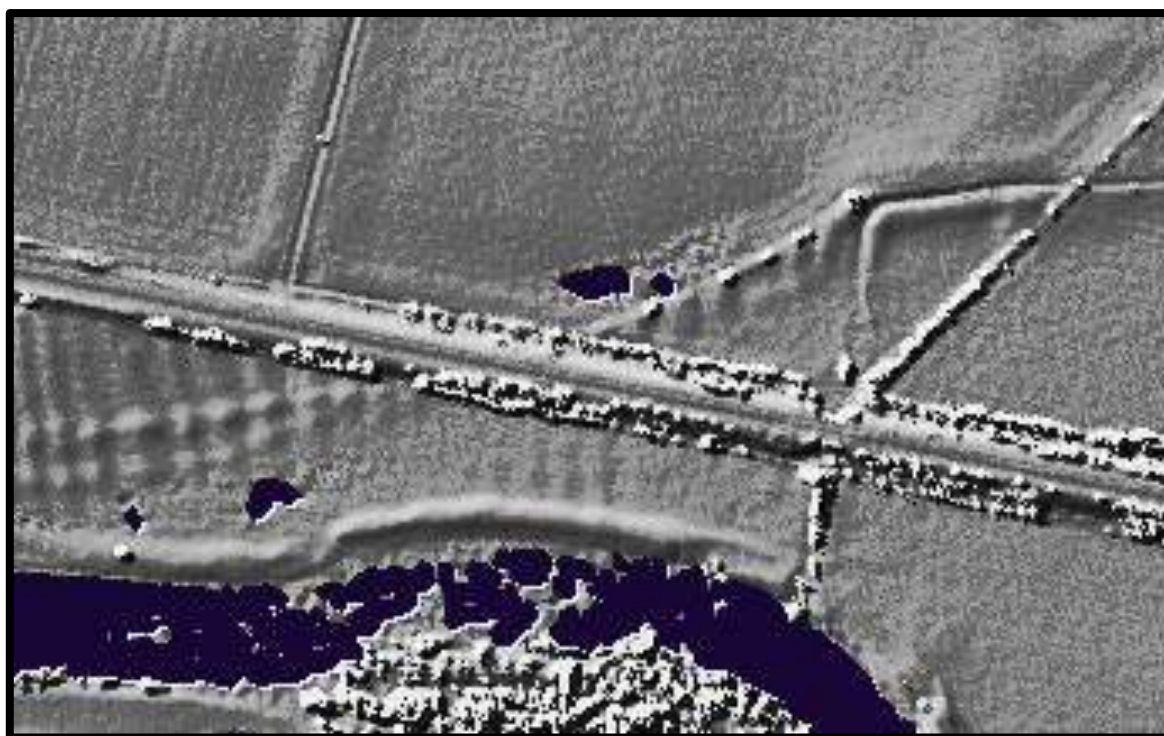
Figure 6.44 Site 6.8 showing the stub ends of ridge and furrow to the north of the railway line. This area was common in 1846 and 1892.

Minor area of ridge and furrow set against the side of the railway to the south and shown on the Lidar image (See Figure 6.44). This area probably represents ridge and furrow ‘stub ends’ that were abandoned after the line of the railway was constructed in 1845-7 and the area is shown as ‘common’ on both the 1846 and the 1892 open field maps (Figure 6.45).
