Heritage Audit and Landscape Assessment for the Nene Park Trust 2018

For and on behalf of the Nene Valley Archaeological Trust

At the instruction of the Nene Park Trust (NPT) and funded by the Heritage Lottery fund the Nene Valley Archaeological Trust were commissioned to carry out a full heritage audit and landscape assessment of land within the Nene Park Trust's land holding and management areas. This work was carried out between February and August 2018 by Dr Stephen Upex. The objective of this work was to itemise, record and comment upon all heritage assets with regard to their importance, present state of conservation and the current understanding, in terms of date and function, of these heritage assets. These assets comprised a variety of sites and finds, both historical and archaeological, some as upstanding structures, some as hidden or buried archaeological features and some as individual find spots of coins or pottery of only minor importance. The area of the NPT's holding comprises 137 separate entries within this heritage audit of which some entries consist of large complexes containing multi period and archaeologically detailed landscapes of international importance.

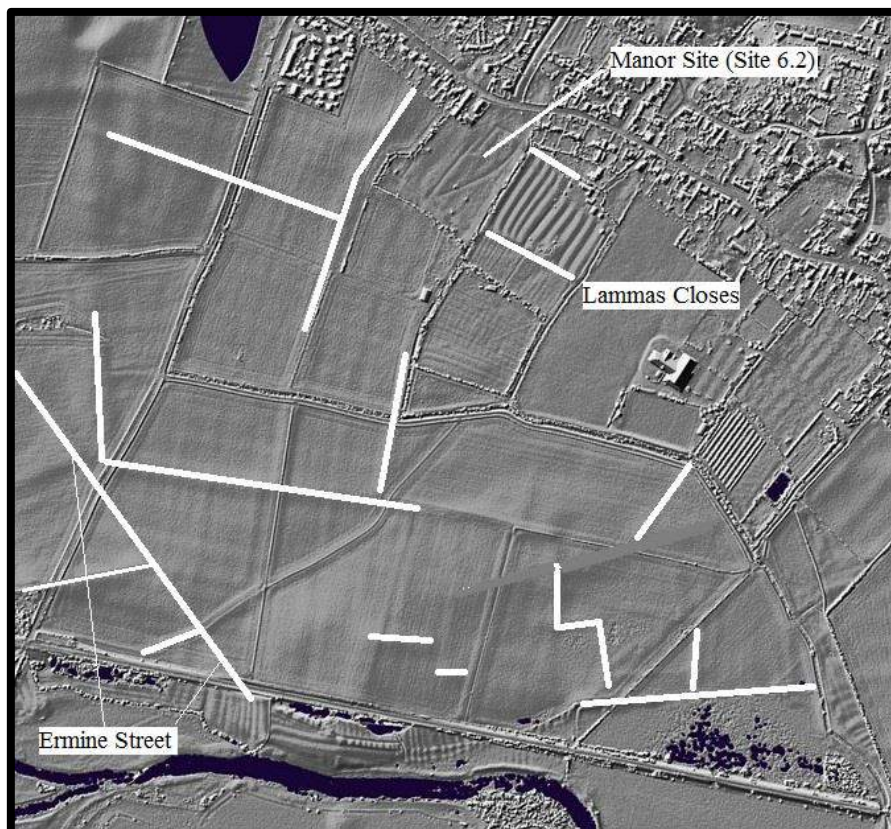
Figure 6.45b Lidar image as shown above with white lines showing the linear headland boundaries which survive in the modern landscape.

Large, well defined medieval and post medieval ploughing headlands extending over the area of Normangate Field and the area that contains the early enclosures of Lammas Closes. The headlands consist of linear accumulations of ploughsoils as the medieval ploughs drew up to and turned on the headland areas (Upex 1984 and 2005). The most notable headland is that which covers the line of Ermine Street which Artis recognised on his 1828 plan of the area (see Figure 6.22a) and which he shows covering the top of the line of this road. The headlands can be seen during ground surveys of the area and seen on Lidar images which are shown in Figures 6.45a and 6.45b. These headlands can be matched exactly with the open field maps of the parish in 1846 (NRO map T 236) and the 1892 map (private collection) which is shown in detail in Figure 6.46.

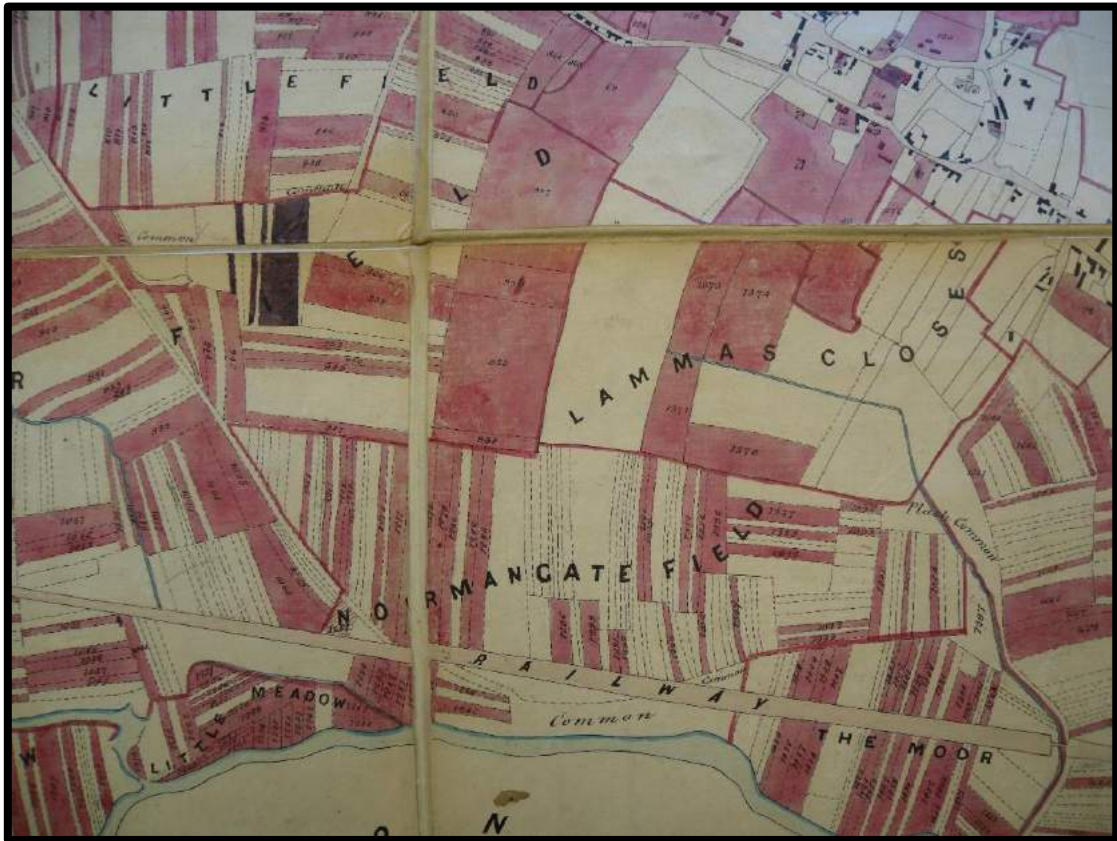
Figure 6.46 Detail from the 1892 open field map of normangate Field showing the strip (selion) and furlong layout which matches the Lidar images and ground surveys. (Private Collection).

The hedge lines around the area of the Lammas Closes could be of considerable age (14th century) – many of the earlier hedges have now been removed but some still remain and can be matched to those lines shown on the early maps of the area 1846, the 1892 open field map (Figure 6.46) and the 1898 enclosure map (Figure 6.42).

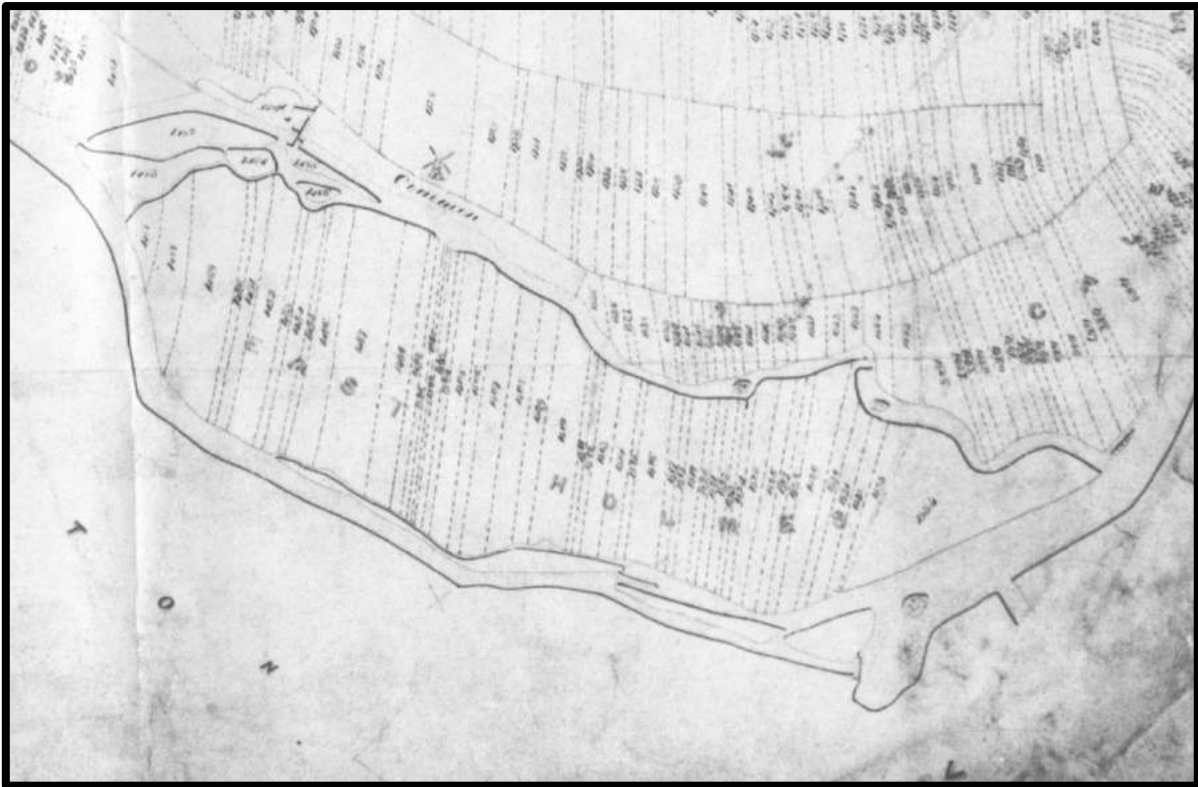
Figure 7.3 Detail taken from the 1846 open field map of Castor showing East Holms Meadow with the meadow strips set out and numbered. (NRO T236)

The area was called East Holmes Meadow from early times; in 1340 for example it was called *Estholm* (Brooke and Postan 1960. P210; Kilby 2014 p 33). The earliest map of the area is that taken from the more general map by E.T. Artis and dated 1828 (Figure 7.2) which shows the meadow area with multiple channels at its western and southern sides and these are shown in the modern landscape (see Lidar below). In 1846 a second map (Figure 7.3) was made which shows the orientation of the meadow strips within the common meadow area of Castor. Meadow strips were not ploughed as were arable strips and thus there is not the formation of ridge and furrow to mark these areas out or to survive within the modern landscape. Instead the meadow strips were marked by wooden, or occasionally stone, meer-pegs and meer-stones which rarely survive within East Midland parishes (Upex 1984).

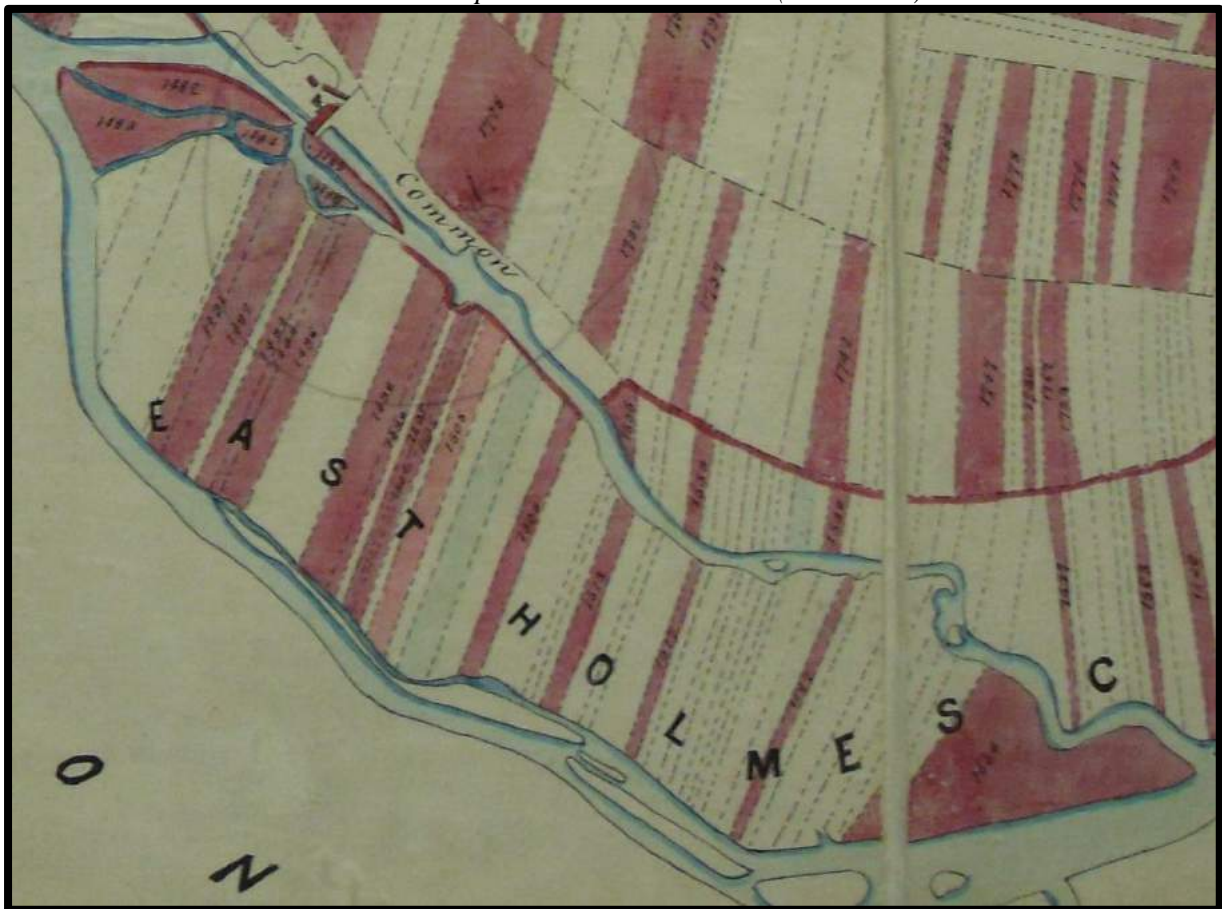
Figure 7.4 *Detail from the 1892 open field map showing the area of East Holms meadow little changed from the 1846 map. (Private Collection)*

A third map of 1892 (Figure 7.4) shows little change from the earlier 1846 arrangements of strips although strips appear to have been amalgamated as tenants sought to rationalise their holdings. The area today remains comparatively flat with no visible remains of earlier management or occupation (see Figures 7.5 and Figure 7.6). What can be seen on the Lidar plot are a series of minor watercourse changes. The 1828 map (Figure 7.2) suggests that there were modifications being made to the western and eastern ends of this meadow area (compare Figure 7.2 with Figures 7.7 and 7.8) while the Lidar plot clearly shows the line of an earlier watercourse channel (palaeo-channel) in the central part of the meadow area (See Figure 7.8)

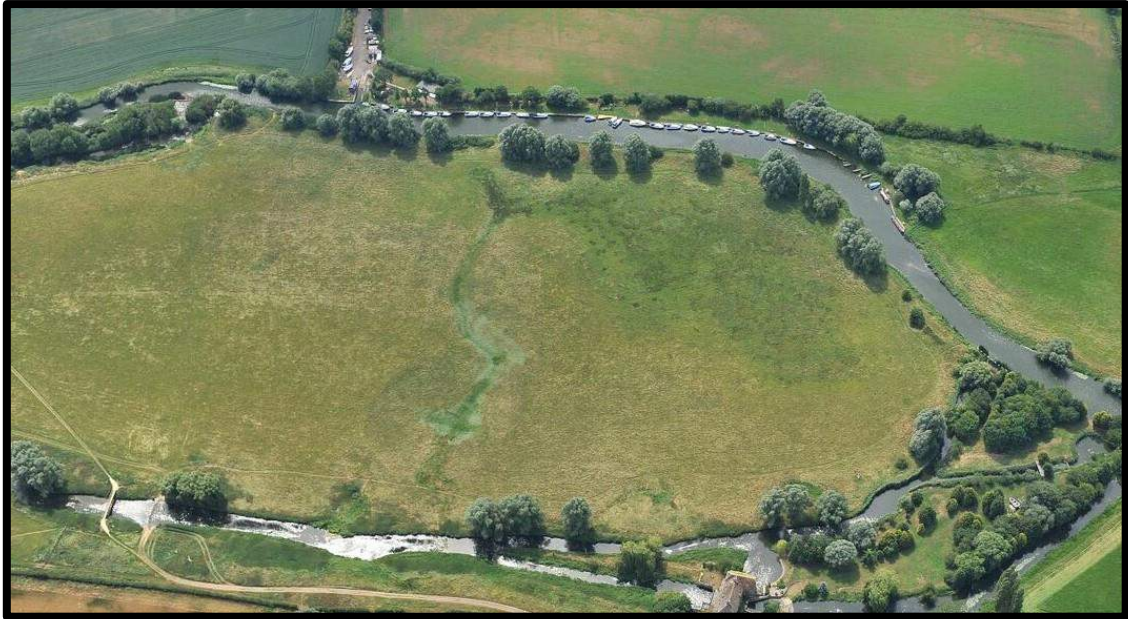
Figure 7.6 The western part of East Holme meadow looking south-west. Castor watermill is bottom right- the palaeochannel shown in Figure 7.8 is centre.

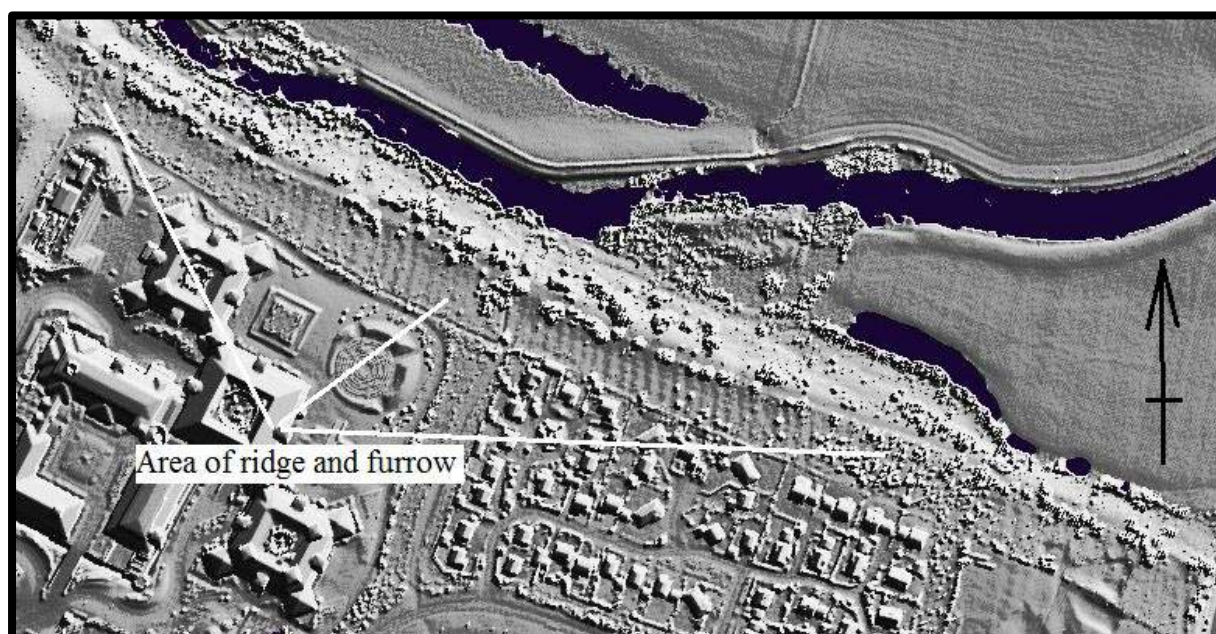
Figure 8.4 Site 8- an area of surviving ridge and furrow to the north-west of the Orton Business Park

An area of ridge and furrow forming part of the former open fields of Alwalton, surviving as visible remains along the walkway to the north west of the Orton Business Park and seen on the Lidar plot of the area which is shown in Figure 8.4. These features represent the remains of selions within the open fields of Alwalton which were enclosed in 1809 (HRO S/m 3/20). There is no detail of the names of the early, pre-enclosure fields

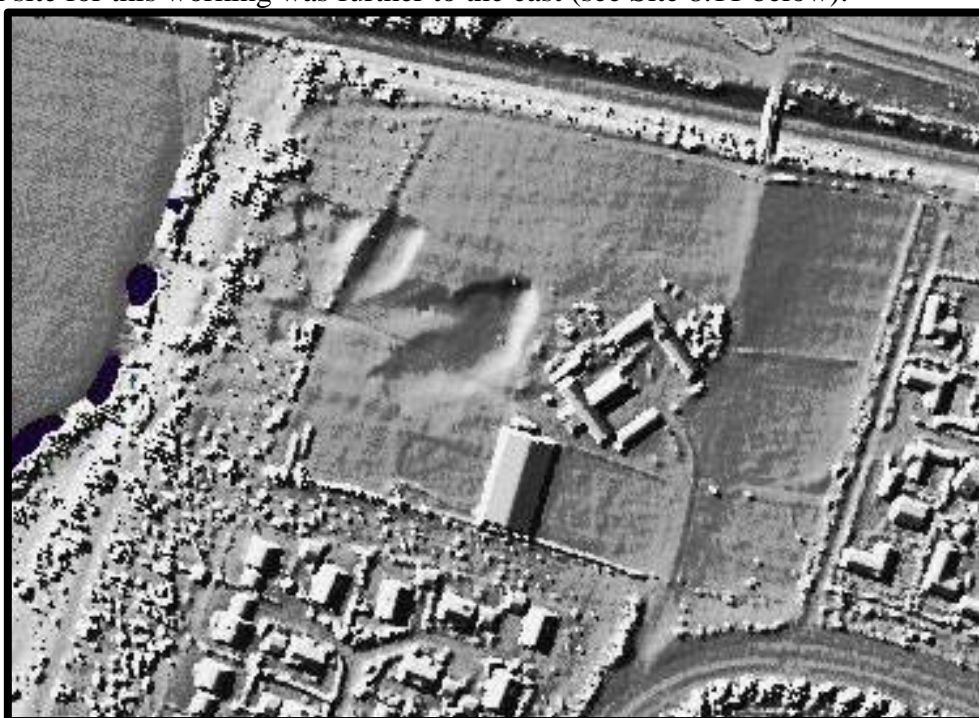
Figure 8.7. Lidar image of the area of surviving quarrying to the west of Lynch Farmhouse.

An area of quarrying to the west of the Lynch Farmhouse (see Site 8.6 above) surviving within the landscape and shown on both air photographs of the area and the Lidar plot, shown in Figure 8.7. In the late 19th century a pond had formed in one part of this quarry area (see Figure 8.3). This quarrying may be related to the construction of the Lynch Farm buildings themselves or may be part of the earlier quarrying activities associated with Alwalton Marble – although the main site for this working was further to the east (see Site 8.11 below).

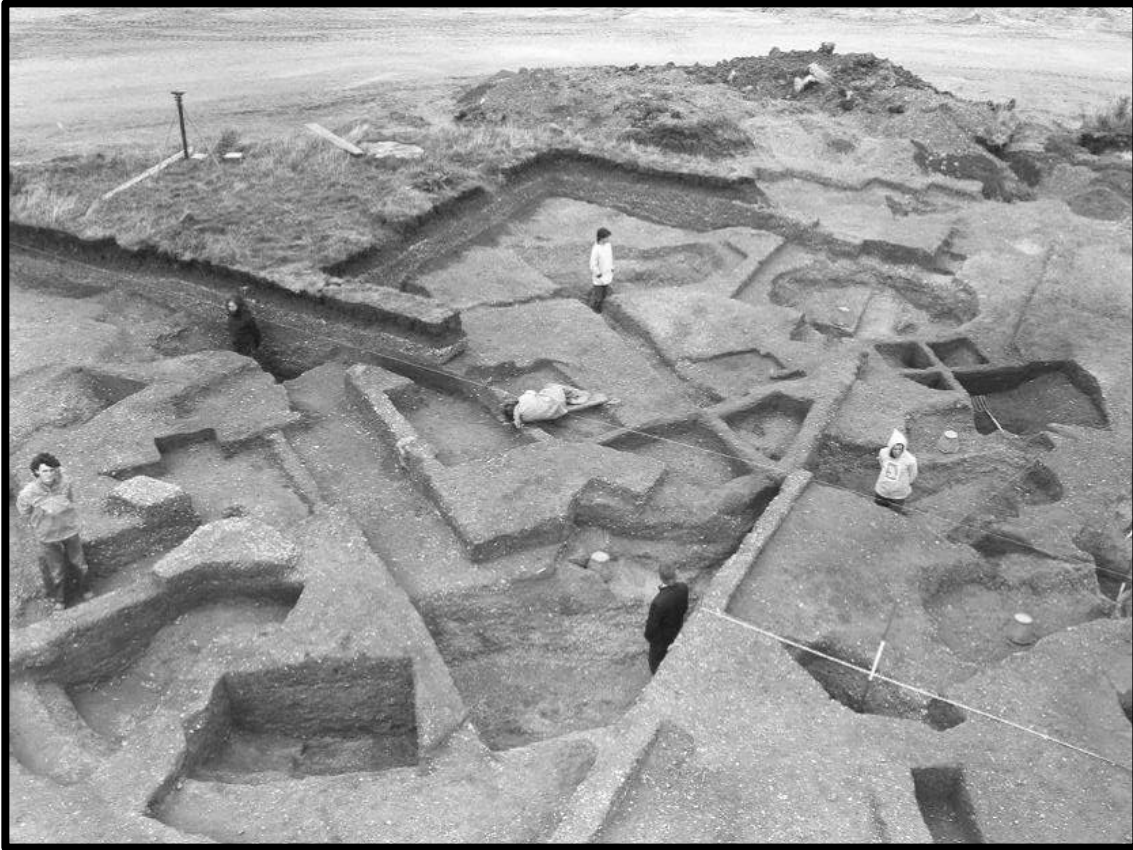
Figure 10.6 General view of the eastern barrow during excavation (Mackreth forthcoming)

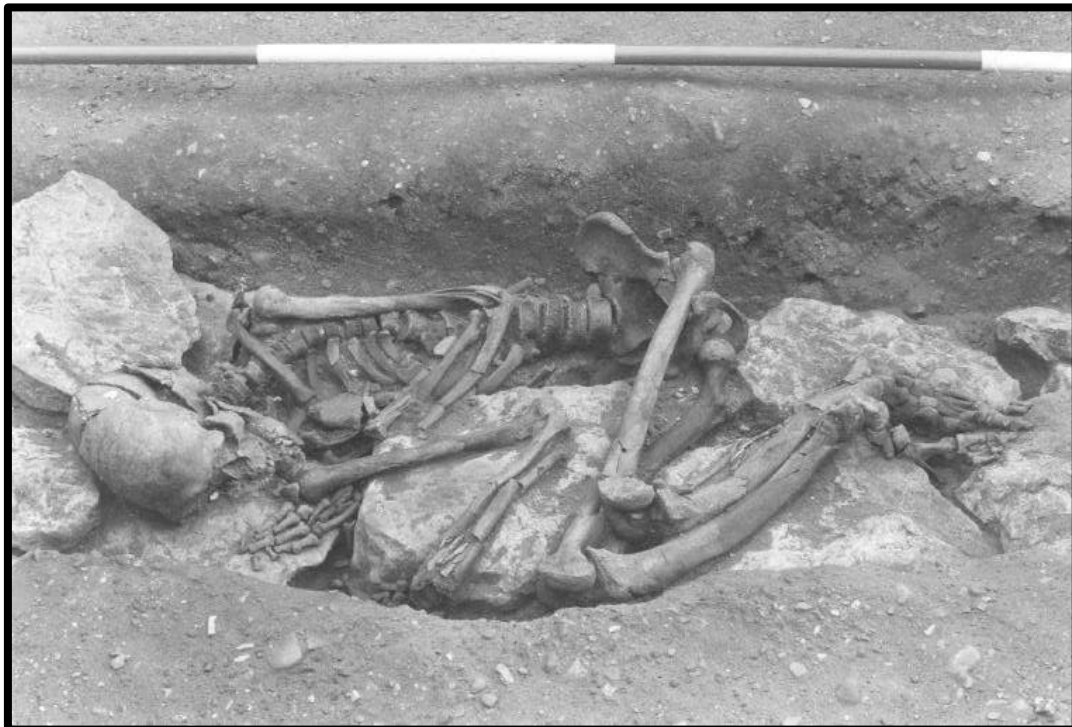
Figure 10.7 Burial 6 from the eastern barrow (Mackreth forthcoming).

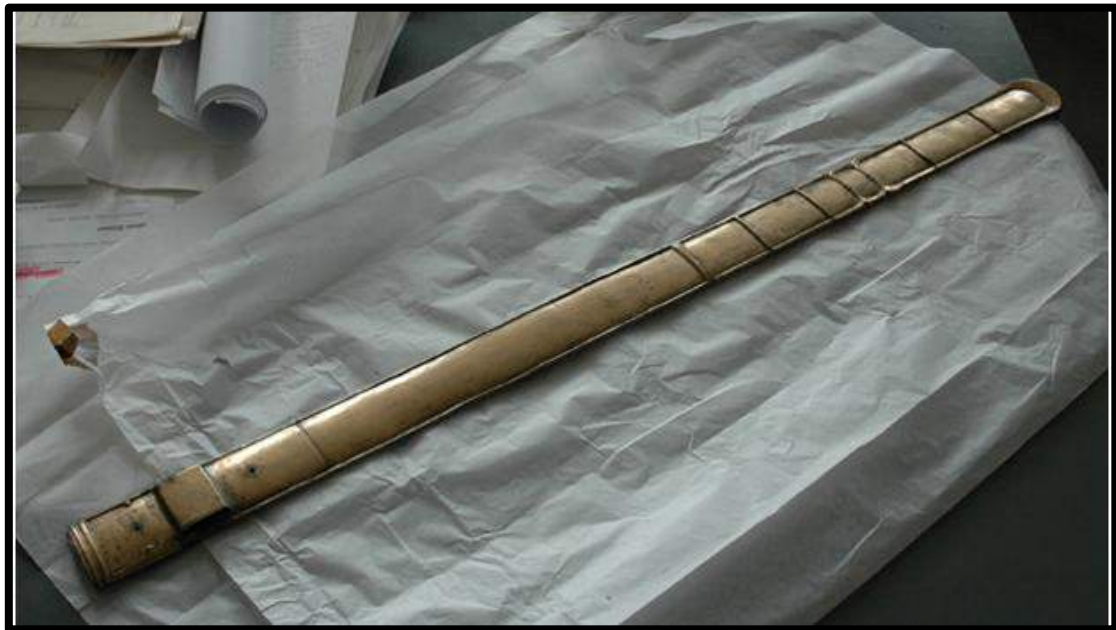
Figure 10.8a The most recent sword from Orton Mere found in 1983

The most recent Iron Age sword was found in 1983 and was a 'La Tene' sword with exquisite bronze scabbard, which would have been owned by a chieftain during the Iron Age, possibly the first century BC. The sword has a rare maker's mark on the blade; similar marks have been found in Europe showing a pan-European trade in such items long before the Romans came to Britain. A wear hole on the bottom of the scabbard may have been made by the owner being

rather short and his scabbard dragging on the ground! The sword was found at Orton Mere in Peterborough in 1983; it was probably a ritual deposit, an offering to gods or ancestors being placed into the waters. Similar pre-Roman offerings have been found in the Peterborough area. The sword and scabbard went on display at Peterborough Museum, only to be stolen. They disappeared for many years only to turn up at auction in Germany in 2005. They were identified and returned to Peterborough Museum in 2007, where they are now on display.

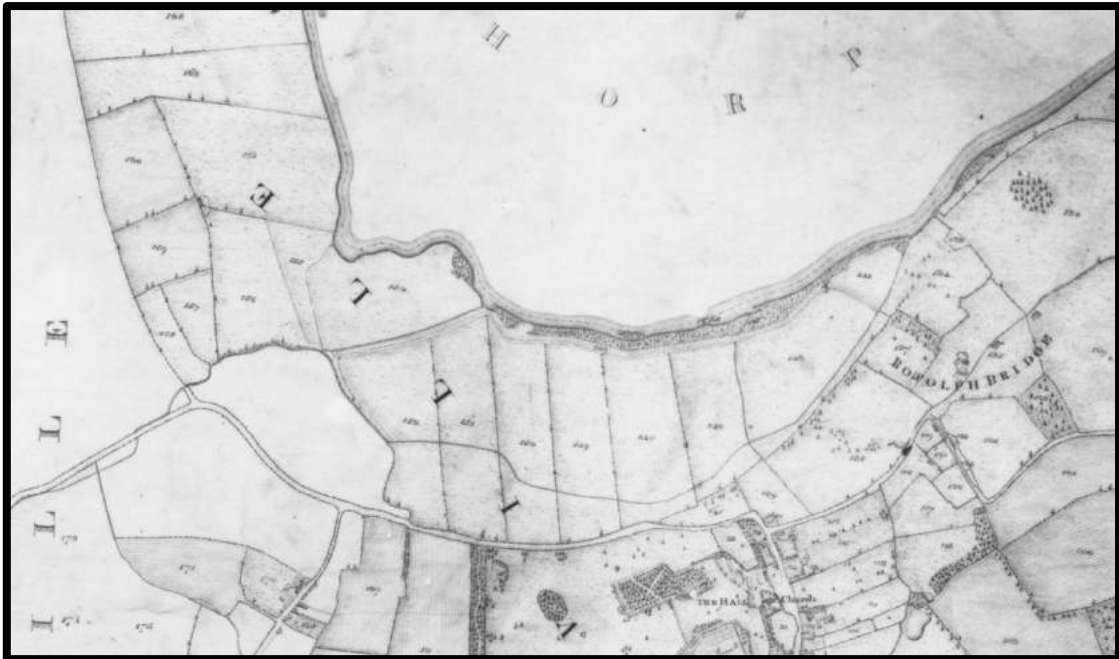
Figure 10.9 Detail of a map dated 1809 by William Custance showing the field layout within Area 10. (HRO.-SRS/15)

There are local features such as hedges that still survive from the 18th and 19th century agricultural landscape in the form of remnant hedge lines and water courses. These can be traced on early maps of the Area shown in Figures 10.9, 10.10 and 10.11. The landscape of Orton Longueville parish was enclosed at some time before 1736 (Parkinson 1813), following an Act of parliament in 1728 (VCH Hunts, 1936. 190) and nothing is known of the former open field arrangements. The fields of Orton Waterville were enclosed later in 1809 (HRO SRS/15) and prior to that time there were three large open fields: Ham, Bush and Church Fields. The post enclosure fields were laid out with hedges and can be seen in detail on the map dated 1809 by William Custance.

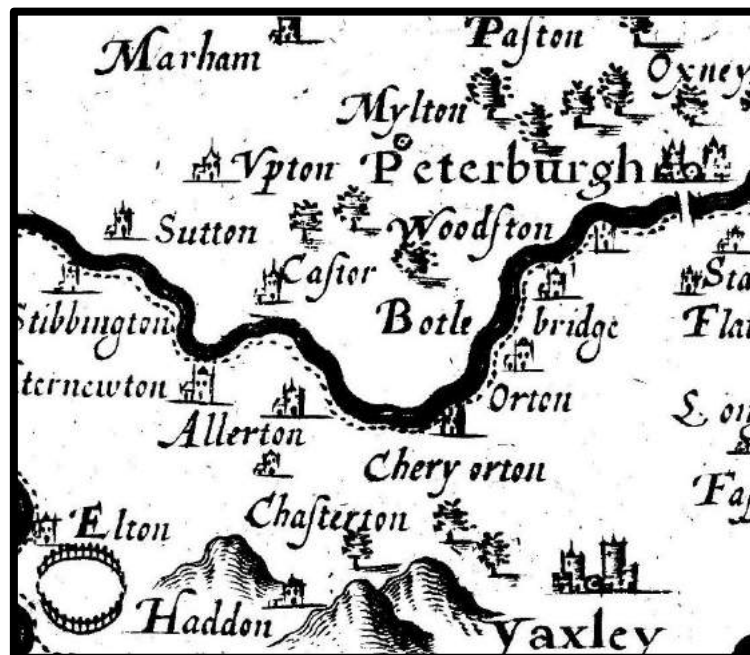
Figure 11.4 Detail from the 1607 map by Saxton and Kip showing the position of Botolph Bridge – here called 'Botlebridge'. (Private Collection)

The church and village are shown on the 1607 map by Christopher Saxton and William Kip and earlier on the 1576 map by Christopher Saxton (Figure 11.4). The village and church are still depicted on a later map of 1649 by William Bleau (Figure 11.5) but by the 1808 estate map made by William Custance (Figure 11.6) the site is shown as open and the area had reverted to fields. And the site of the church is simply marked on the 1886 OS map of the area (Figure 11.7). The decline of the village and church are outlined by Spoerry and Atkins (2015. 14-16, 20).

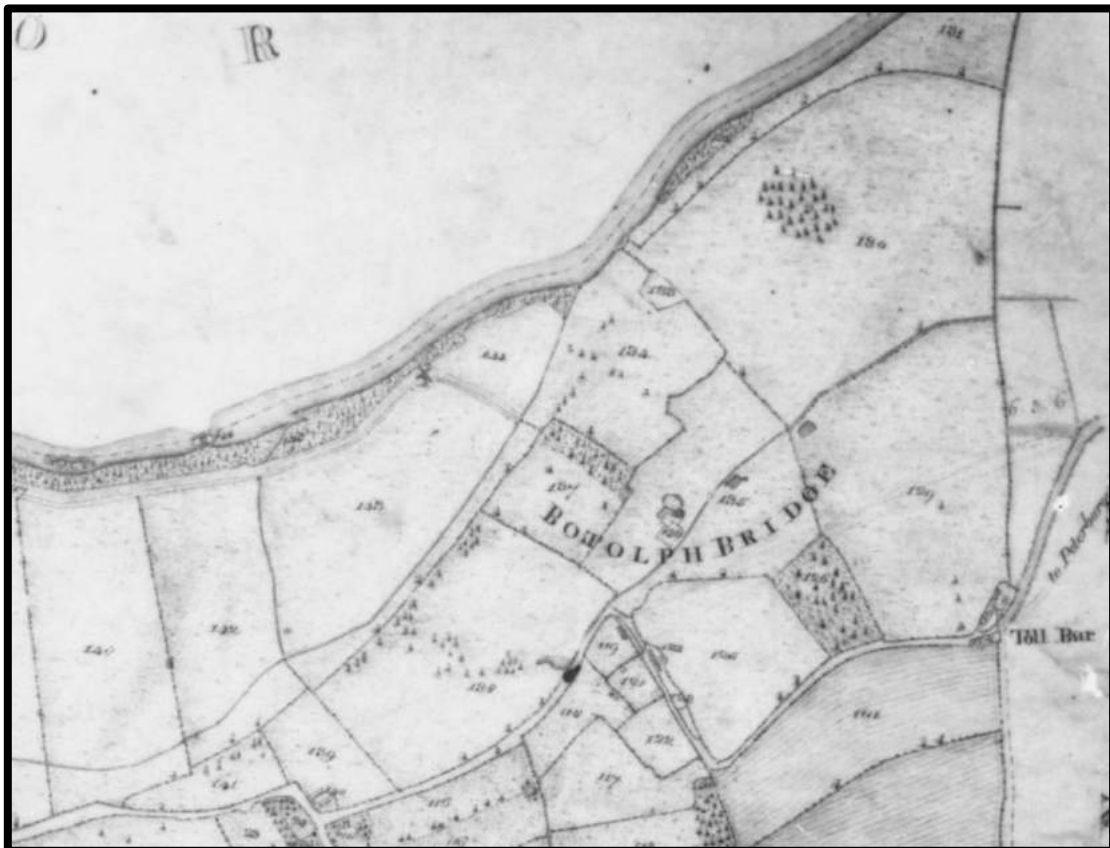
Figure 11.6 Detail from a map dated 1808 by William Custance which shows the area of the village and church now devoid of buildings and laid out to fields. (*HRO map 3/13*).

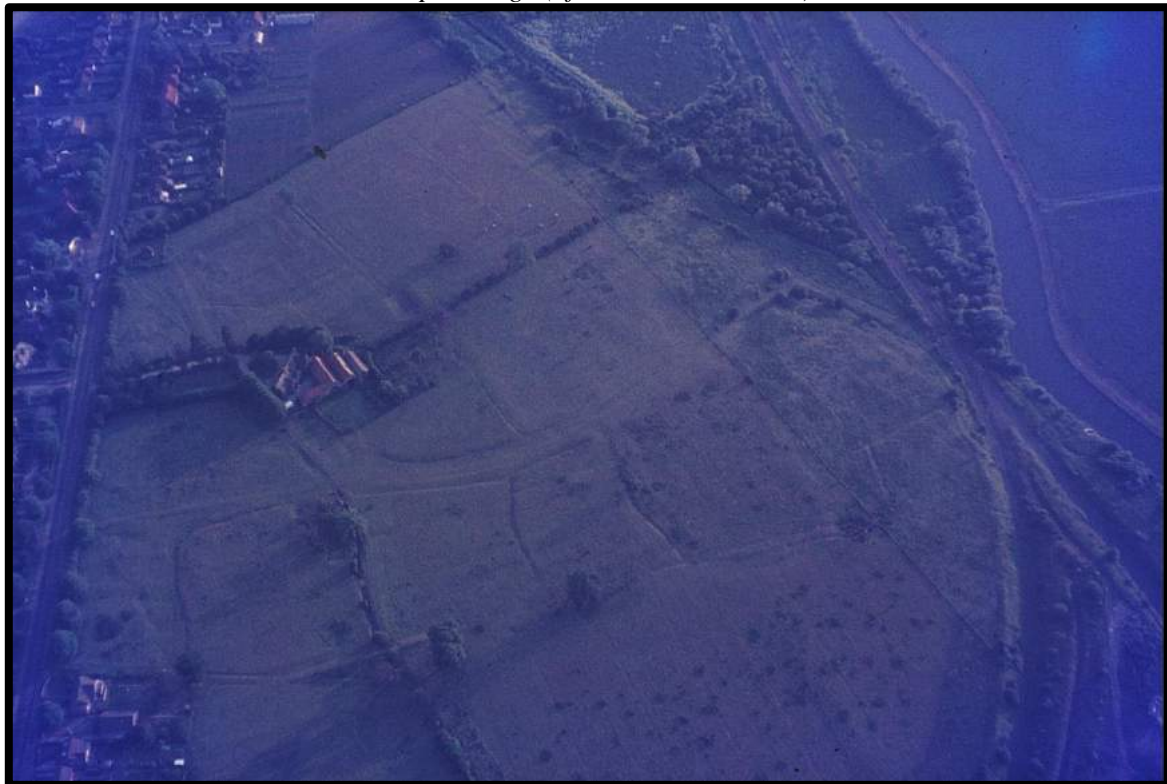
Figure 11.9a Air photograph looking south west showing the area of Botolph Bridge village, Church and manors (SGU/NVAT)

manor and the small manor of *Overton* (VCH 1936). The site of one of these manors can be identified within Area 11. and to the south of the site of the church and is shown in Figure 11.9a and 11.9b. Botolphbridge or Bottlebridge is now only a hamlet in Orton Longueville parish, containing a few houses and has been engulfed by new housing development so that very little of the original layout of the area and village survive.

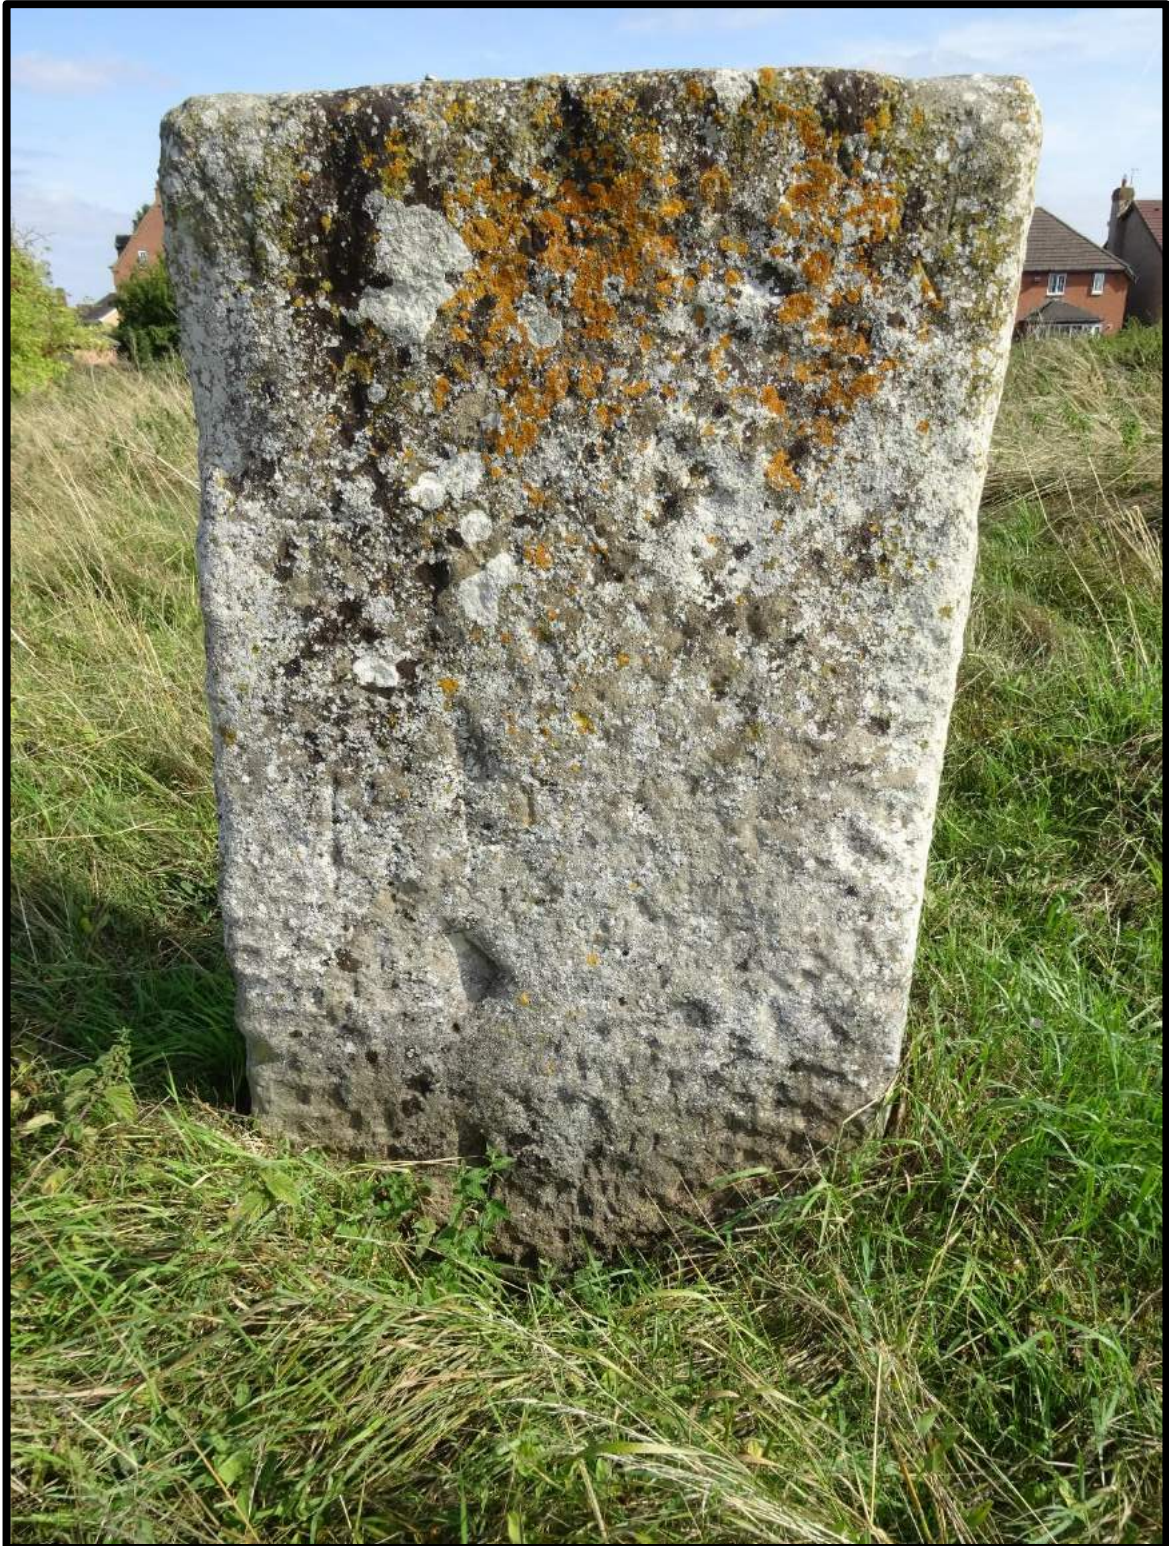
Figure 11.15. *The stone slab, standing 1.30m high marking the church site. The slab shows evidence of medieval adze tooling and a vertical line of 'v' shaped cuts which remain difficult to interpret. (SGU 2018)*

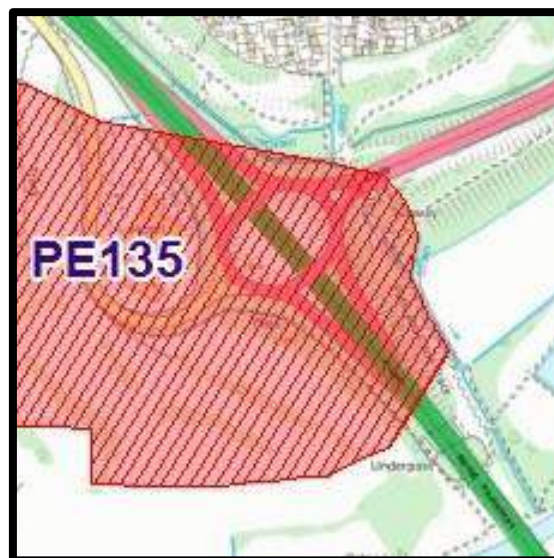
Figure 12.2 The western part of Area 12 showing the extent of the scheduled monument area.

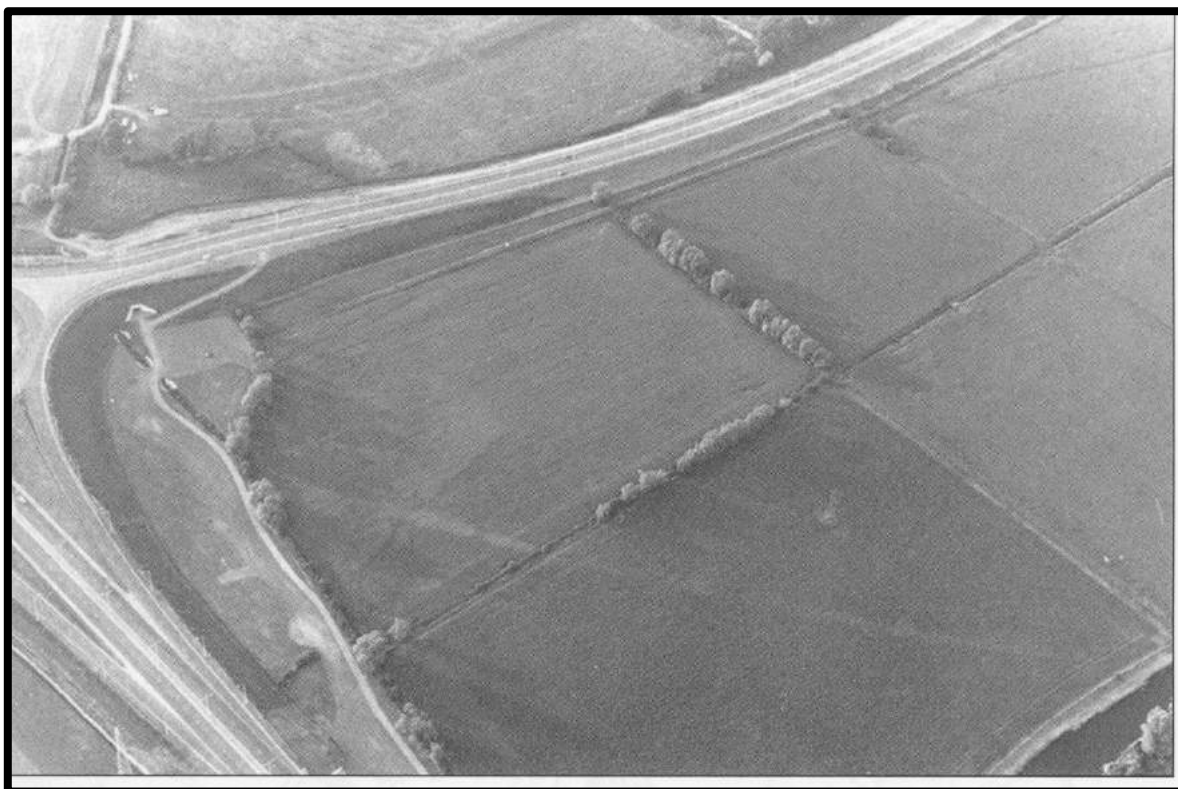
Figure 12.3 Air photograph looking northeast showing the possible line of a Roman road making for the crossing of the river Nene opposite Botolph Bridge. The Longthorpe parkway is to the top of the image and the rowing course is yet to be built. (SGU/NVAT)

The line of a parch mark (Figure 12.3) showing on air photographs which may be the line of a Roman road running from the area of the Longthorpe fortress (see Area 13) to a crossing of the river Nene at the point opposite to Botolph Bridge which, as the village name suggests, marked a crossing point of the river. The Lidar plot is unclear at this point as since this earlier photograph was taken the construction of the rowing course has caused the area to be graded down and the topography to have been changed. Spoerry and Atkins (2015. Plate111) suggest the line of this road and its possible route to the Longthorpe fortress but this line is by no means proven and awaits further archaeological confirmation. The early edition of the OS 6 inch map (see Figure 12.5) suggests a slight rise in the ground at a point that would coincide with this road and may represent some form of causeway to get this road across the floodable area alongside the Nene.

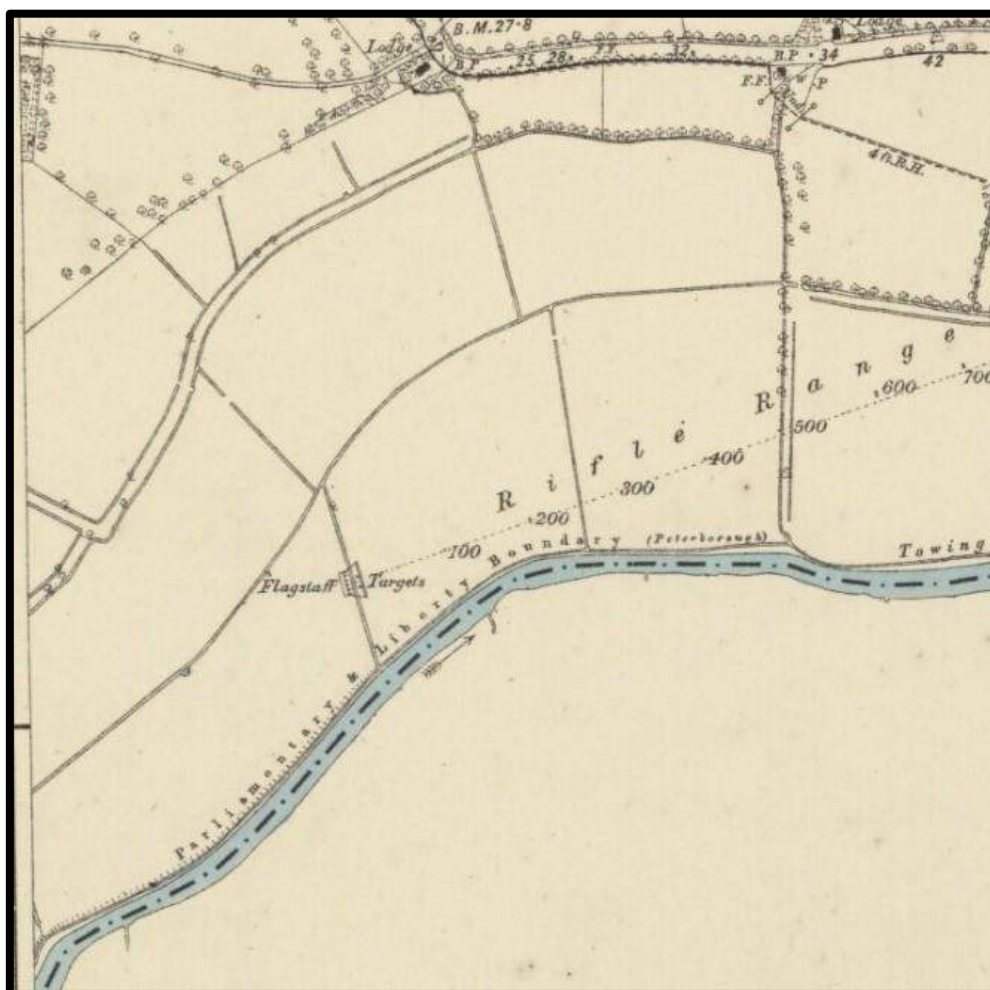
Figure 12.6 Detail from the OS 6 inch map showing the layout of fields in the eastern part of Area 12 with the line of the 'rifle range' and its 'butts' (target) marked (OS 6 inch Northants VII SW 1886)

The area to the south of the Longthorpe parkway was within the former park area associated with Thorpe Hall. There are no obvious visible remains of this park area within Area 12. Early maps of the area show a layout of fields (See Figure 12.6) that must date from the enclosure period, although when the enclosure in Longthorpe took place is uncertain. A map dated 1808 may represent the enclosure landscape (NRO map 1823) while an earlier map of 1798 shows some open field areas, but these areas are very small (NRO 1965). Figure 12.5 shows the layout of the landscape in 1886 at the western end of Area 12 and Figure 12.6 shows the landscape at the eastern end of Area 12. The NPT's area of this park is now within the leisure amenity next to the rowing course and as such appears to be stable in its overall condition.

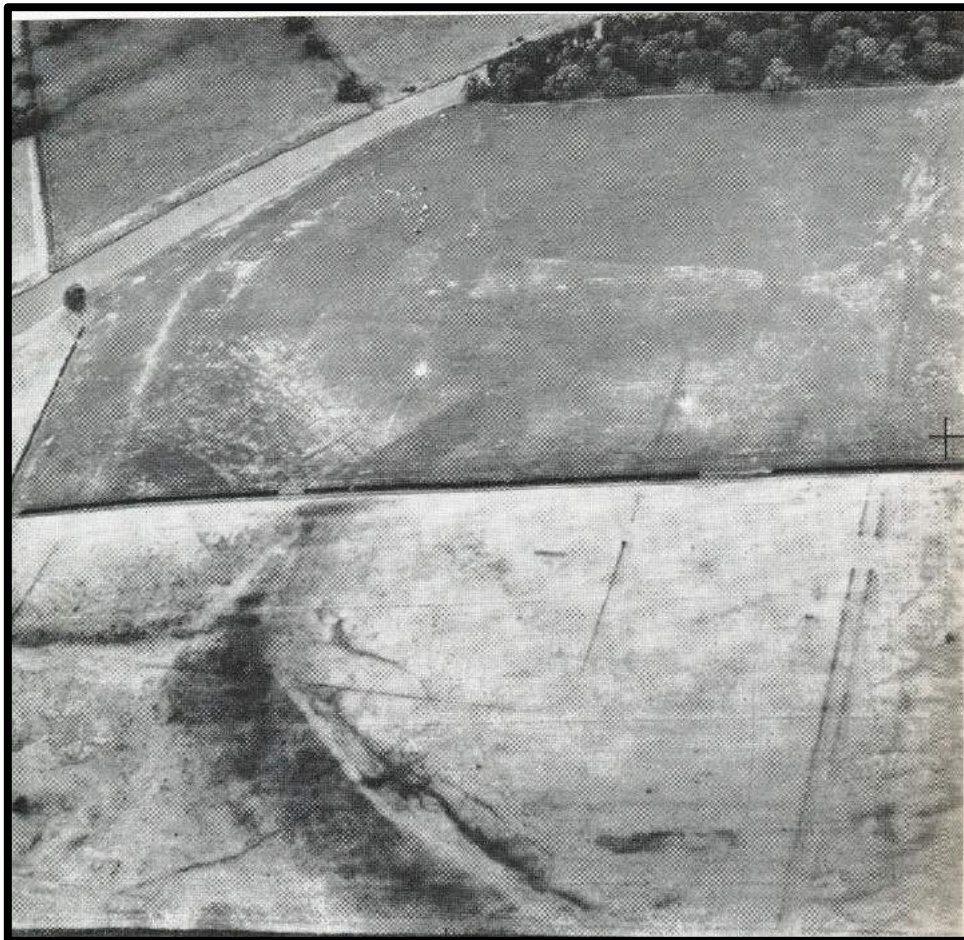
Figure 13.6 The Roman Fortress looking west with the river Nene top left. The inner (single ditch) and the outer earlier defensive circuit (double ditches) are seen as dark lines on this B&W image. (CUAPC)

The dump rampart of the fortress, now ploughed away, was protected externally by a pair of ditches, each 2 metres deep and 4 metres wide. There were four gates, of which the north and east gates have been excavated. They have double portals 4 metres wide and are flanked by guard-chambers 3.30 metres square.

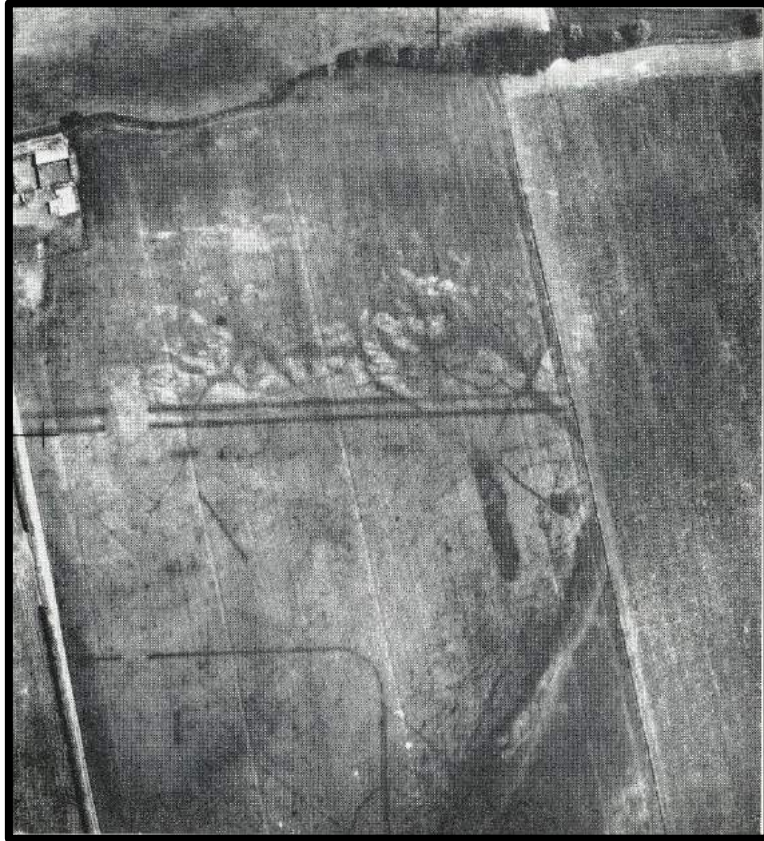
Figure 13.7. *Near vertical photograph of the north-eastern quarter of the fortress again showing the inner (single) and outer and later (double) sections of defensive ditches. (CUAPC)*

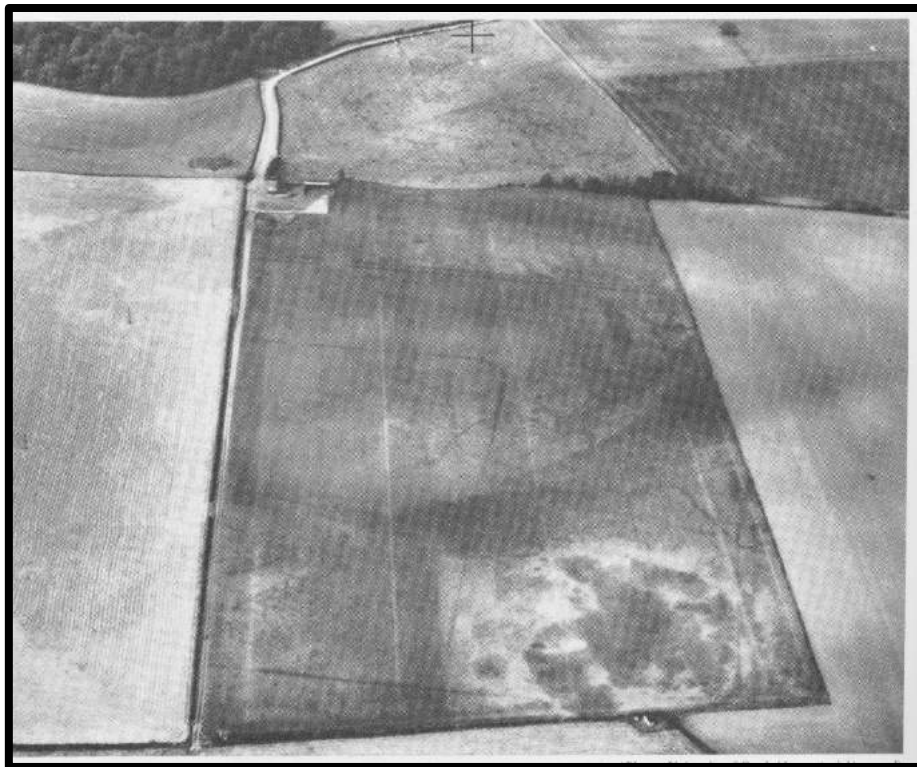
Figure 13.8 *The fortress looking east with the disturbance of the old quarry in the bottom right (CUAPC)*

described as Site 13.6 or it may be linked to the area of quarrying (see Figure 13.8) which is seen on the air photographs within the corner of the fortress.

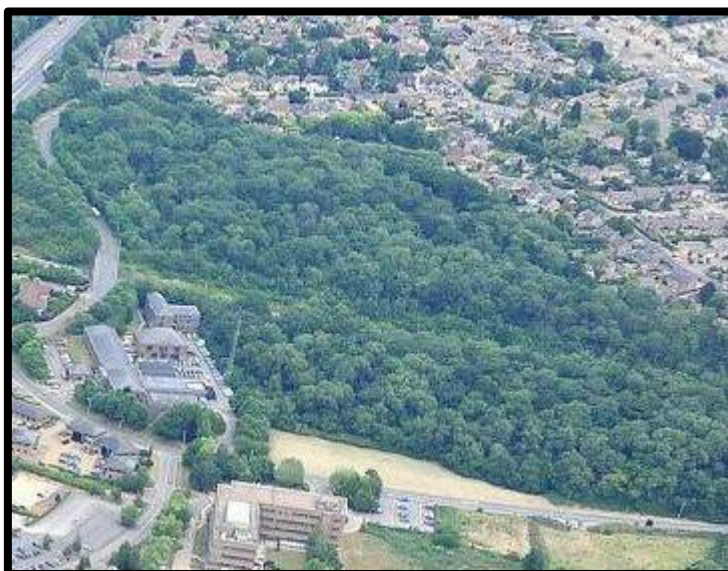
Figure 14.2 The area of Thorpe Wood seen looking east with the housing development of modern Longthorpe beyond (NVAT/A & CPC and St K's)

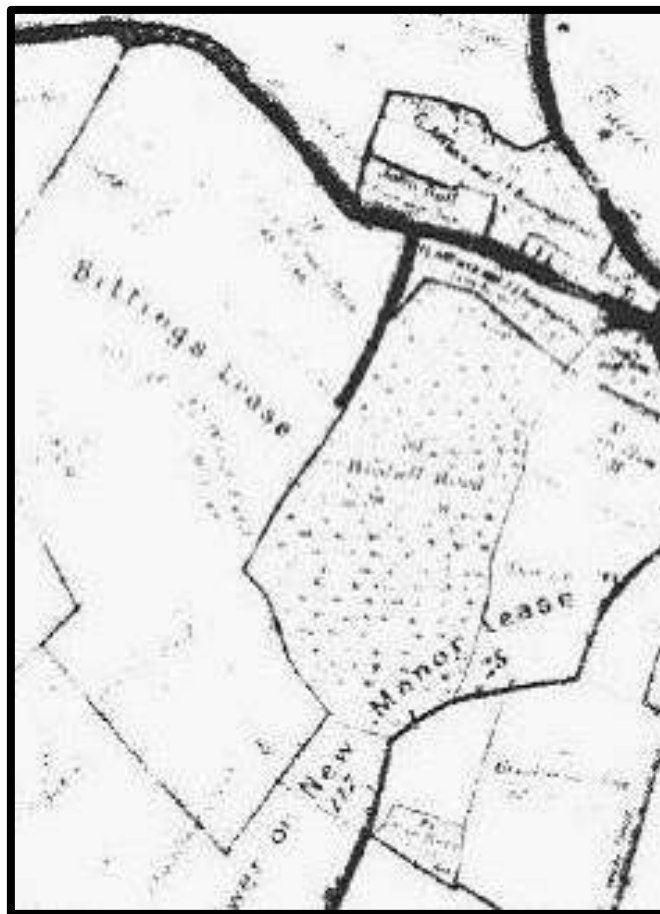
Figure 14.3 Detail from a map dated 1814 showing Thorpe wood then called Wostell Wood.
(Private Collection)

The overall shape of the wood area appears not to have changed although the name has changed over time. In 1814 (Figure 13.13) the area was called Wostell Wood and this name continued to 1832 when the area is shown on a map by Robert Dawson (Figure 14.4).
