Heritage Audit and Landscape Assessment for the Nene Park Trust 2018

For and on behalf of the Nene Valley Archaeological Trust

At the instruction of the Nene Park Trust (NPT) and funded by the Heritage Lottery fund the Nene Valley Archaeological Trust were commissioned to carry out a full heritage audit and landscape assessment of land within the Nene Park Trust's land holding and management areas. This work was carried out between February and August 2018 by Dr Stephen Upex. The objective of this work was to itemise, record and comment upon all heritage assets with regard to their importance, present state of conservation and the current understanding, in terms of date and function, of these heritage assets. These assets comprised a variety of sites and finds, both historical and archaeological, some as upstanding structures, some as hidden or buried archaeological features and some as individual find spots of coins or pottery of only minor importance. The area of the NPT's holding comprises 137 separate entries within this heritage audit of which some entries consist of large complexes containing multi period and archaeologically detailed landscapes of international importance.

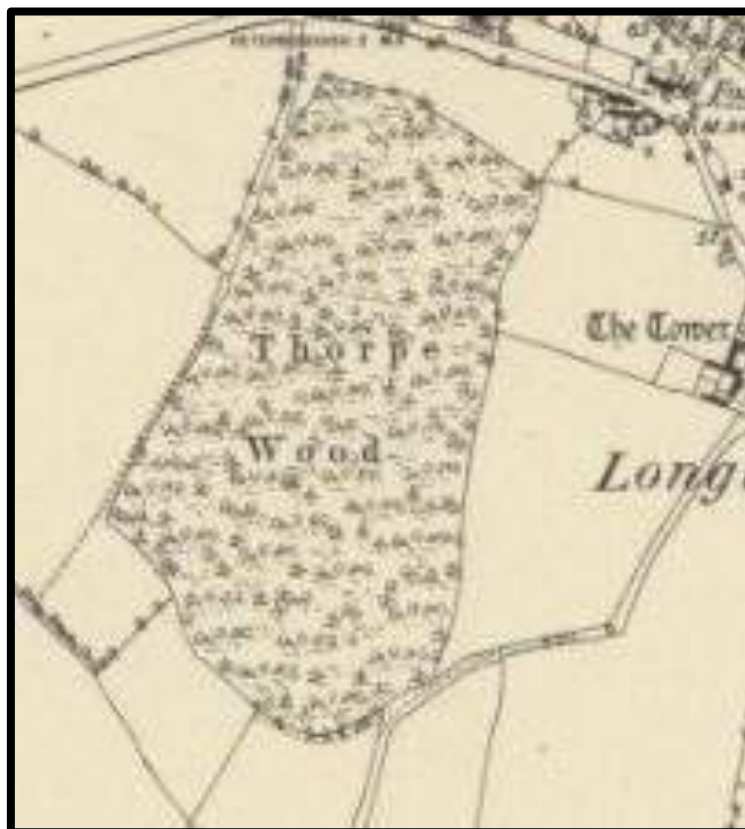
Figure 14.5 Detail from the 1886 OS 6 inch map showing the wooded area now called Thorpe Wood

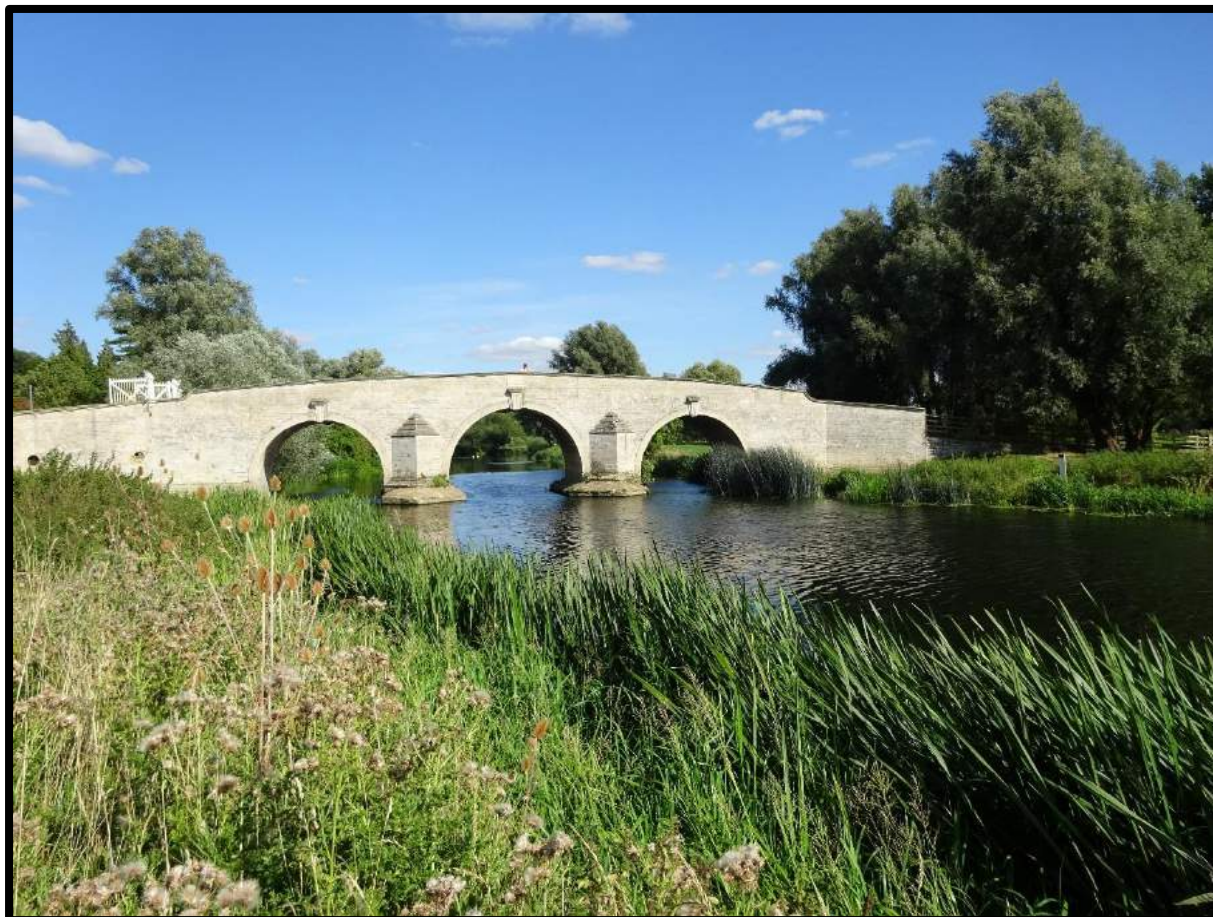
Figure 15.3. *Ferry Bridge (Gunwade Bridge) looking east. (SGU2018)*

Ferry Bridge (also termed Gunwade Bridge) crosses the Nene (See Figure 15.2 and Figure 15.3) in the northern part of Area 15 and was listed as a scheduled monument/building (number 1126812) in 1955 and is Grade II*. The bridge sits on the common boundary of the Parishes of Castor and Orton Waterville. It was listed under the Parish of Orton Waterville on 13 December 1957. The bridge is dated 1716 and is a fine ashlar bridge of 3 spans with round arches with fluted keyblocks and cutwaters. It has moulded parapets ramped up to the centre. The north abutment contains 2 chambers with 2 plain segmental-headed doorways on the east

side and 2 bulls-eye windows on west side. A stone tablet is inscribed "*The Bridge was built at the sole cost and charge of the Rt Hon William Fitzwilliam 1716*". The bridge gave access to lands and houses owned by the Fitzwilliam family in Alwalton. The bridge stands on the site or close to the site of a medieval ferry crossing (Gunwade Ferry – see below) and an earlier crossing of the Nene during the Roman period.

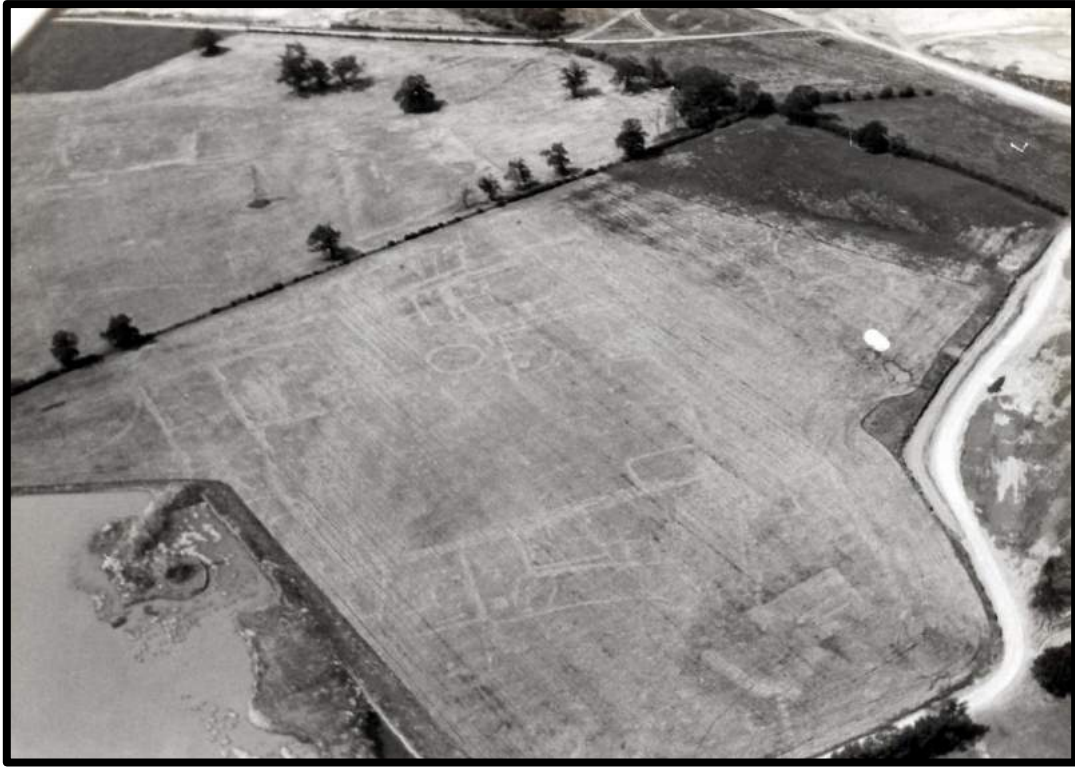
Figure 15.5 Air photograph of the Lynch Farm Complex (Site 15.2) looking north west in 1976 showing crop marks and (bottom left and top right) areas of gravel extraction (SGU/NVAT)

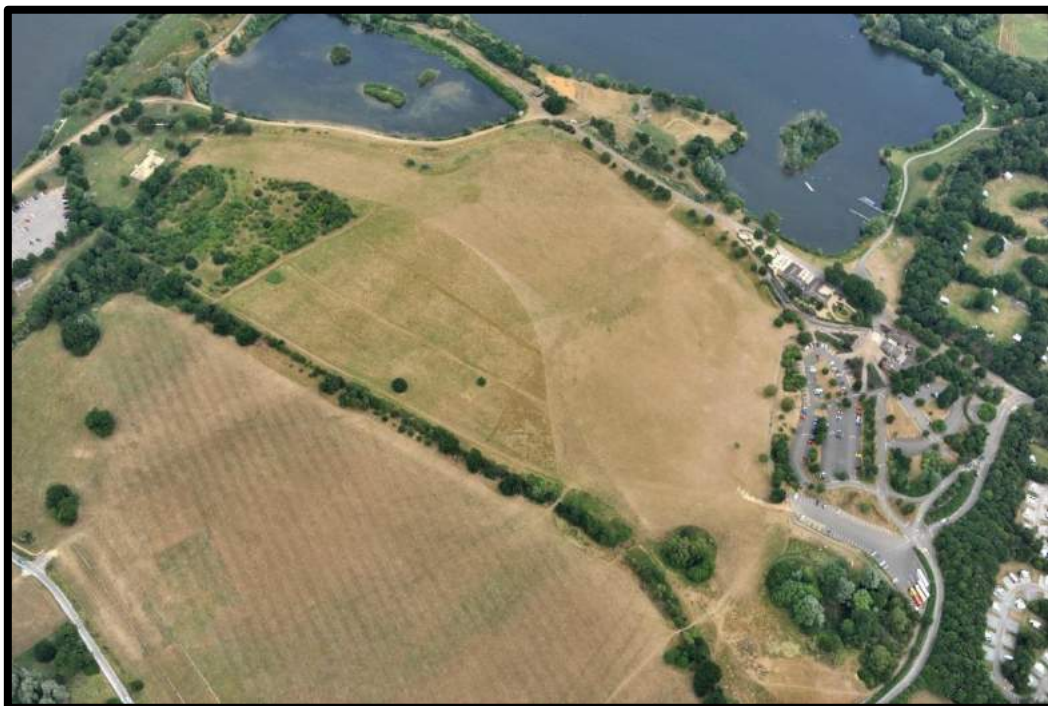
Figure 15.8 The extent of the scheduled area (Site 15.2) with the car park and visitor centre right and the multiple ditched system of iron Age date showing as a crop mark through the grass in the bottom centre of the image. (NVRC/A&CPC& St. K's)

This consisted of a series of internationally important excavations concerned with the multiple ditched system that has been outlined above and where the ditched system has been shown in Figures 15.4, 15.6, 15.7 & 15.8 and within the geophysical survey in Figure 15.14. In addition excavation dealt with Neolithic enclosures and pits and Bronze Age material. This site remains largely unpublished apart from summary notes by Challands (1973; 1974) and notes within the Northamptonshire Archaeological Journal (Northants Archaeology 1974, 85; 1975, 149).

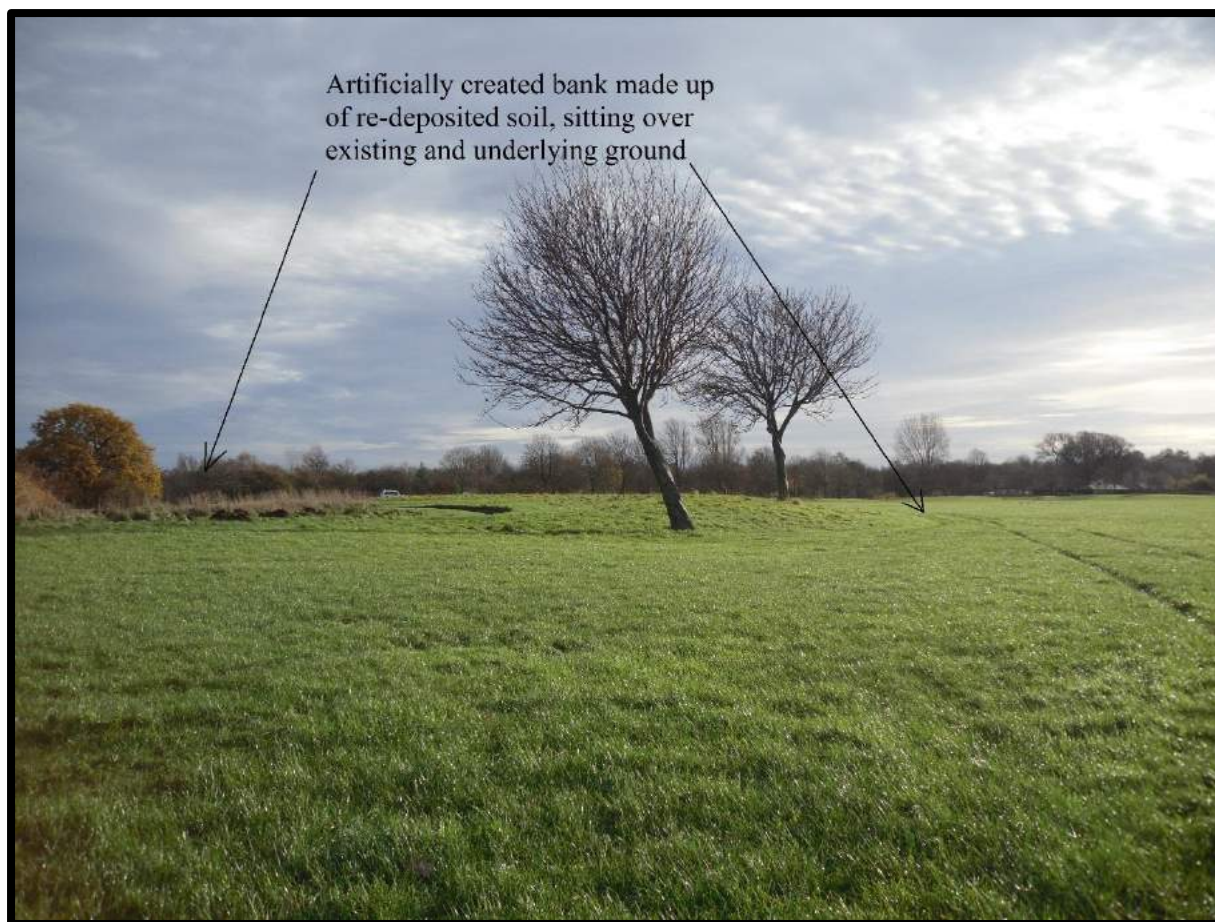
Figure 15.10 The area of tree planting outlined by the watching Brief referenced by HER 53958 which shows the 'bund' of earth around the lake edge and which sits above the level of the rest of the field area and thus over the top of the underlying archaeological features. (Upex 2016)

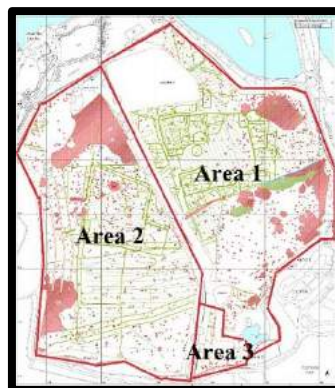
Figure 15.12 The geophysical survey divided up into three areas

The ASD geophysical plot was divided into three working /surveying areas due to the constraints of the landscape of the area. These three areas are shown in Figure 15.12.

The survey commented on the archaeological features in Area 1 (see Figure 15.12) as follows – numerical references are to be found in Figure 15.13. The text is credited to ADS (2016):-

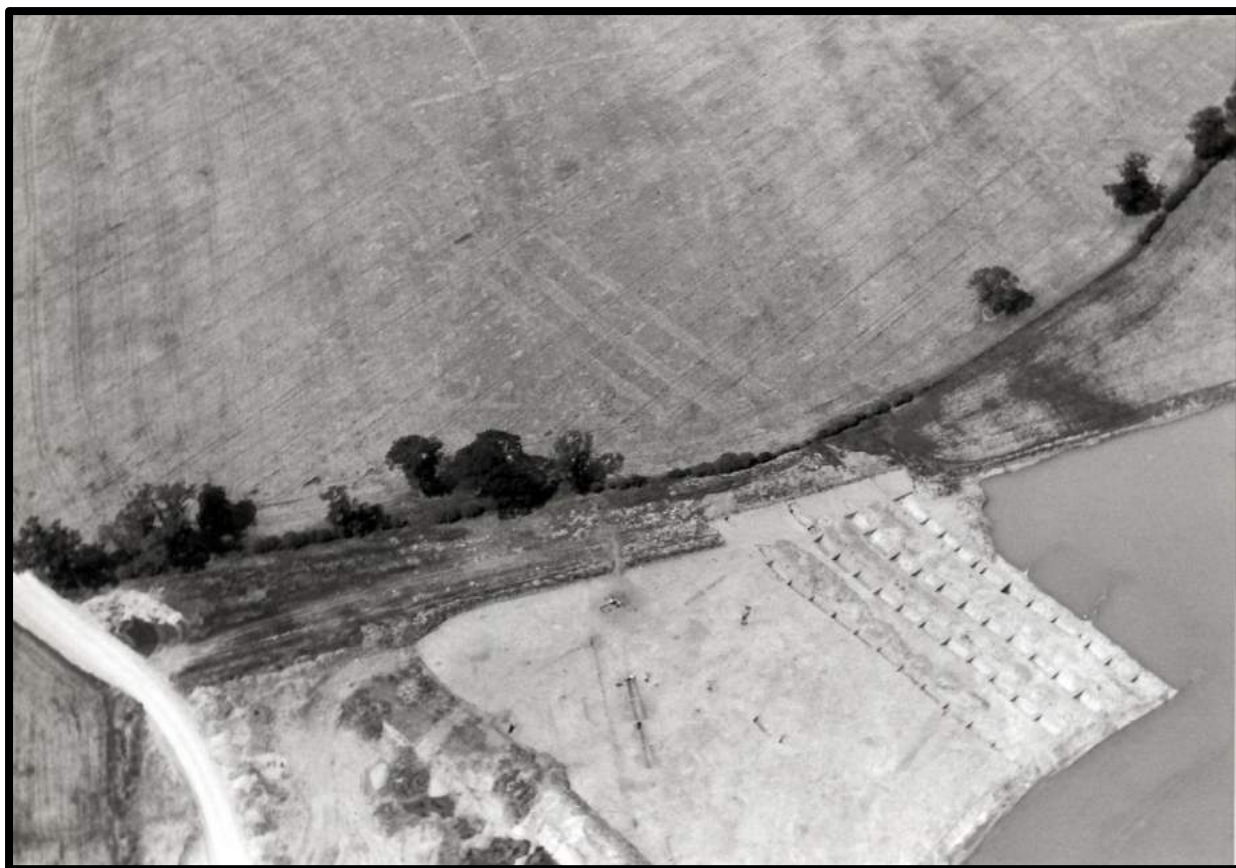
Figure 15.17 Air photograph taken in 1976 looking west and showing the multiple ditched system as a crop mark (upper frame left) and the area of the excavations (lower right). These excavations jut out into the lake formed by earlier gravel extraction. The tree line (top right to lower left) is that remaining between Areas 1 and 2 within the geophysical survey (see Figure 15.12) (SGU/NVAT)

The multiple ditched system is shown in Figure 15.17 where some of the remaining crop marked areas and some of the excavated area are shown.

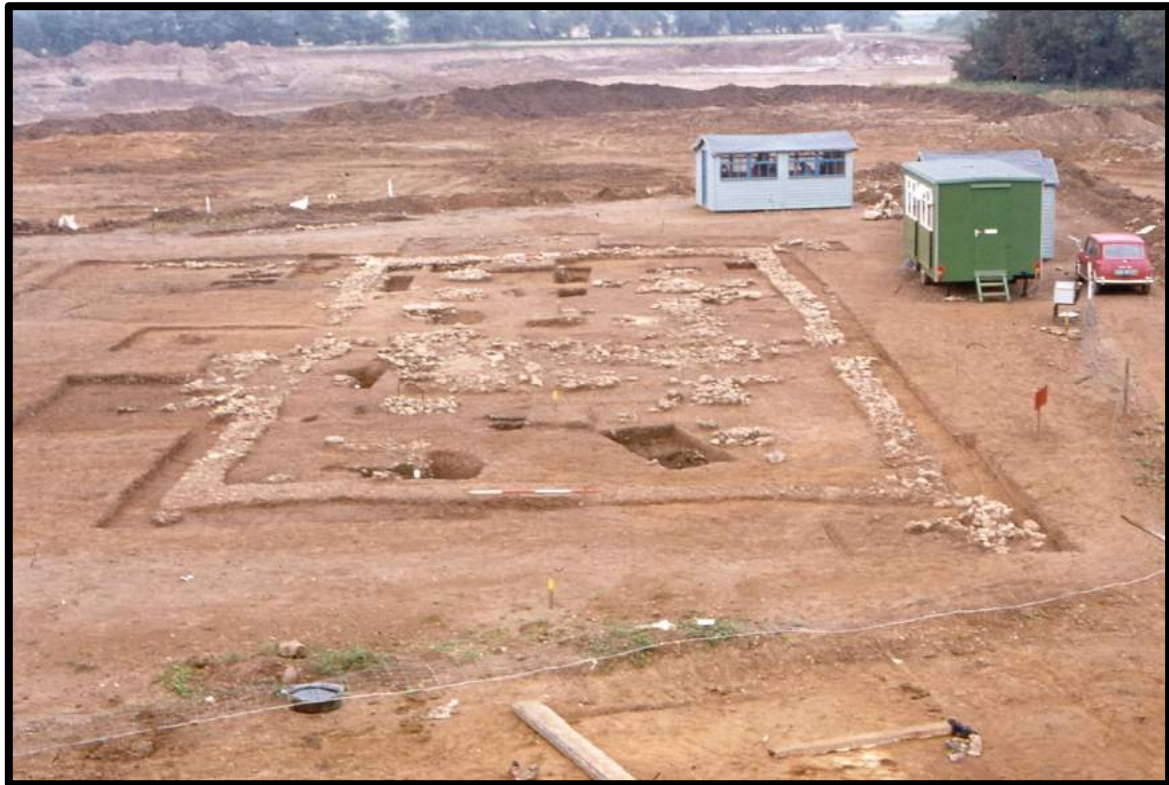
Figure 15.20. *The later phase of the Aisled build at LF2 looking east. (NVAT Archive)*

Initial work during 1972 was also undertaken on excavations over the site of a large Roman aisled building which was within the tongue of land intended for preservation. This work was described in summary form (Wild 1973, 20-21). Further work was carried out on this building and other features during the spring and summer of 1973 where excavations continued to uncover and clear the ditch complexes surrounding the aisled building and other Roman stone structures which lay to the east. One of these features was initially interpreted as some form of fish pond for the breeding of fish and where what was thought at the time to be a stone lined pool was fed by a complex system of ditches and sluices (Wild 1973, 20-21). Work also indicated the presence of earlier features including part of a pit alignment which was thought to date to the late Iron Age and also a double ditched system which was thought to be part of some form of first century military installation (Northamptonshire Archaeology 1974, 92-95).

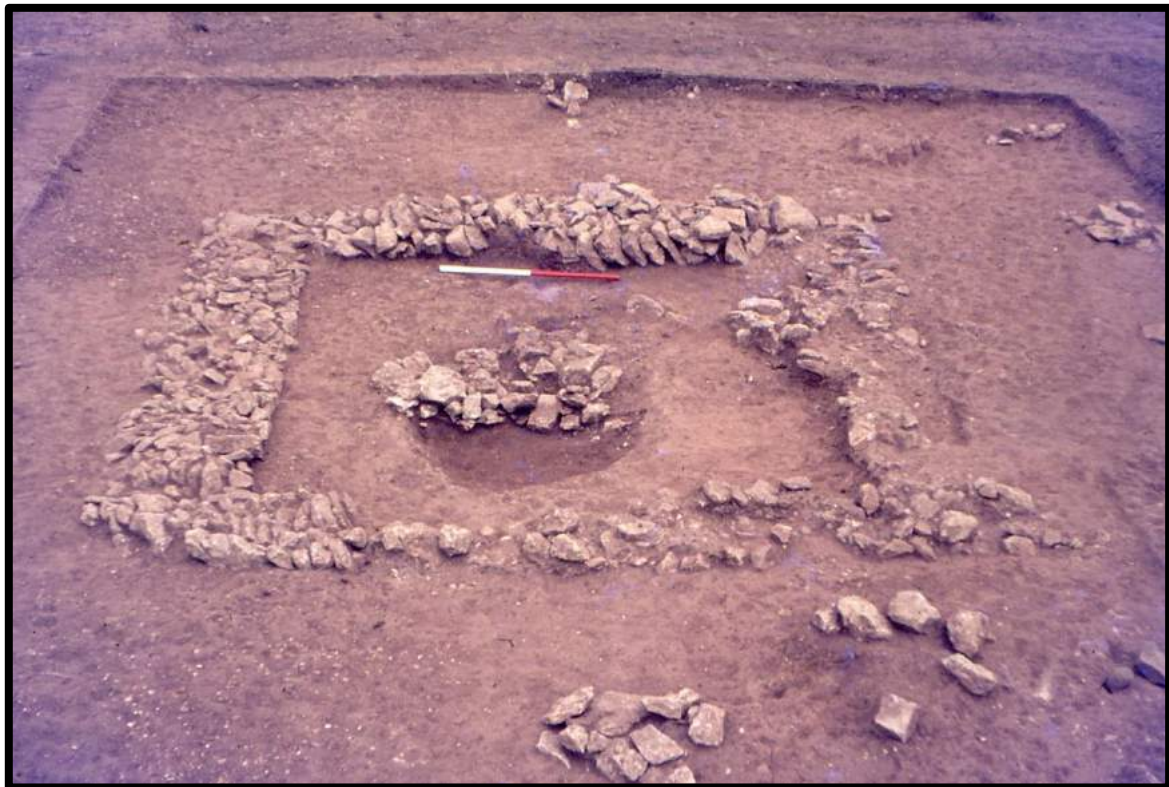
Figure 15.21 *The small Romano-Celtic temple at the site of LF2 (NVAT Archive)*

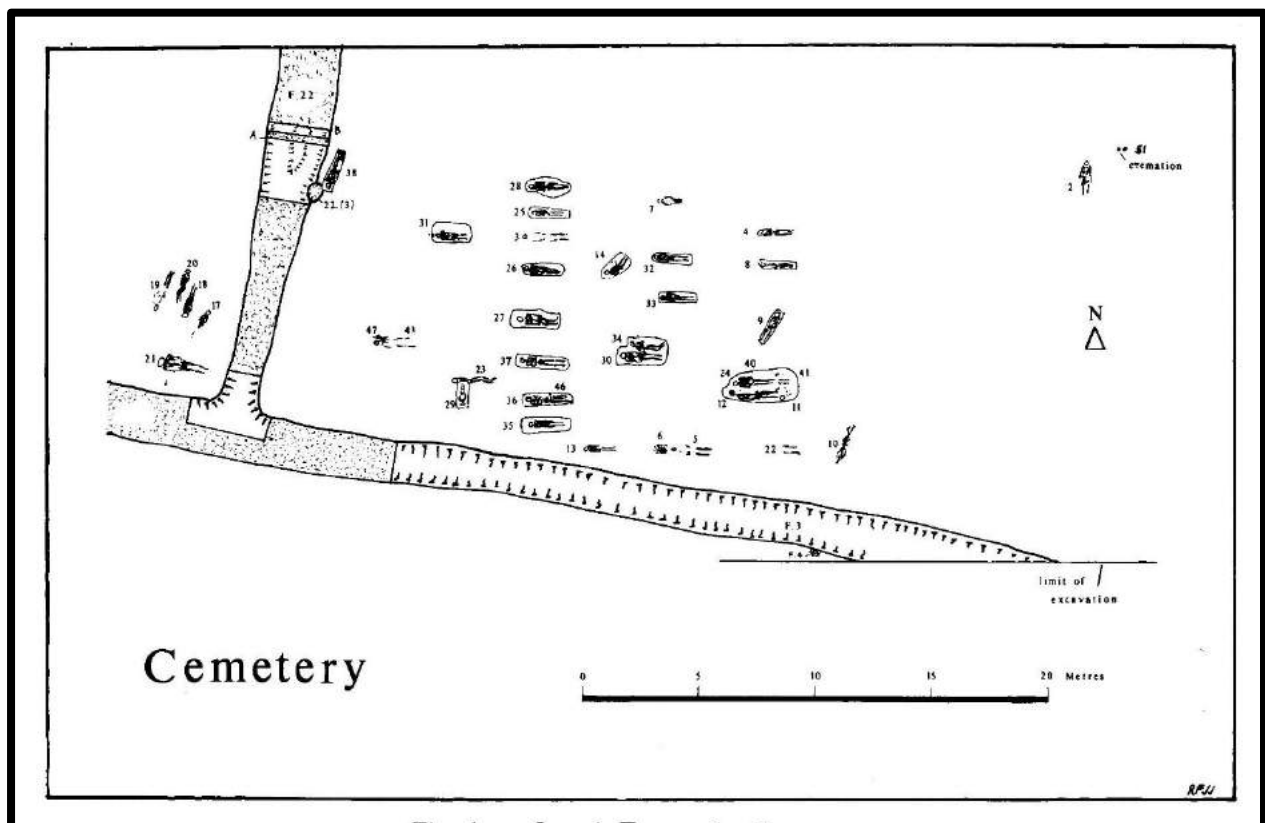
Figure 15.25 Detailed plan of the cemetery area at LF3 (Jones 1975)

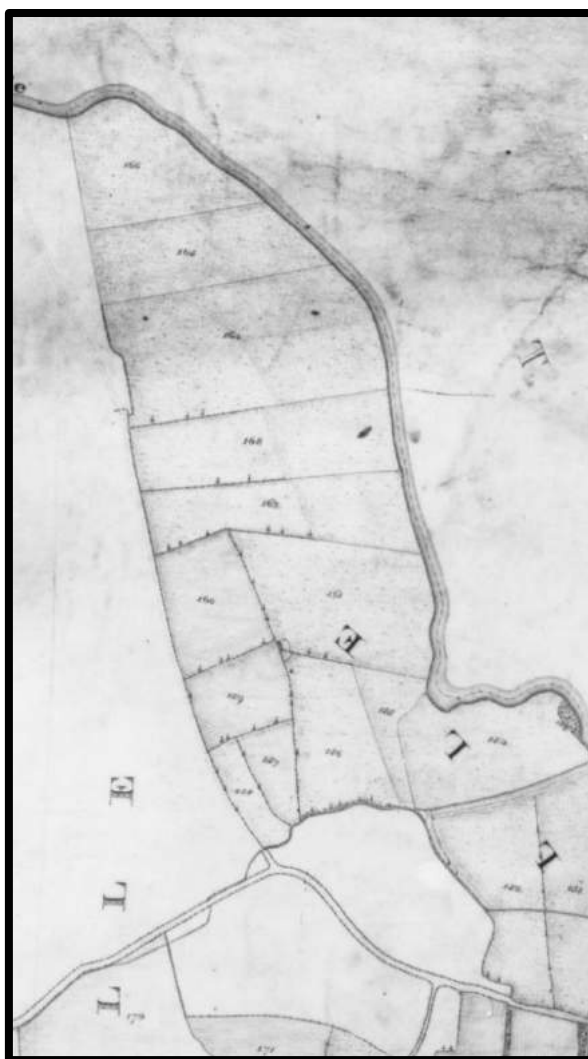
Figure 15.30 Detail from a map by William Custance dated 1808 showing the layout of hedges within Orton Waterville parish (HRO SRS/15)

The late and post medieval landscape is to some extent shown on early maps of the parishes which form part of Area 15. There is no clear enclosure detail for Orton Longueville parish, which seems to have been enclosed in 1736 (Parkinson 1813) following an Act of Parliament dated 1728 (VCH Hunts III 1936, 190). The field layout of the parish is shown in detail in Figure 15.30 on a map dated 1808 by William Custance. Ridge and furrow can be seen on early RAF air photographs of which almost nothing now remains.

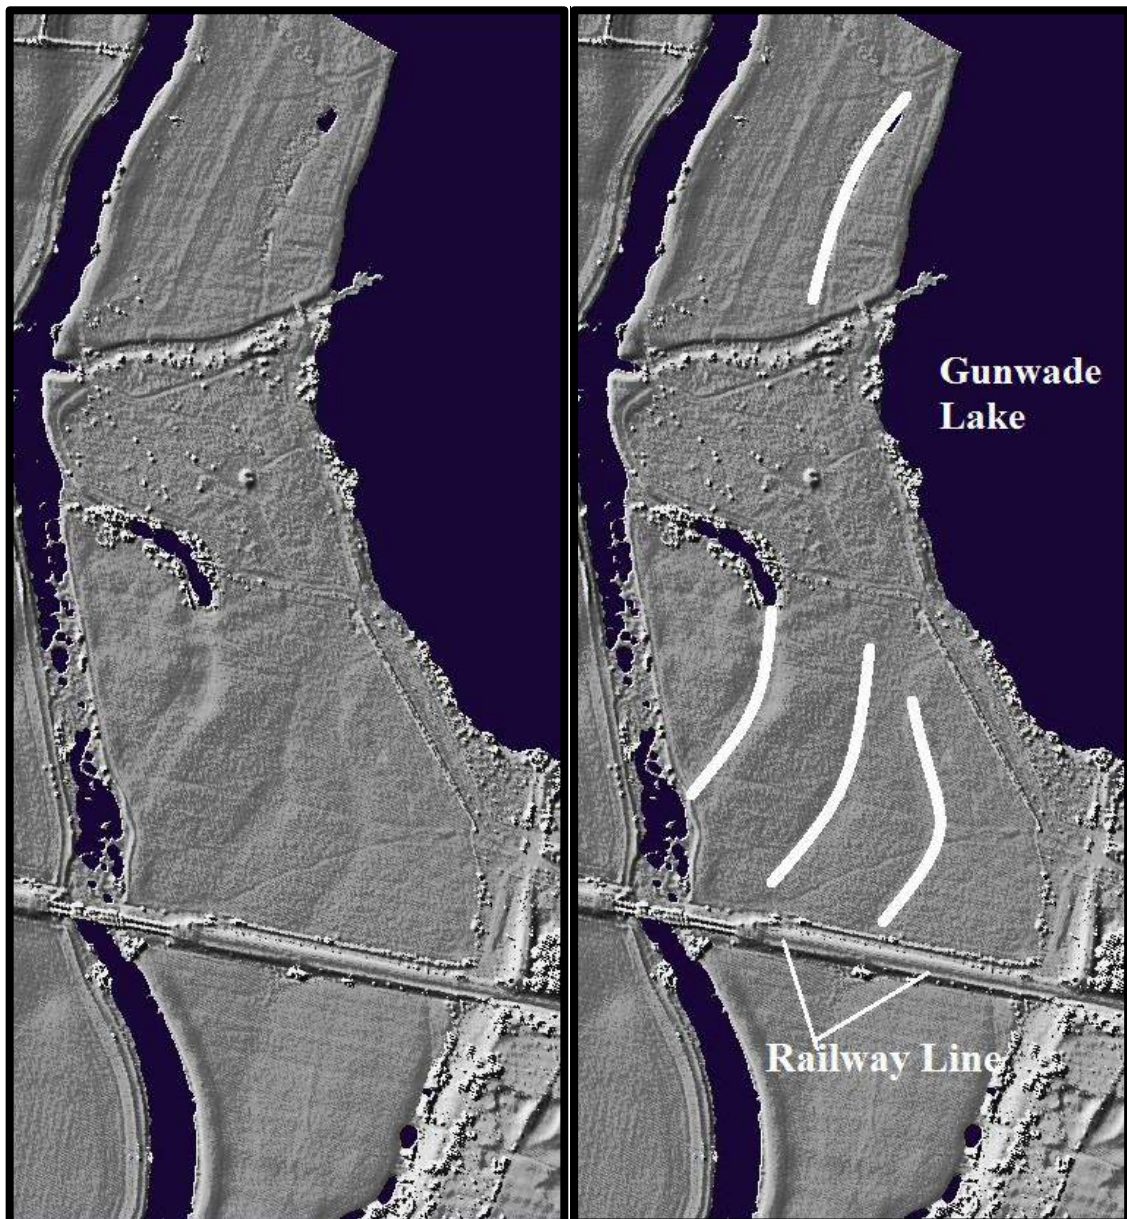
Figure 15.33 Lidar Plot of the western side of Area 15 showing the position of possible palaeo-channels between Gunwade Lake and the River Nene. (The palaeochannels are shown in white in 15.32a)

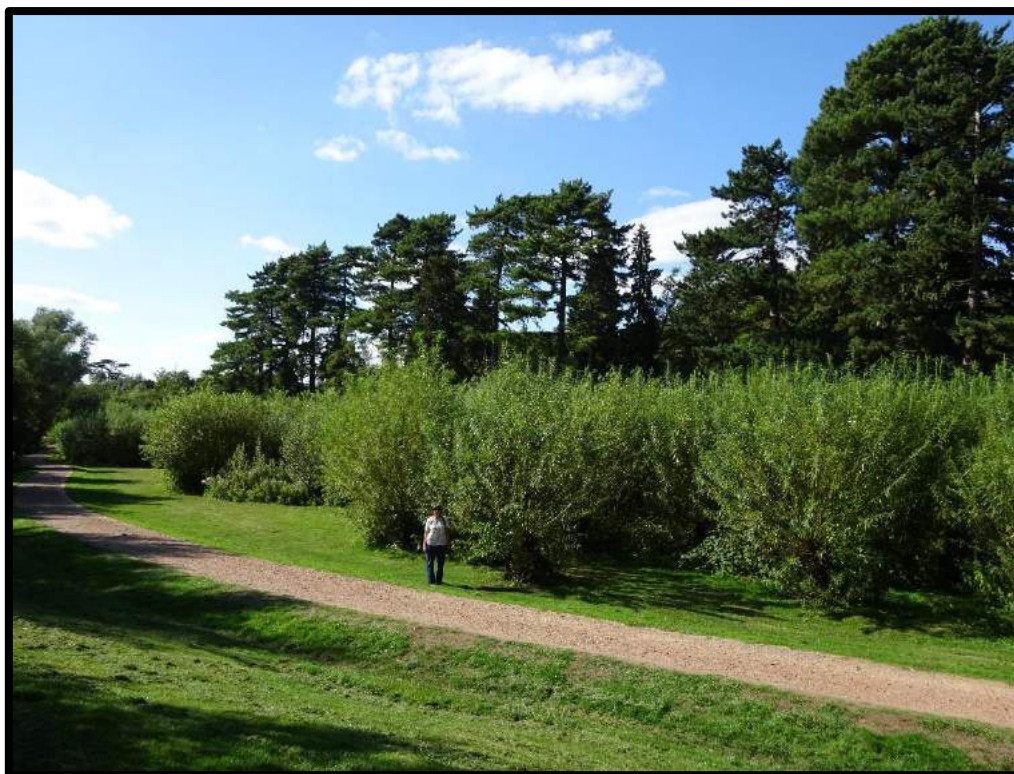
A small remnant of Osier beds (Figure 16.2) to the east of Ferry Bridge. Osiers were cut for basket making from the prehistoric period onwards, although these beds are probably post medieval. The beds are described in Stevenson (2013) –reproduced here:-

Figure 16.2 The Oiser beds looking west (SGU2018)

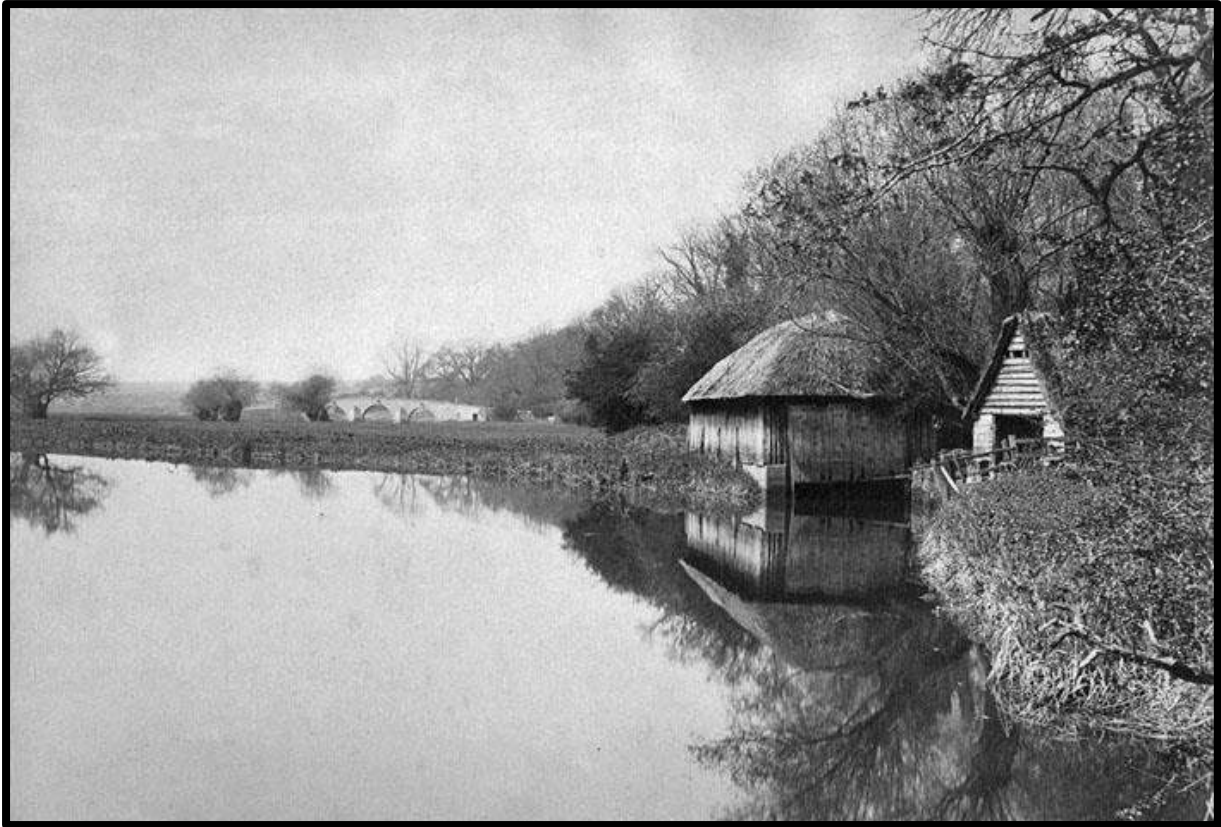
The foundational and photographic evidence (Figure 16.3) shows that at some time there were at least two boat houses set into the north bank of the river Nene to the east of Ferry Bridge. Stevenson (2013) describes the history of the site thus:-

Figure 16.3 The Boathouses below Ferry Bridge (in the background) – undated image but possibly c. 1900 (www.peterboroughimages.co.uk)

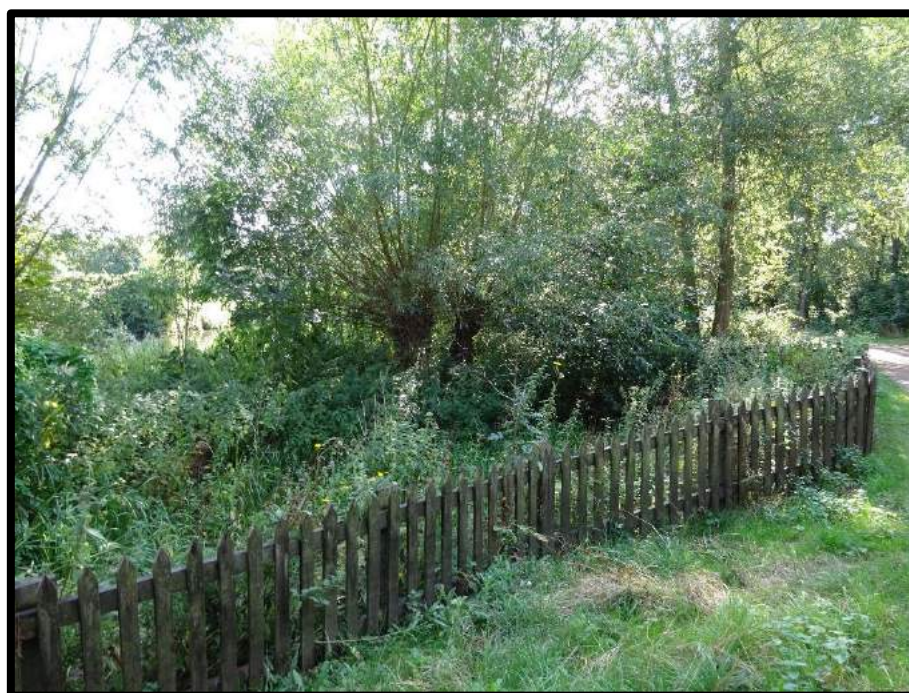
Figure 16.6 The site of the western Boat house (SGU2018)

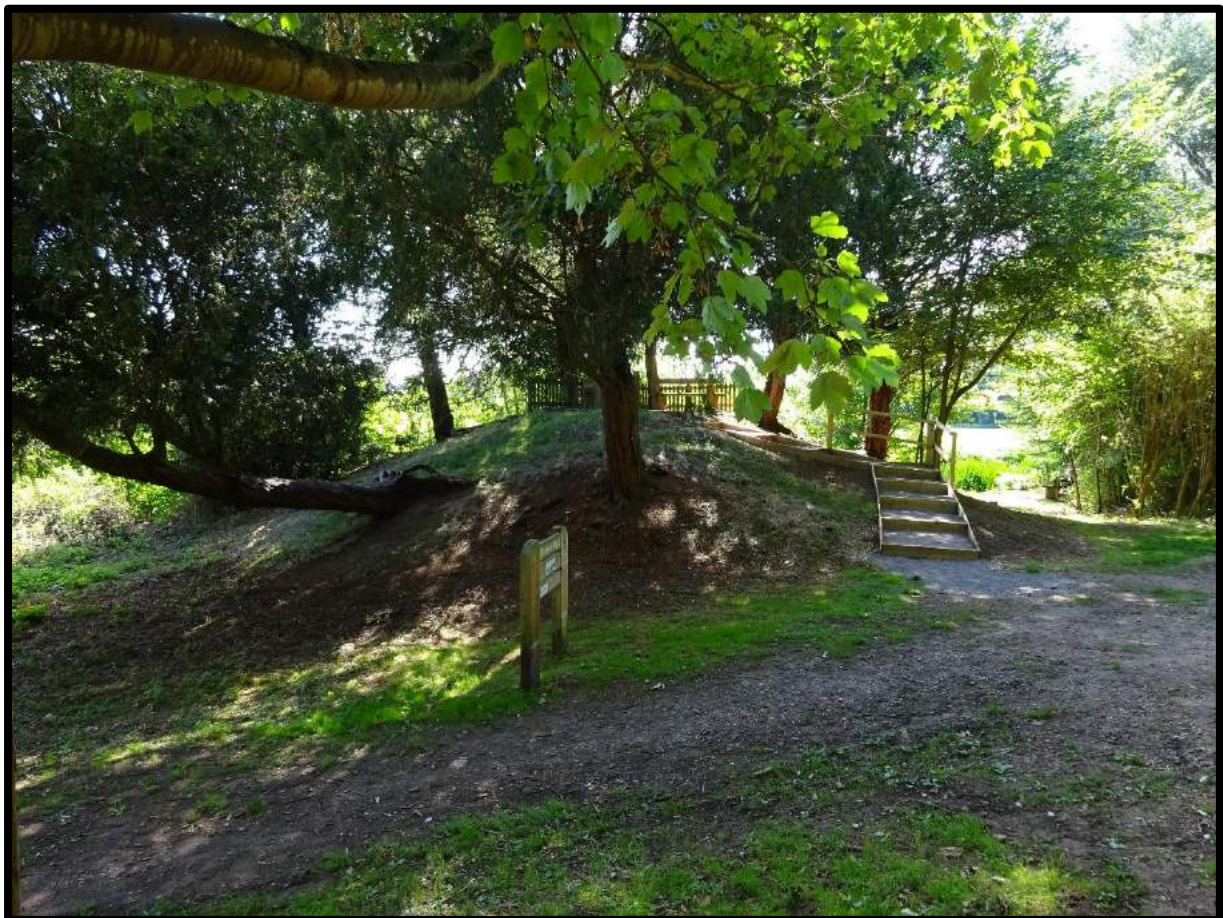
A small man-made mound (Figure 16.7) which overlooks the river Nene. The date of this feature is uncertain but it is probably connected with the use of the area by the Fitzwilliam family in the 19th century and was used as a 'prospect mound' (Harvey 1981) from which to view the landscape. Stevenson (2013) describes the site thus:-

Figure 16.7 The 'prospect' mound in Bluebell Wood looking west. (SGU2018)

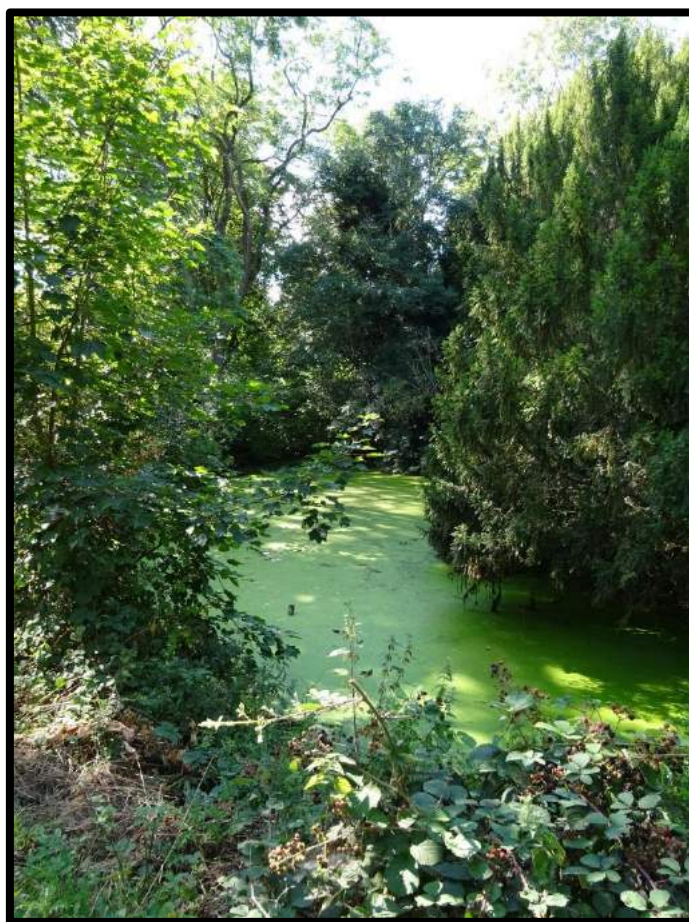
The site of the Sheepwash in Bluebell Wood (Figure 16.8) now largely destroyed. Stevenson (2013) writes of the site that:-

Figure 16.8 The site of the Sheepwash looking west (SGU2018)

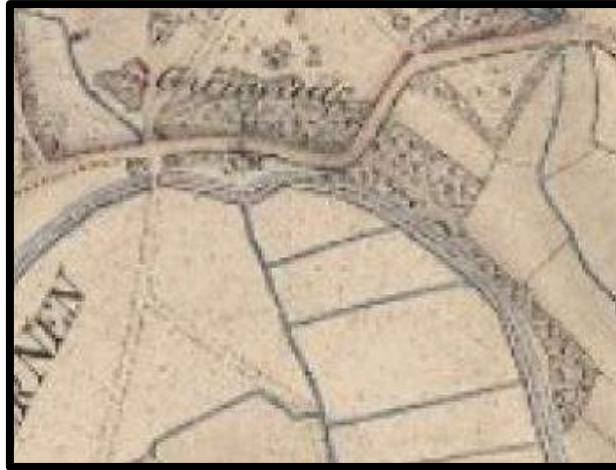
However, another map from the British Library collection, also dated 1814, (Figure 16.11) shows woodland over the same area and it may be that the plantation forming Bluebell Walk was set out at this date and created out of the former open field / enclosed area owned by Earl Fitzwilliam. Certainly by 1832 the woodland appears to have been well established and is shown on a map of that date drawn by Robert Dawson (Figure 12.) and this seems to have been the basic outline plan of the woodland that remained the same in 1887, where it is called Bluebell Walk Plantation Figure 16.13). The planting of yew within this area of woodland further suggests that the whole area was part of a planned leisure walk set out to provide a leisure amenity for the occupants of Milton Hall.

Figure 16.11 Detail from an 1814 map in the British Library showing the extent of the woodland
(Brit. Lib. OSD 267 pt. 2)
